This Standard Timber Pest Detection Report (hereinafter called “the Report”) is issued subject to the Terms and Conditions of Inspection and Report set out in Clause A.1 of this document.

Inspection Date: **11-02-2014**

NAME OF CLIENT: **Mrs Sample**
ADDRESS OF CLIENT:
ADDRESS OF PROPERTY INSPECTED: **123 Sample Lane, Sampleton**
DATE OF INSPECTION: **11-02-2014**
NAME OF PRINCIPAL (where applicable):

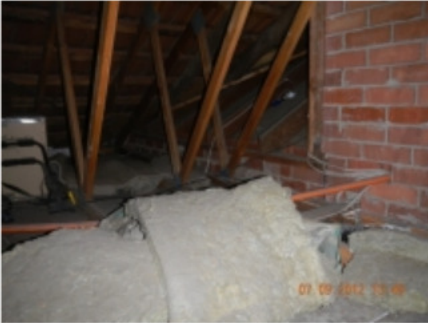
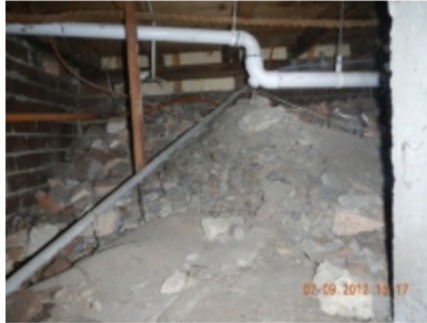
Subfloor Space

Height restrictions, Pipe/duct work.

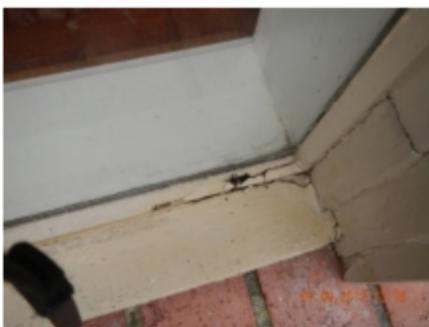
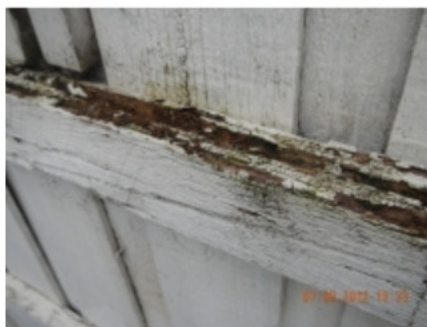
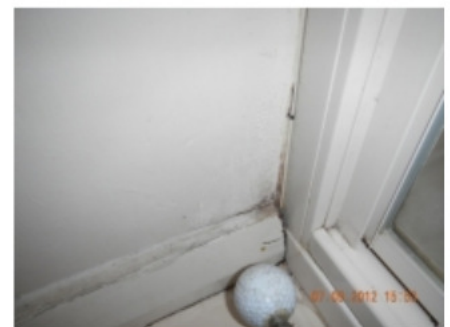
Retaining walls

Window frames

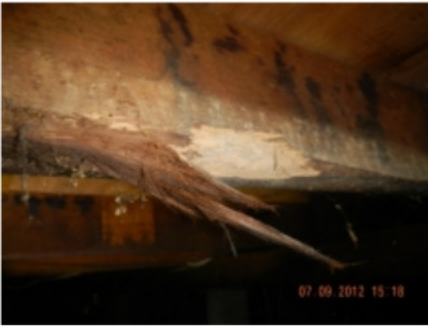
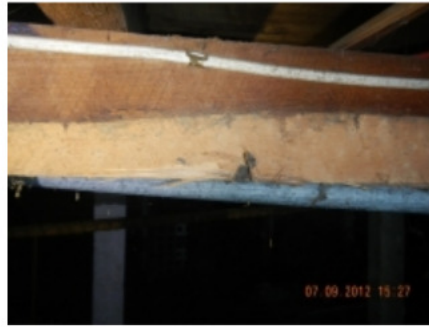
Lyctid borer damage to subfloor timbers. Only the sapwood in timber is susceptible to infestation by this species of borer causing damage of a non structural nature. No treatment is required.

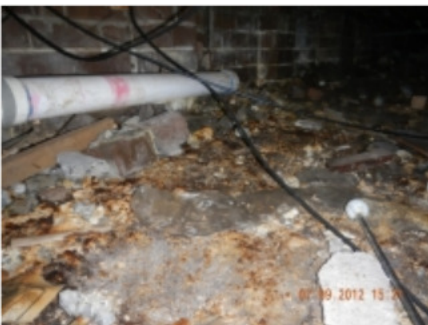
Larger vents required

Poor subfloor ventilation is a condition conducive to timber pest attacks

Recommend a plumber to evaluate

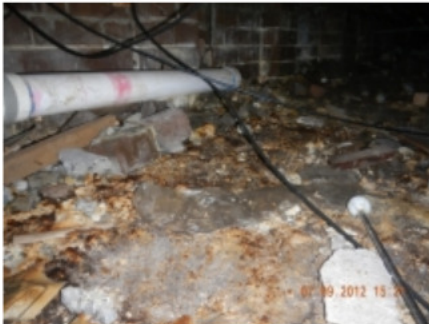
Better subfloor ventilation required
Damp subfloor surface with evidence of fungal growth
Excessive moisture is a condition conducive to timber pest attack.
General dampness to subfloor, plumber required to evaluate
