Buy-Wise Pre Purchase Building & Pest Inspections P/L

BUILDING INSPECTION REPORT

Inspected Property Address:		
Client Details:	Name: Sample 2	
	Address:	
	Phone:	Mobile:
	Email:	
	Client Attended Inspection: No	Contract Details: No Contract
Inspection Date & Time:	Tuesday, 28 April 2015 12:45:00 PM	
Building Consultant:	Peter Hearn DB-U12617	Phone: 9775 7188
Agent:	None	Phone:

Building Type:	Residential House
Description:	Single Storey, Addition, 10 Squares of living, Pergola, Garage, Deck
Estimated Age:	60 years old
Foundation Type:	Timber stumps, Concrete stumps
Walls External:	Vinyl cladding over Cement sheet
Roof:	Corrugated iron
Furniture:	Yes
Weather Condition:	Overcast

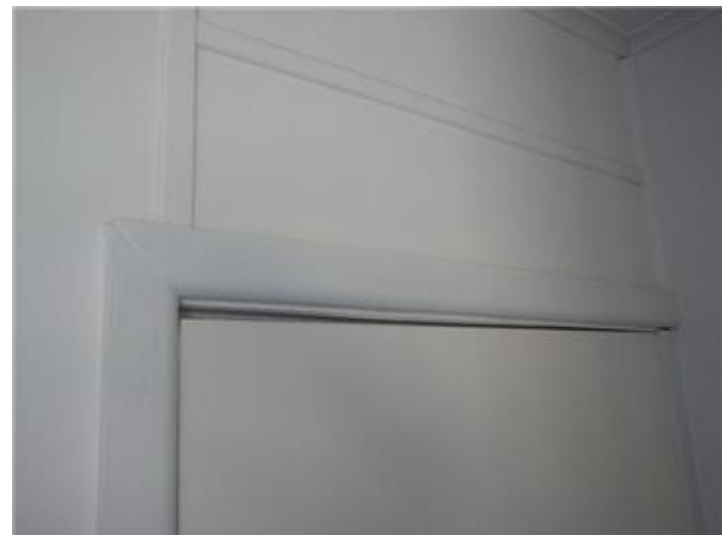
Large gap between top of door and door jamb and is due to movement, this area may require extra support then door adjusted

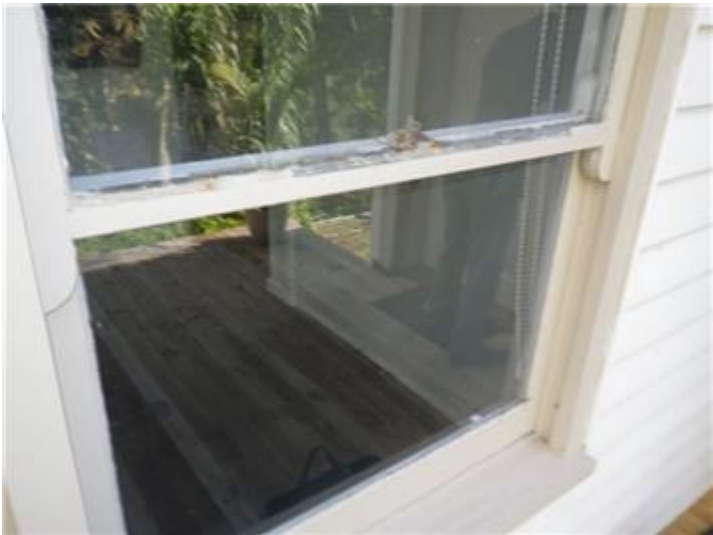
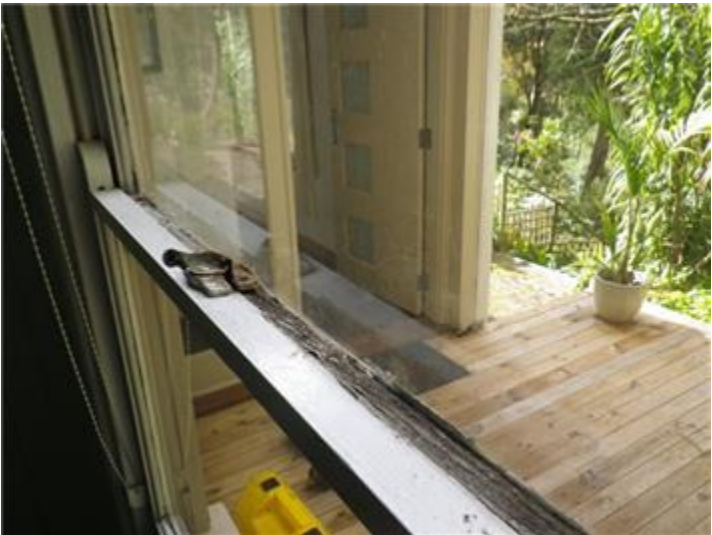
Repairs required to window due to rot \$600

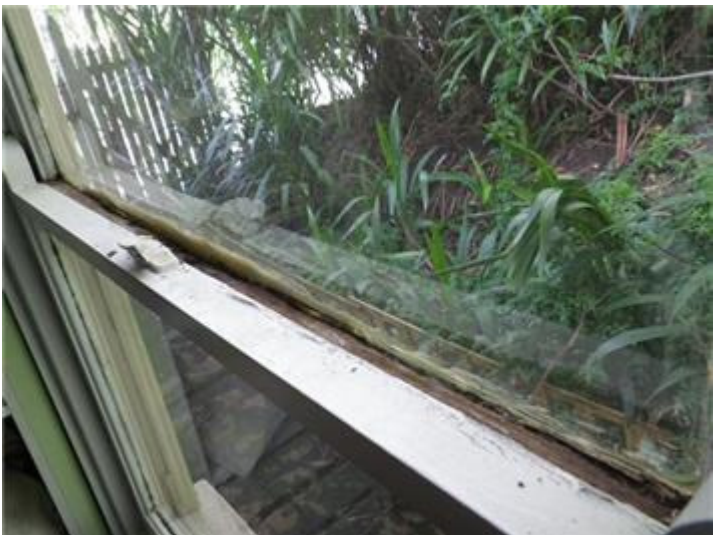
Windows Repairs required to window due to rot \$600

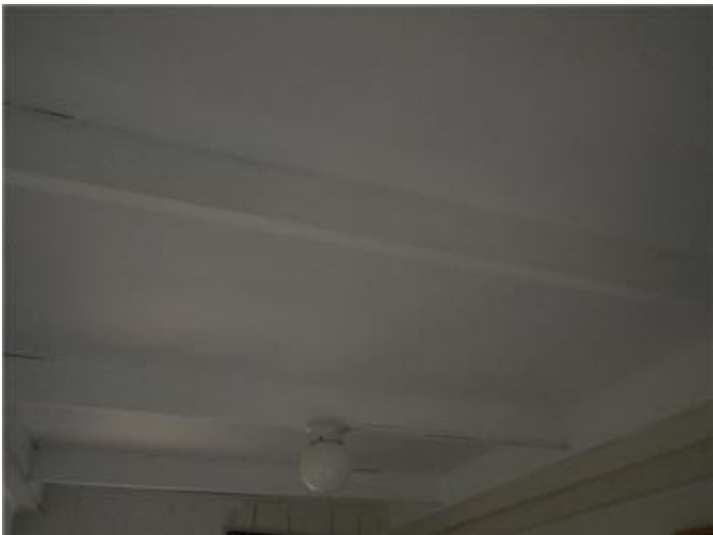
Ceilings Cement sheeting that contains asbestos
All cement sheeting containing asbestos should be well sealed, it appears to be well painted

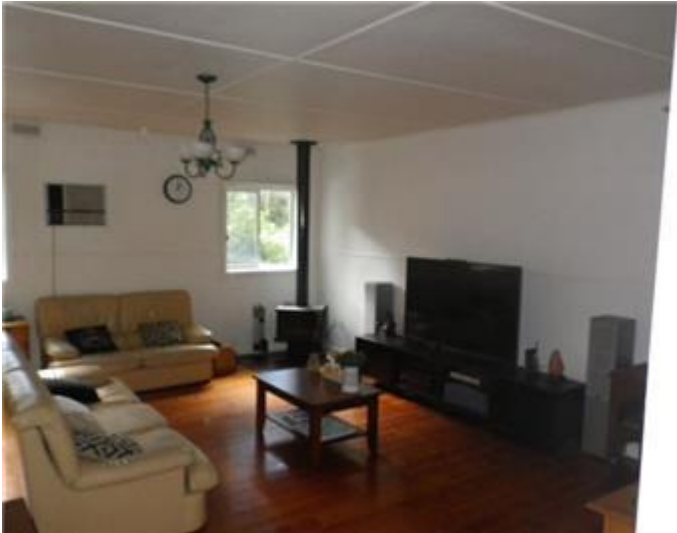
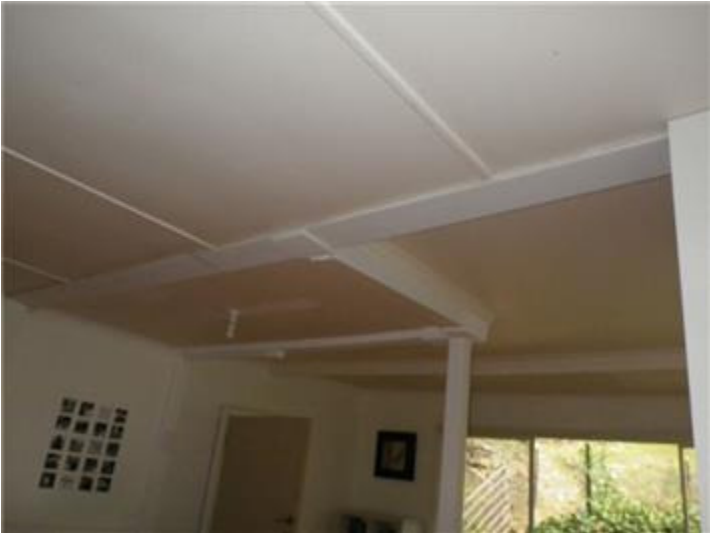
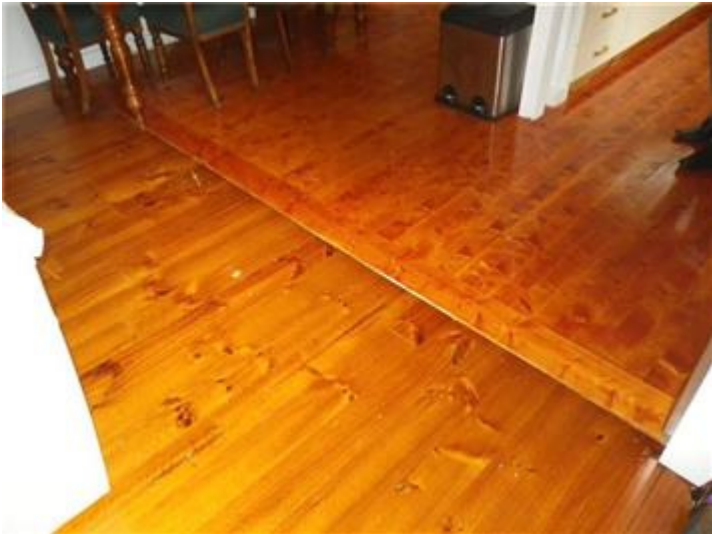
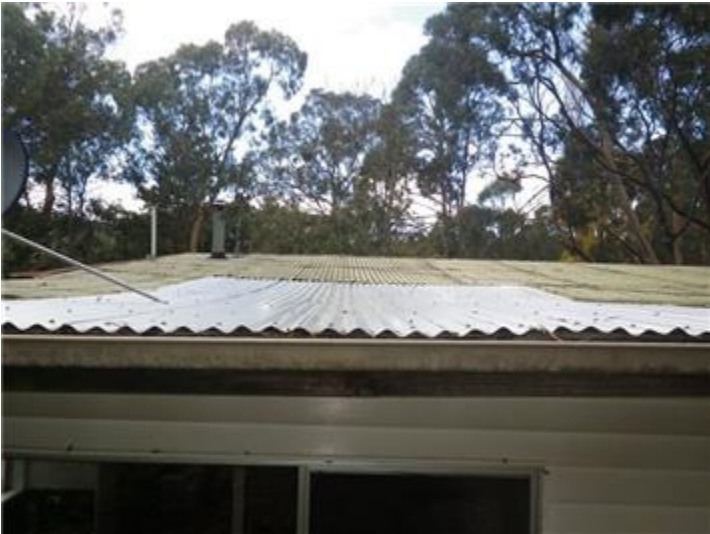
This room has been altered since being built, may require further investigation
 Support to roof has been removed where addition starts, Major Structural Defect
 Repairs are required
 See roof structure comments

Support has been removed between lounge and kitchen causing roof to dip Major Structural Defect

A beam is required either in roof space when roofing is lifted or installed under ceiling Cost \$3000-\$4000

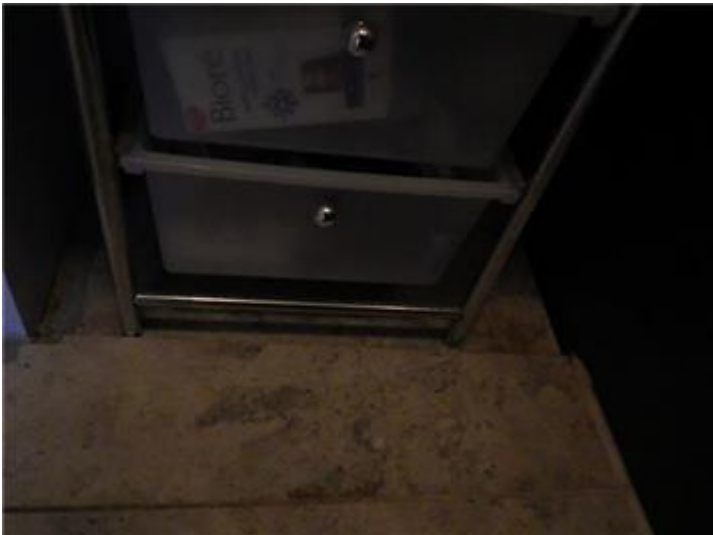
Floors	Missing floor tiles noted
--------	---------------------------

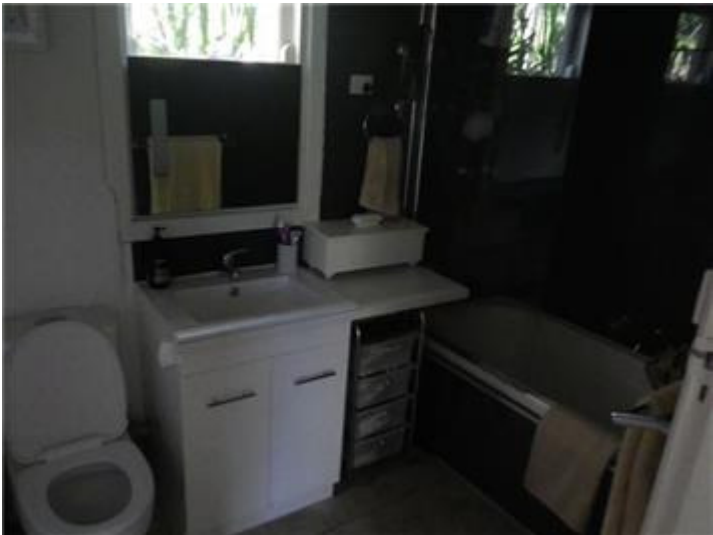
High moisture recorded behind bottom row of tiles of shower, this is a very common problem and can cause tiles to dislodge from wall over time and depends on what tile adhesive was used and how well applied
Tiles and grout should be well dried and then sealed in shower, this is to manufactures recommendations. The sealer is clear and can not be seen once dry
- Comments

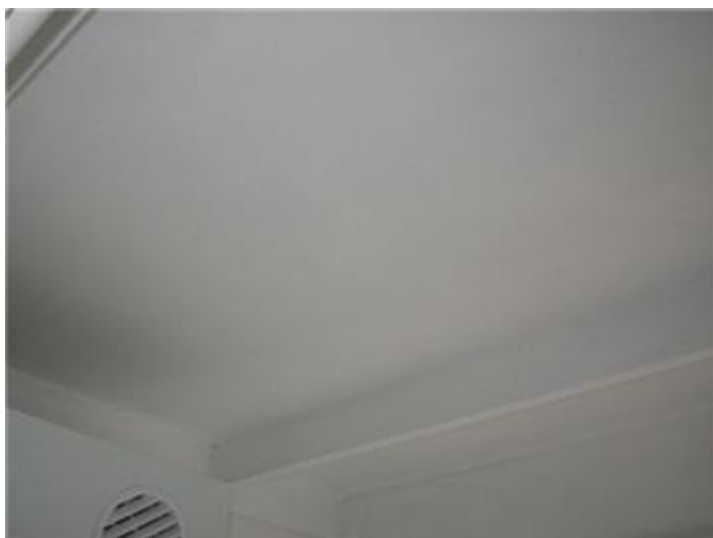
All cement sheeting containing asbestos should be well sealed, it appears to be well painted

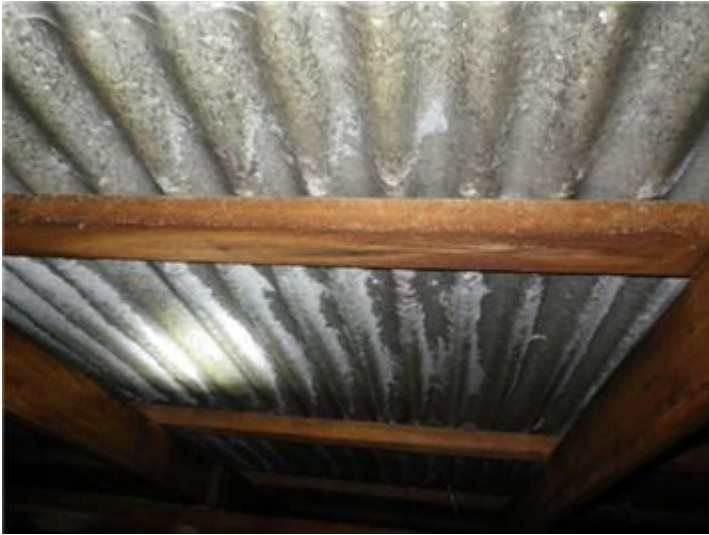
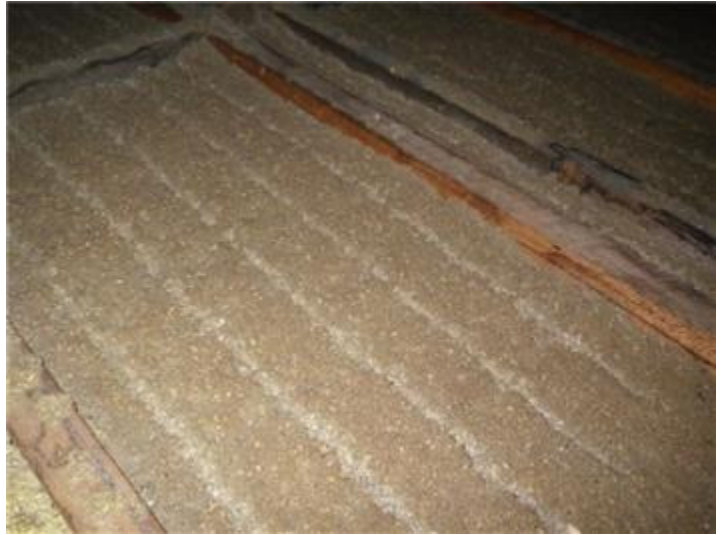
Sisalation/Sarking None noted, condensation has been dripping in insulation
Recommend installing sisalation under roofing, roofing will require removing to do this

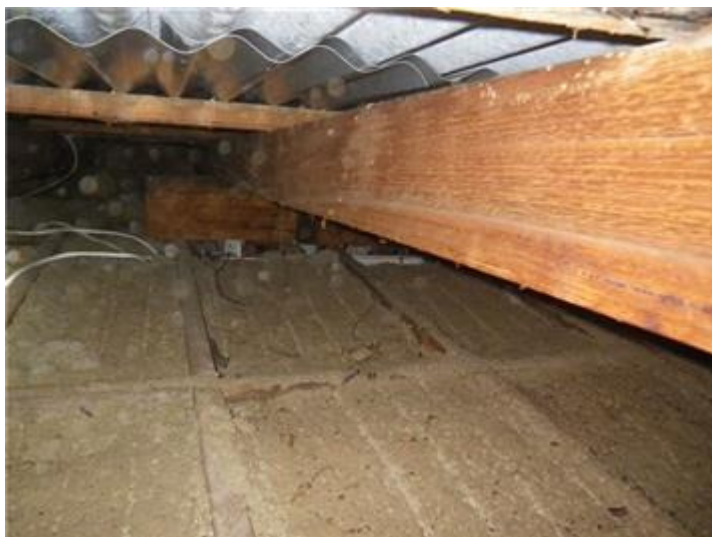
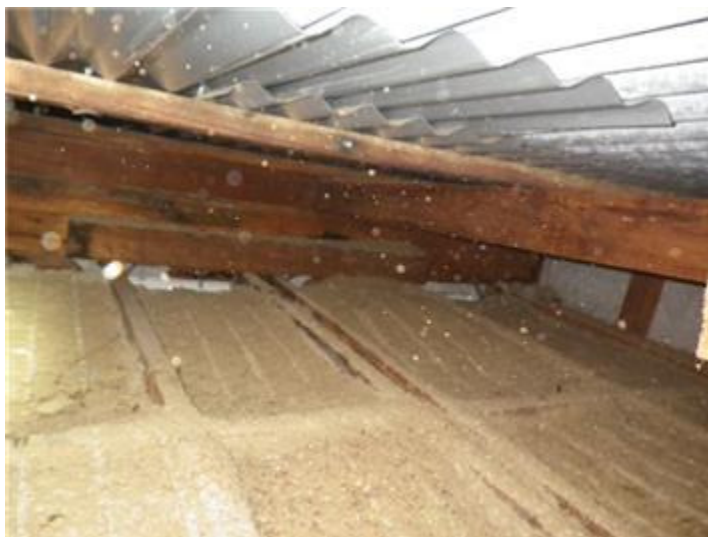
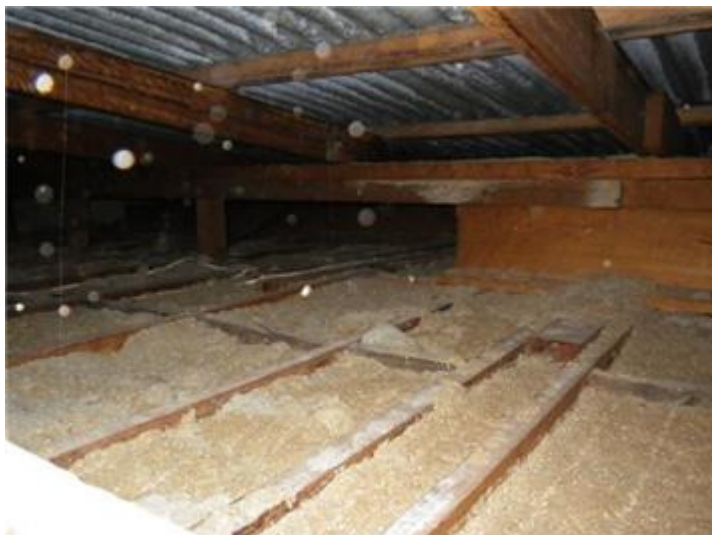
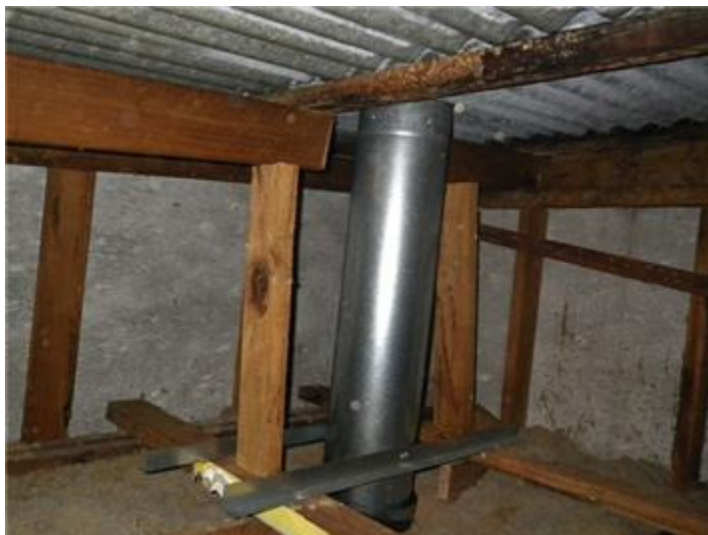
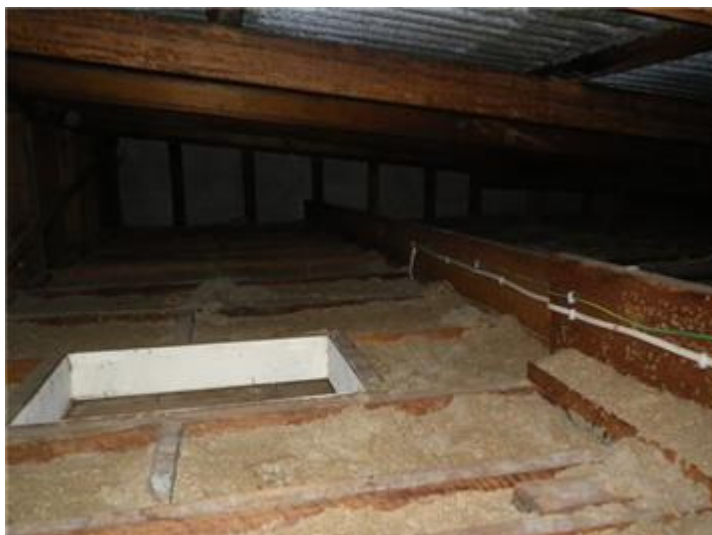
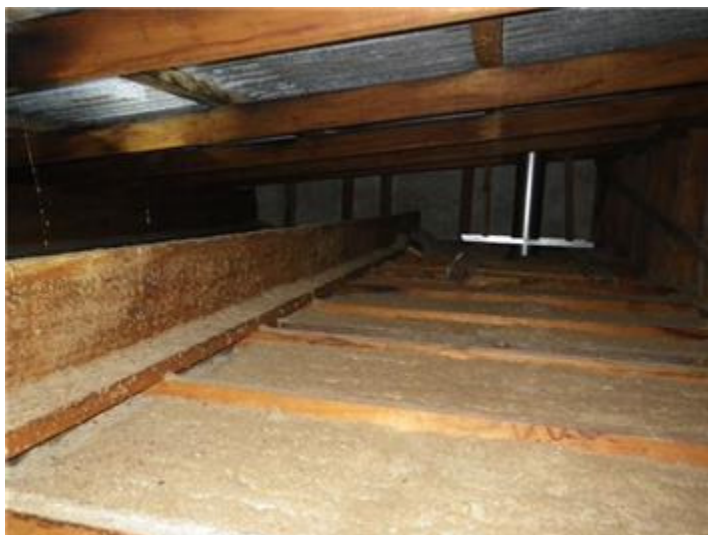
Alterations have been made to install heater flue, rafters are supported off ceiling joists which is not recommended

Proper quote is required

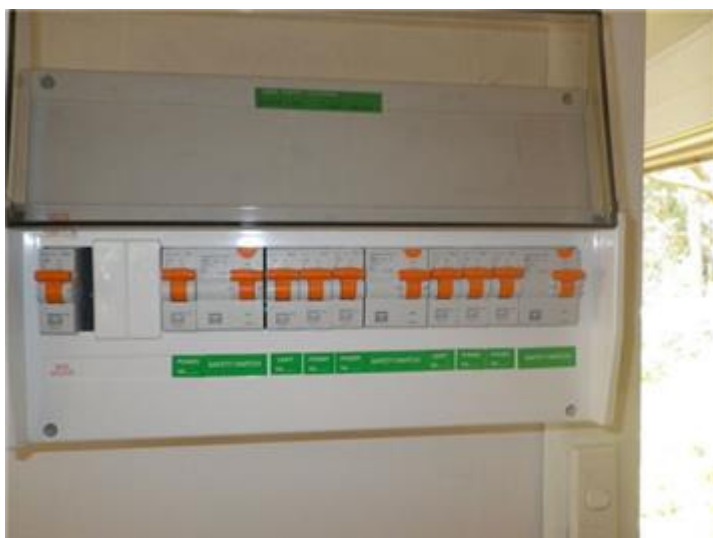
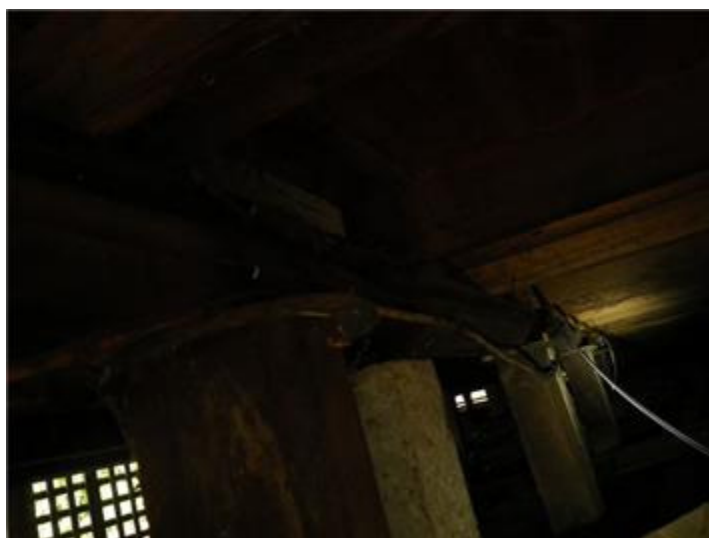
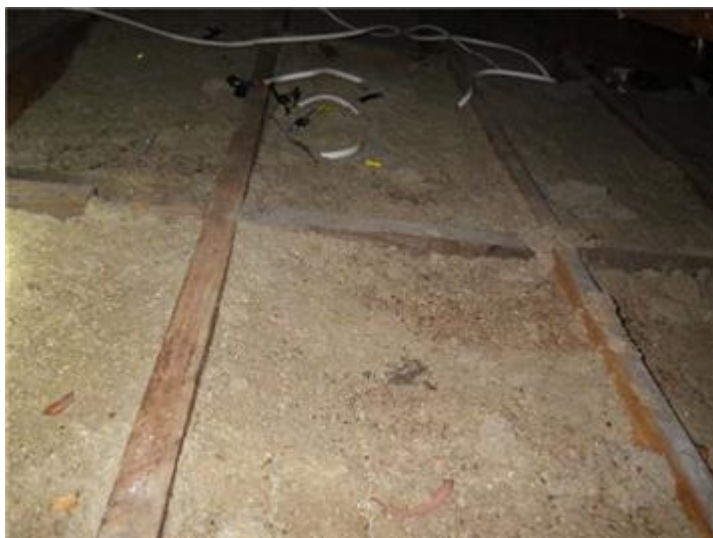
Loose wires noted in roof space

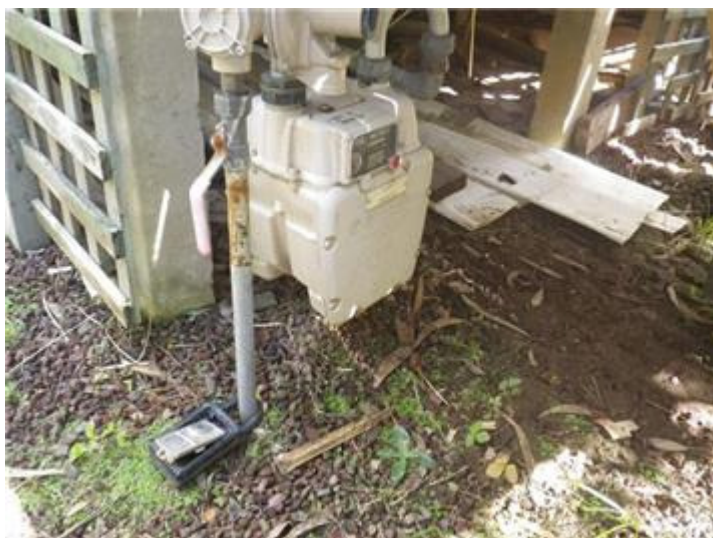
Pipes appeared serviceable and can only be reported by a licensed plumber or gas fitter
 Some rust may be present to gal gas pipes as they are in contact with the ground in areas

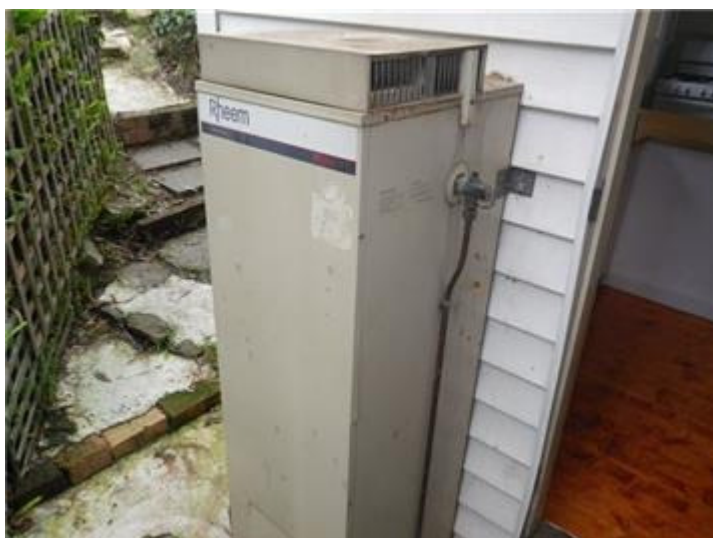
Hot water unit is near the end of its life span as it is over 10 years old, may only last another year or a possible 5 years longer

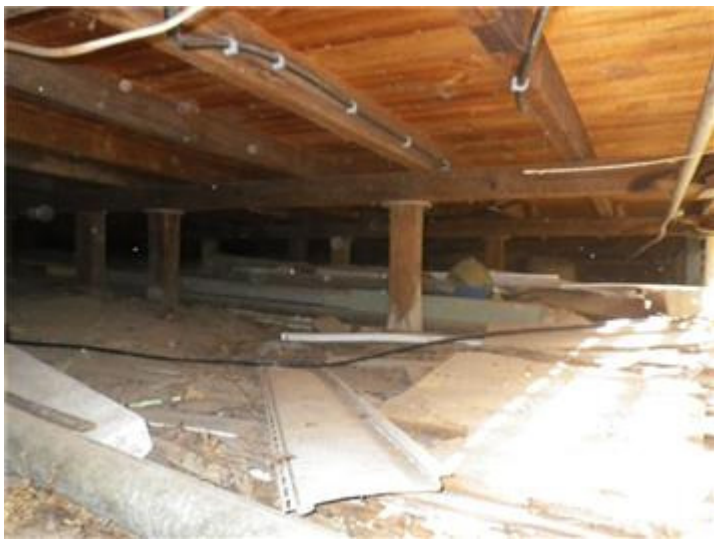
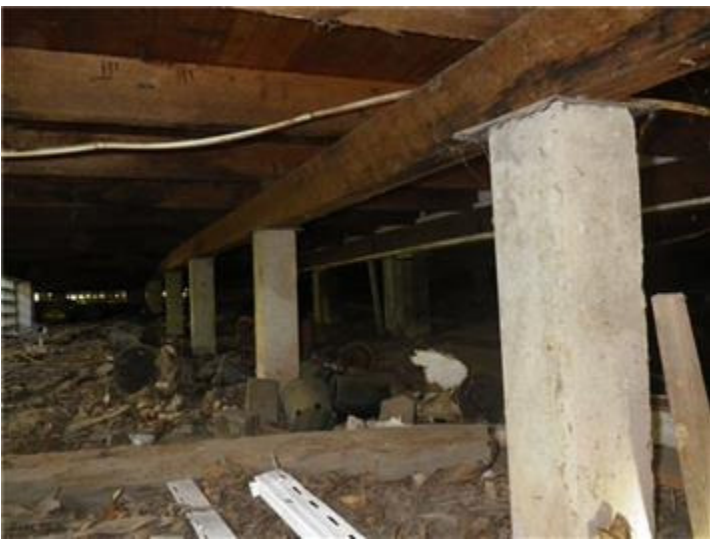
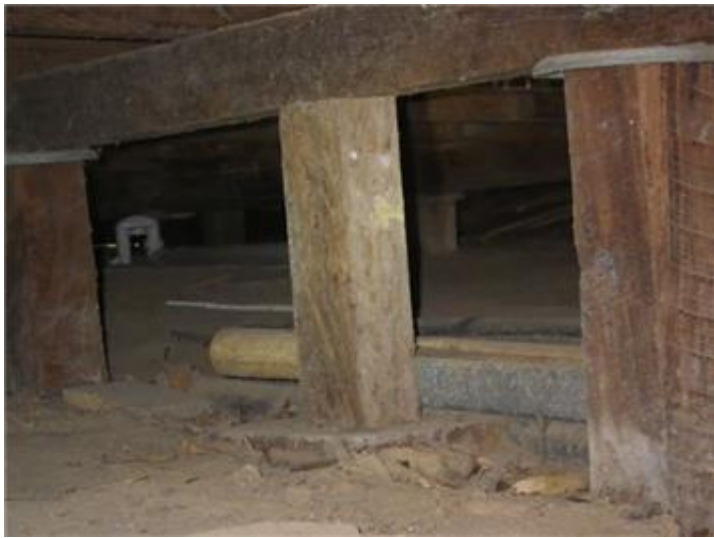
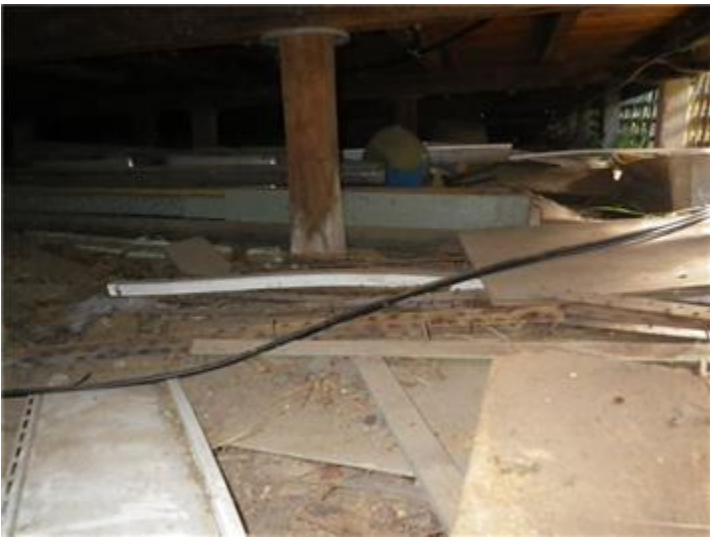
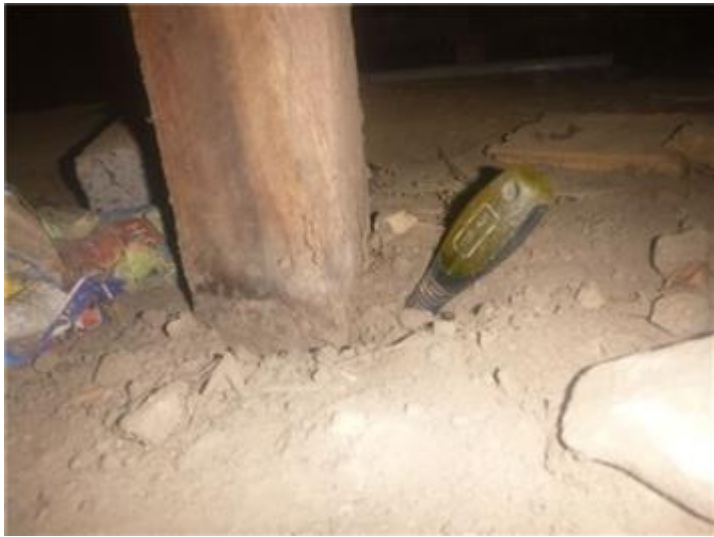
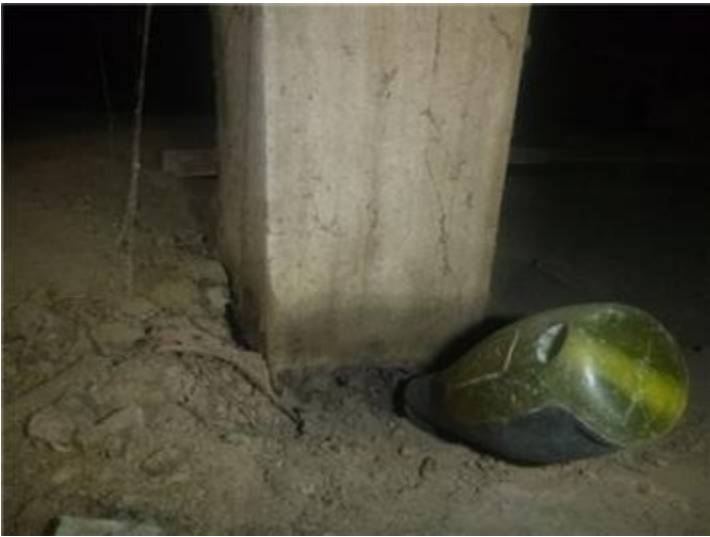
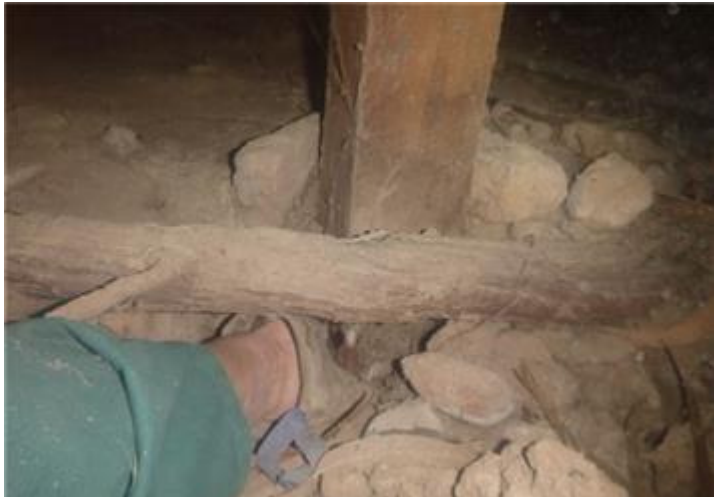
Rot was noted to timber stumps under the existing dwelling Major Structural Defect

The condition of the timber stumps will vary from poor to fair due to the amount of rot caused from moisture that has been around them over the years

Some settlement has occurred to concrete stumps in areas, this is quite normal for a house of this age and type of construction but should be monitored

Recommend replacing all timber stumps Cost \$7000

Proper quote to be obtained

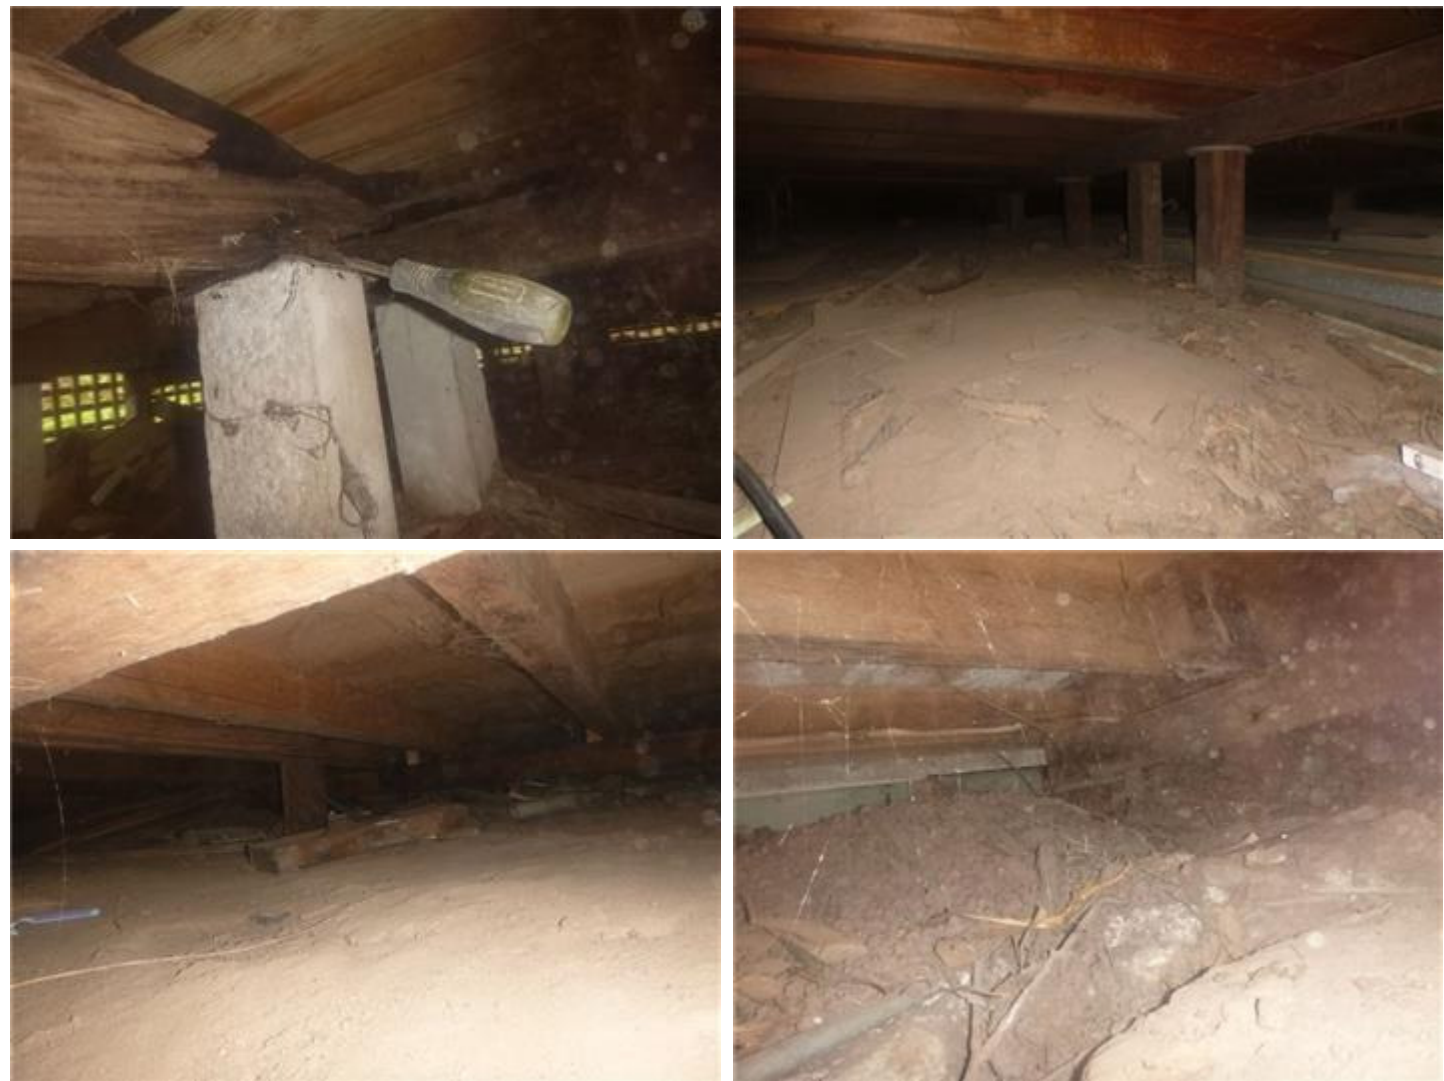
Rot noted to timber bearer under front door, requires repairs \$1000

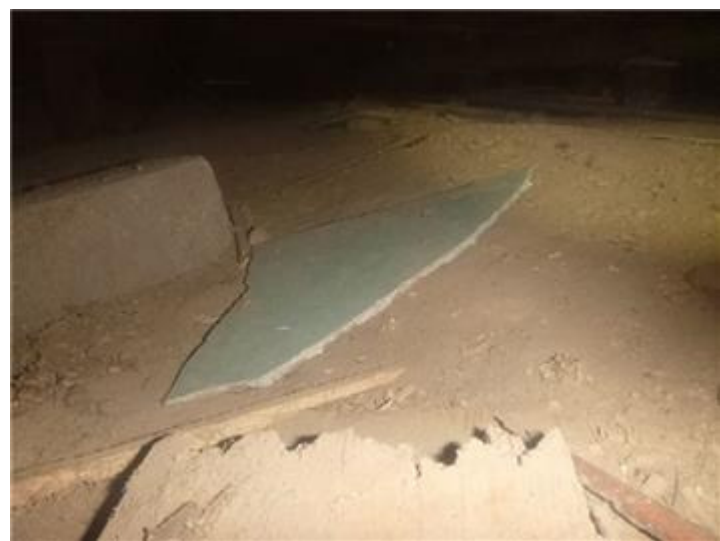
Cement sheet that contains asbestos noted to sub floor area that is broken and should be removed for safety reasons

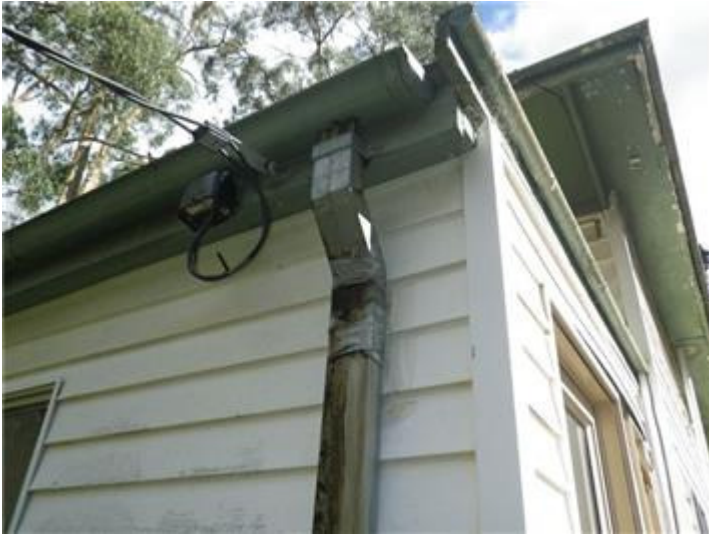
Rust noted at front and should be replaced

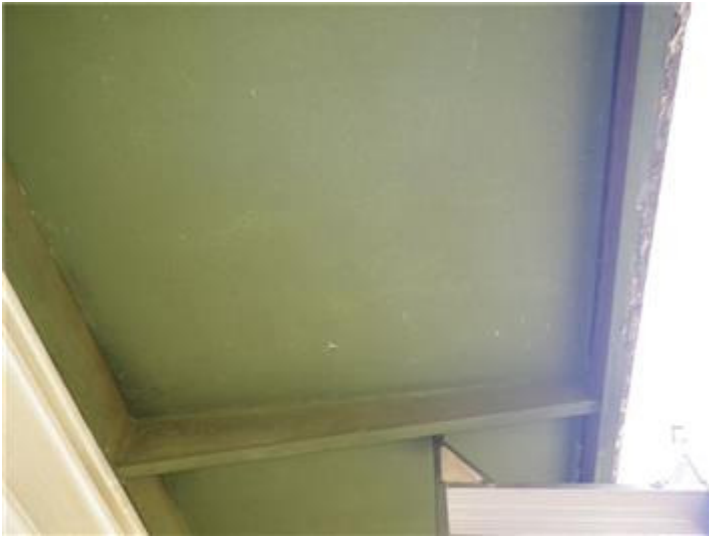
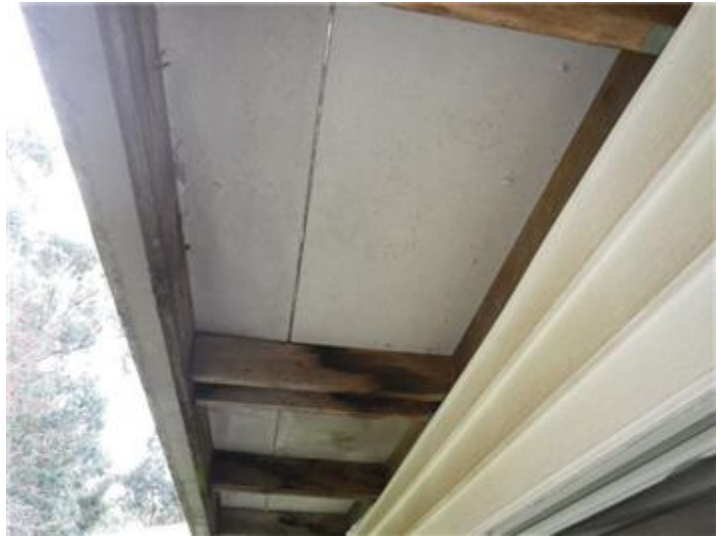
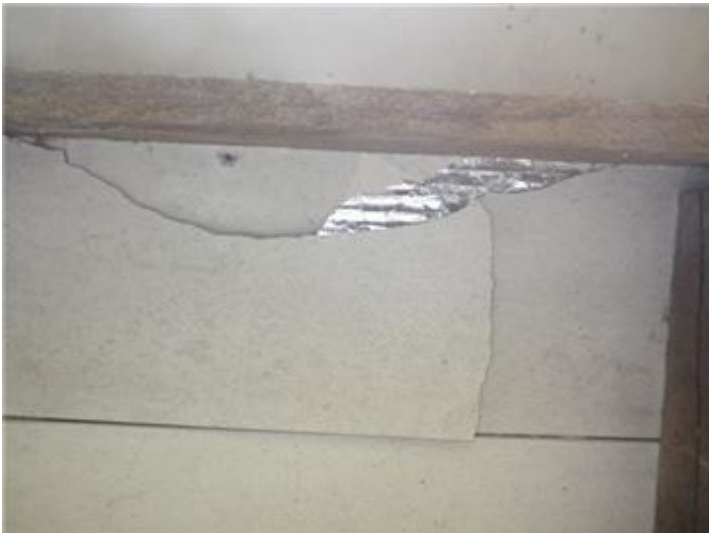
Eaves are cement sheet and contain asbestos, some repairs required or replaced as sections are broken and is a health risk

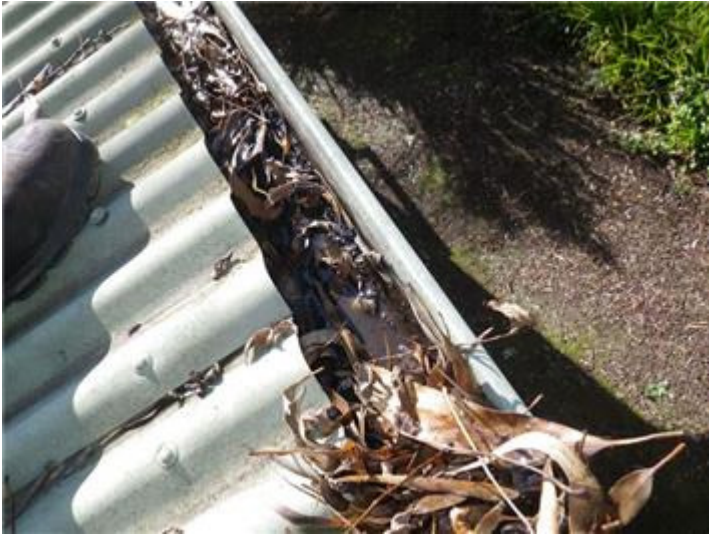
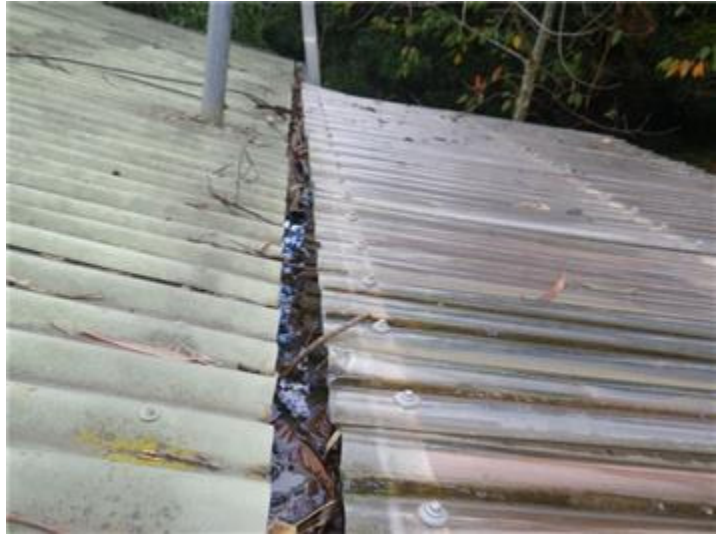
Gutters require cleaning, this will prevent rust and will last longer
Rust noted in areas, surface rust noted in others

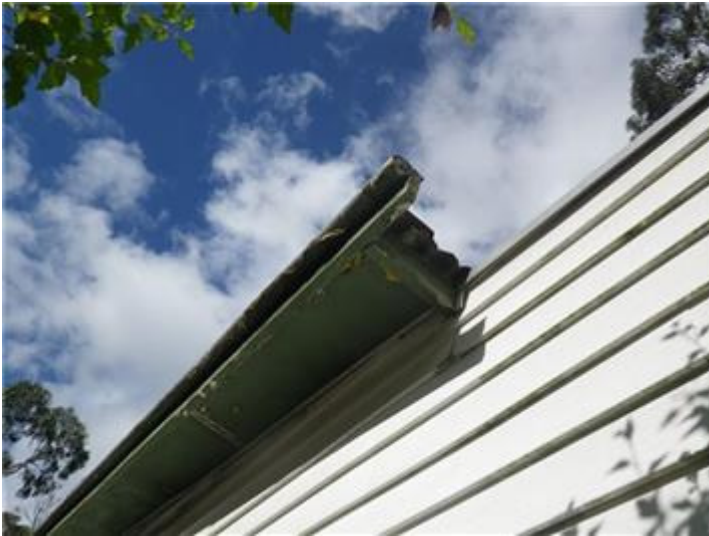
Painting required to most external timbers to protect them from further deterioration

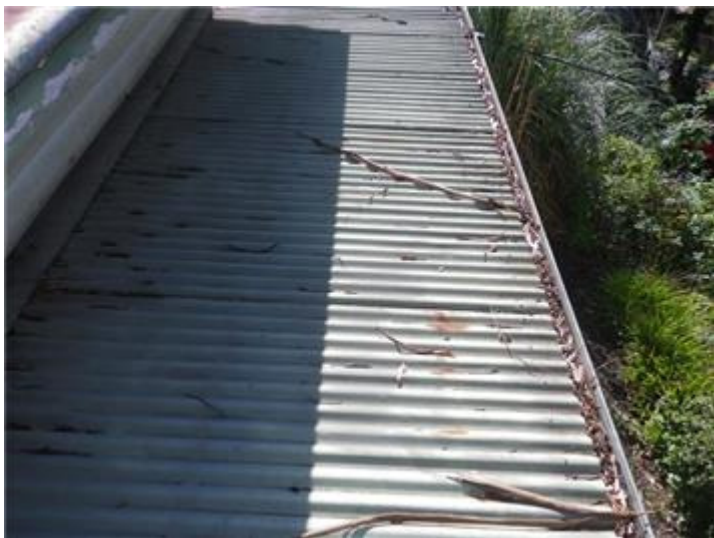
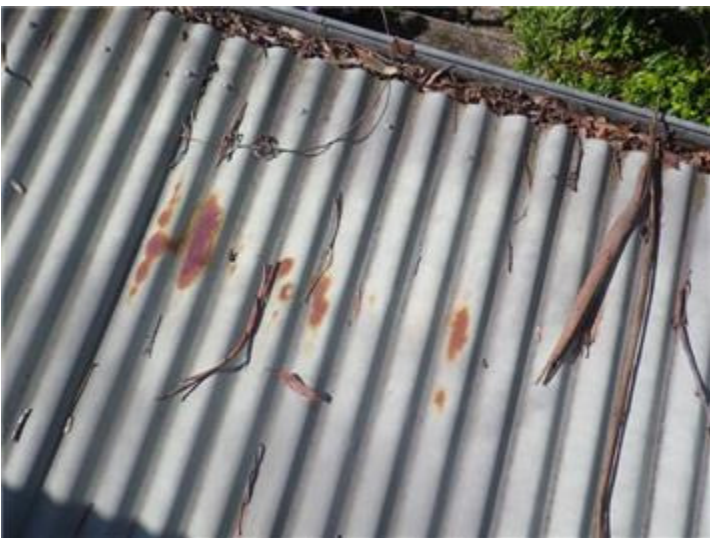
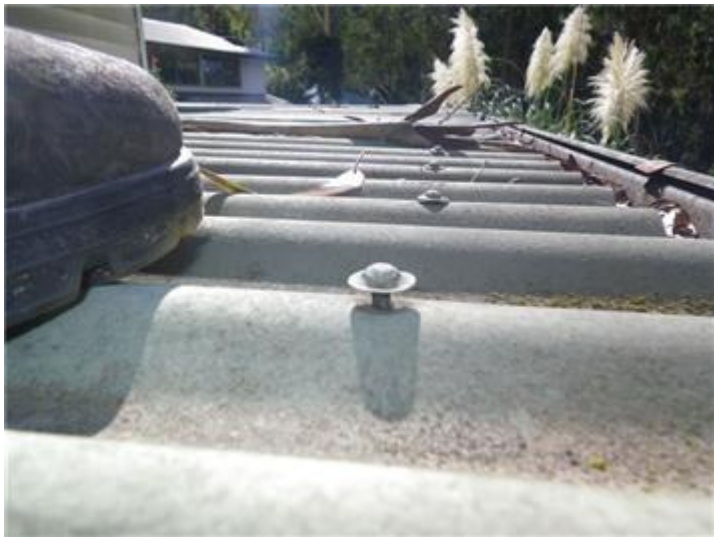
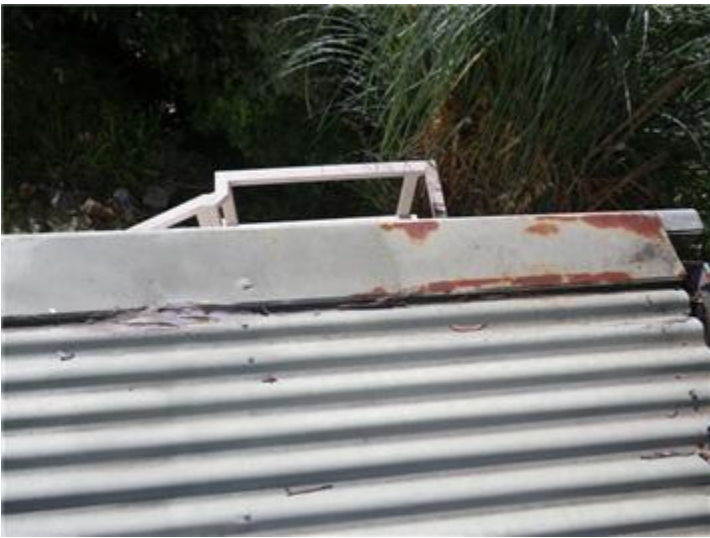
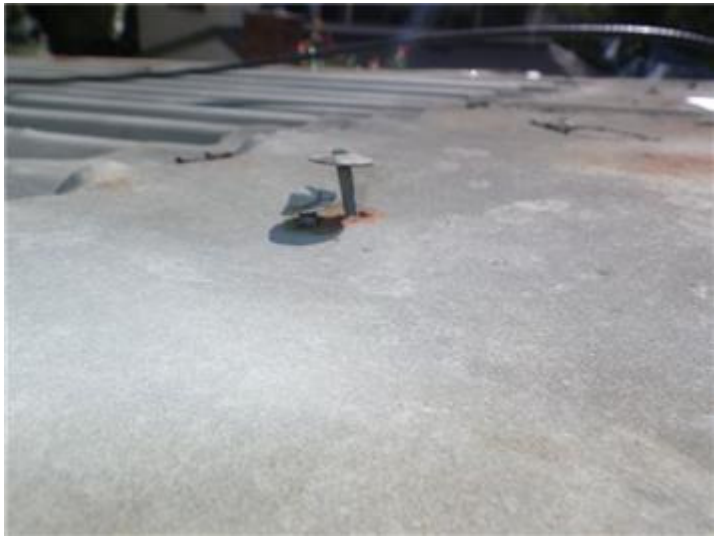
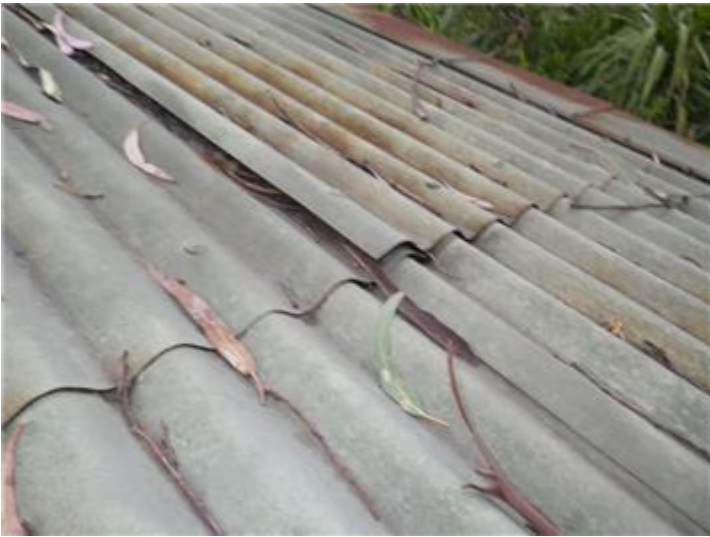
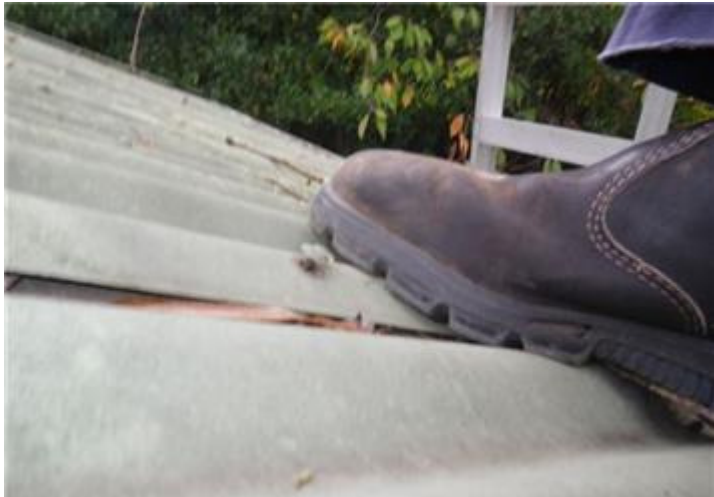
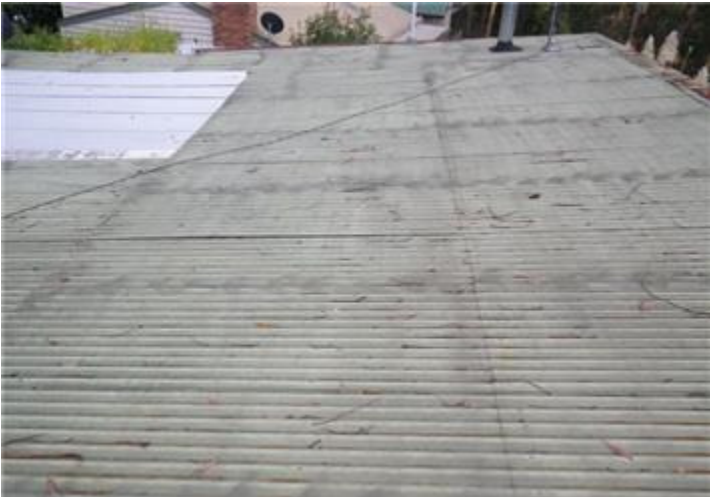
Roofing is in fair to poor condition

Roof sheets are nailed down and are lifting in areas, should be replaced with screws

Surface rust noted in areas and will need protecting to stop further deterioration

Roof sheets have been put with turn up and siliconed together, poor installation Major Defect

Recommend removing roofing and install sisalation paper and re install with screws Cost \$3000

Or replace with a metal tray roofing Cost \$15,000

Plumber to advise and quote
