Buy-Wise Pre Purchase Building & Pest Inspections P/L

BUILDING INSPECTION REPORT

Inspected Property Address:		
Client Details:	Name: Sample 2	
	Address:	
	Phone:	Mobile:
	Email:	
	Client Attended Inspection: No	Contract Details: No Contract
Inspection Date & Time:	Tuesday, 28 April 2015 12:45:00 PM	
Building Consultant:	Peter Hearn DB-U12617	Phone: 9775 7188
Agent:	None	Phone:

Building Type:	Residential House
Description:	Single Storey, Addition, 10 Squares of living, Pergola, Garage, Deck
Estimated Age:	60 years old
Foundation Type:	Timber stumps, Concrete stumps
Walls External:	Vinyl cladding over Cement sheet
Roof:	Corrugated iron
Furniture:	Yes
Weather Condition:	Overcast

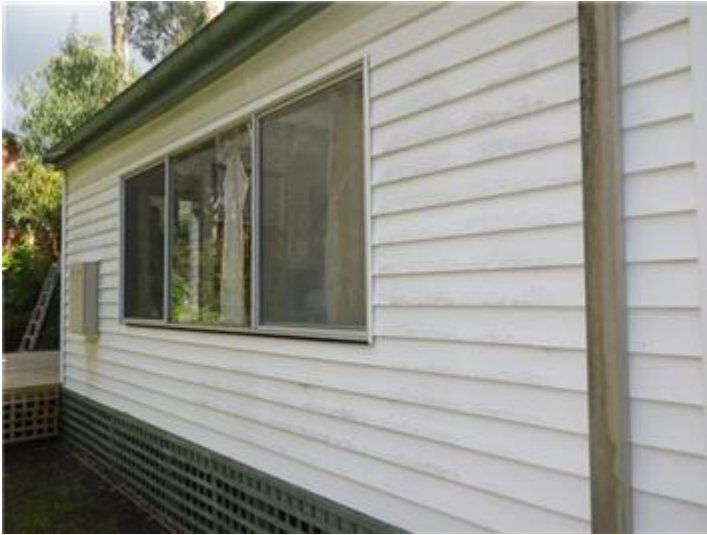
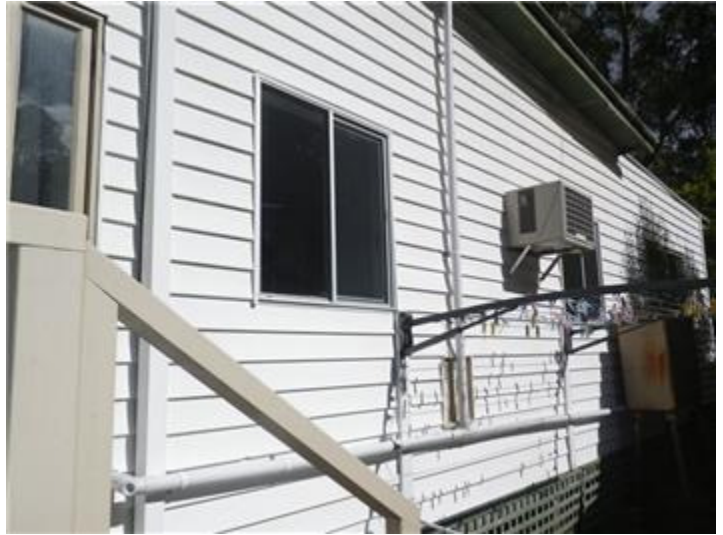
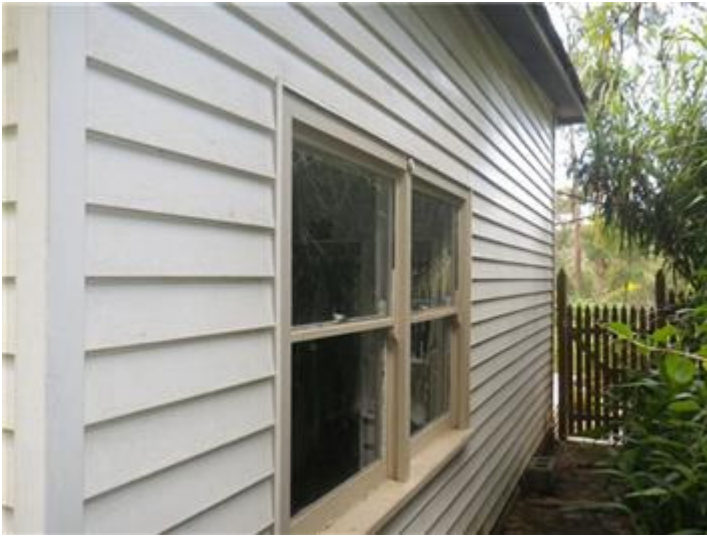
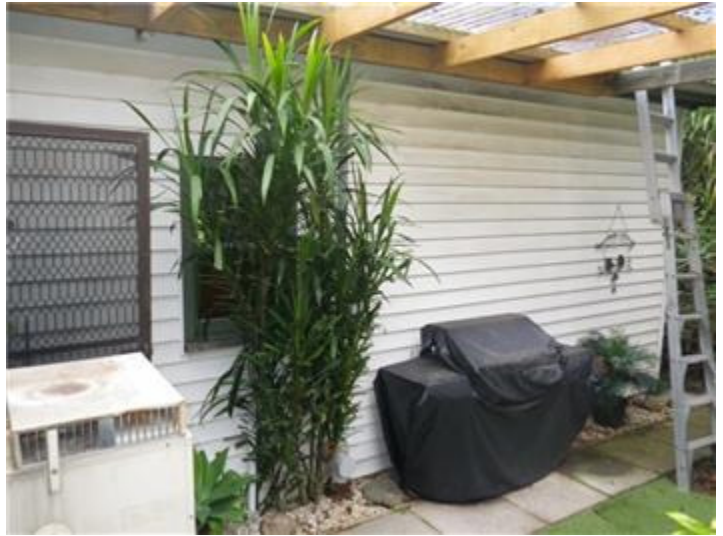
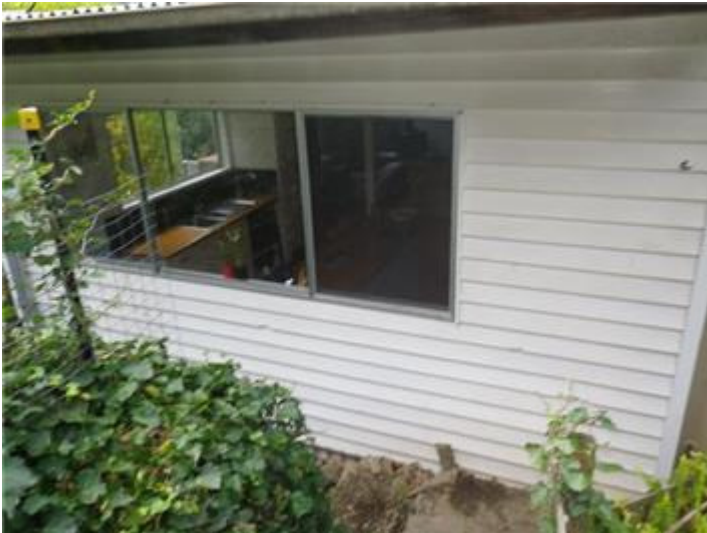
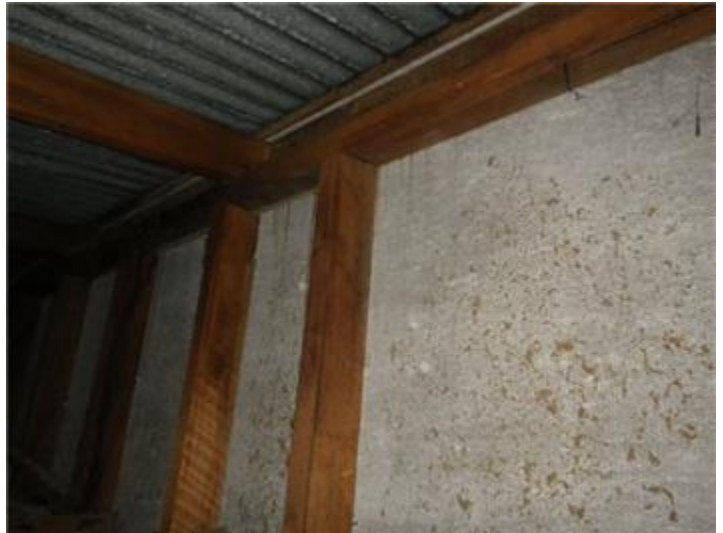
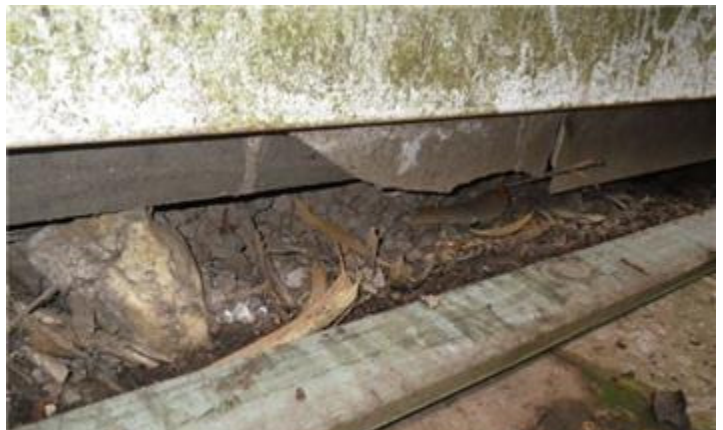
Vinyl cladding has been installed over cement sheeting that would most likely contain asbestos
Broken sections could be seen at bottom of walls and is a health risk

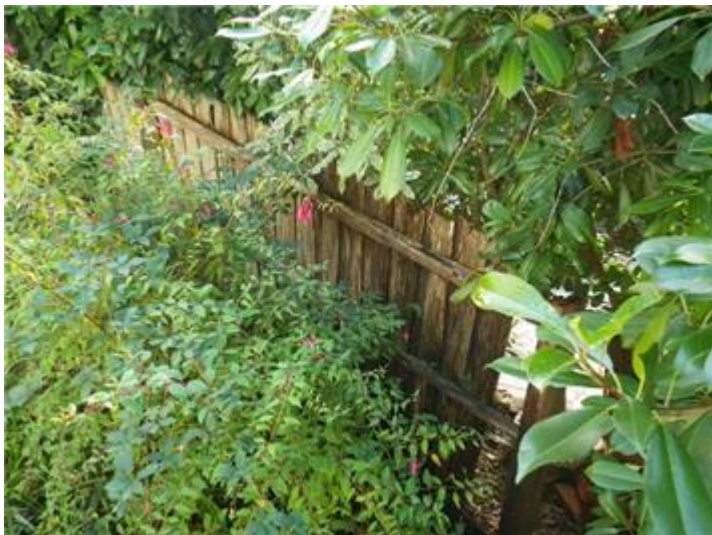
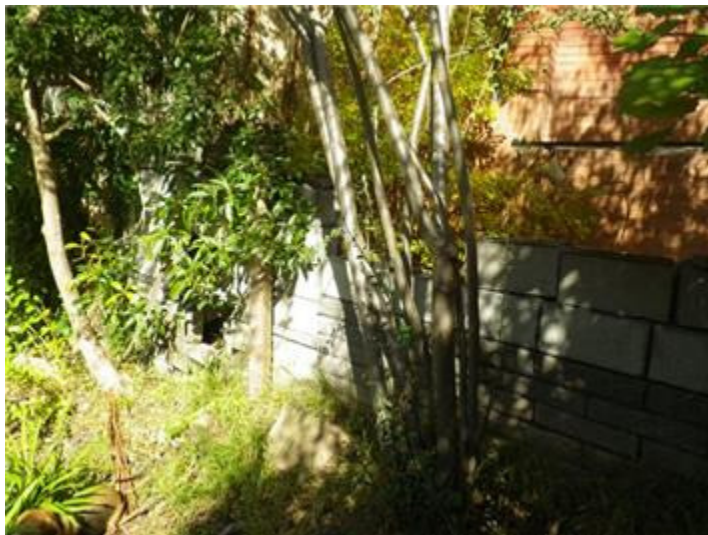
Requires replacing at right side due to rot

Left side wall is a safety concern and requires removal

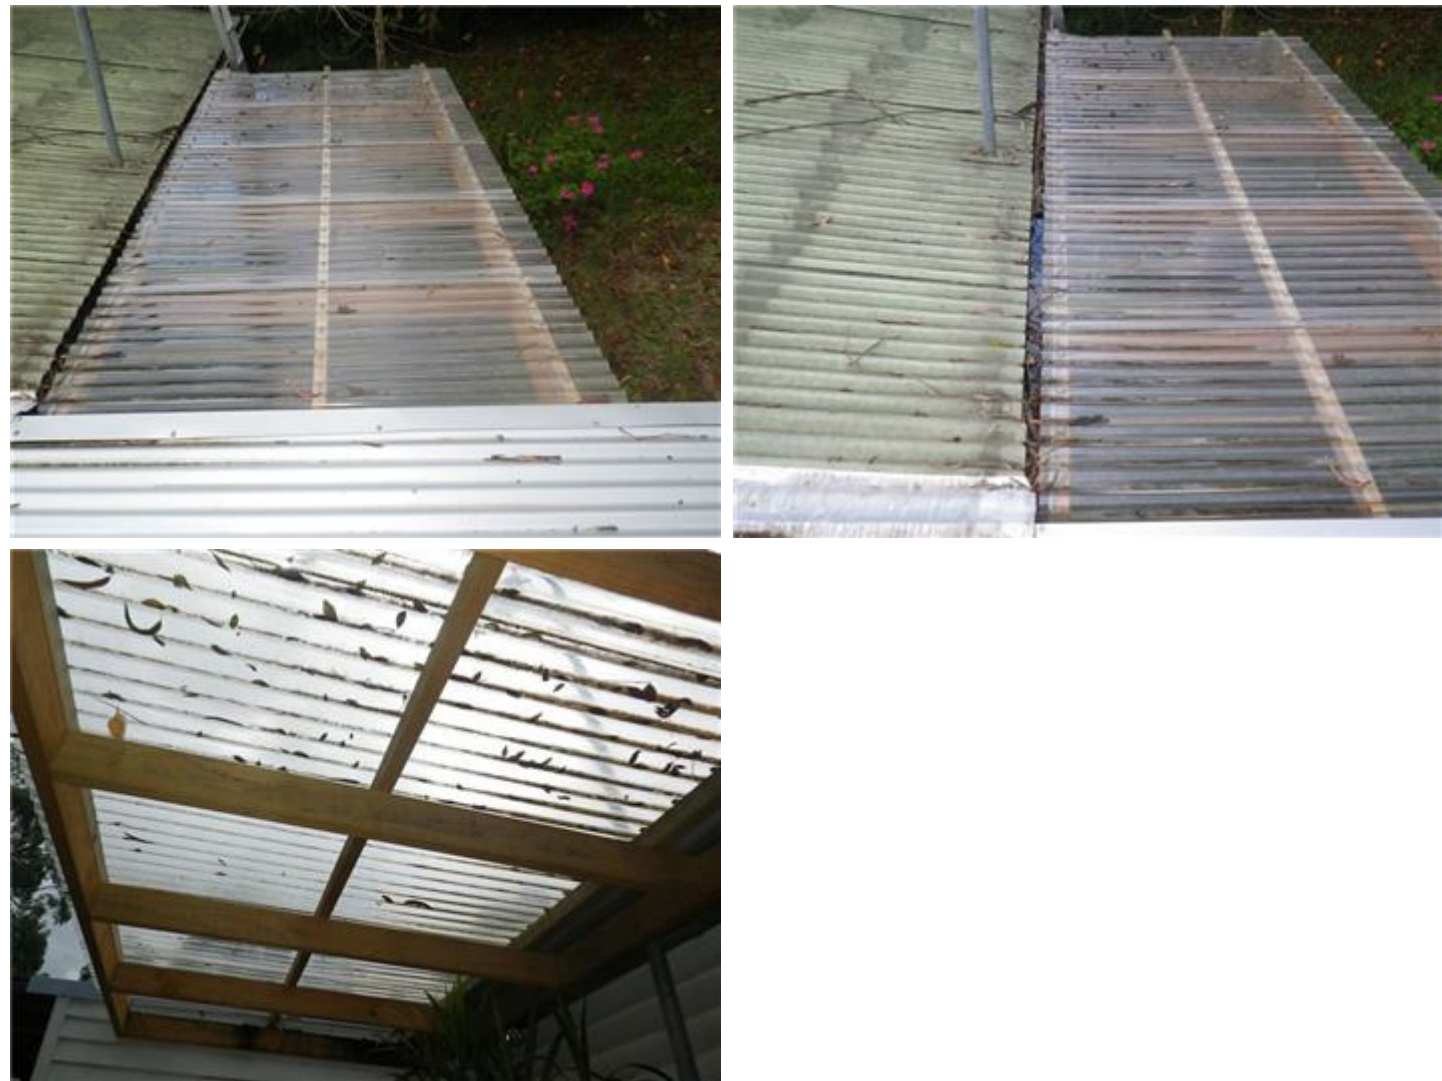
Unknown if the roofing is to requirements regarding correct roof pitch, further investigation is recommended.
Water from roofing runs down to house gutter, this is increasing the catchment area for house gutters and may overflow in heavy rain
