Buy-Wise Inspection Services P/L

SPECIAL PURPOSE INSPECTION REPORT

PRE SALE INSPECTION

Inspected Property Address:	Albert Park		
Client Details:	Name: Sample Report		
	Address:		
	Phone:	Mobile:	
	Email:		
	Client Attended Inspection: Yes		Contract Details: N/A
Inspection Date & Time:	Thursday, 31 March 2011 1:00:00 PM		
Building Consultant:	Peter Hearn DB-U12617	Phone: 9775 7188	
Agent:			Phone:

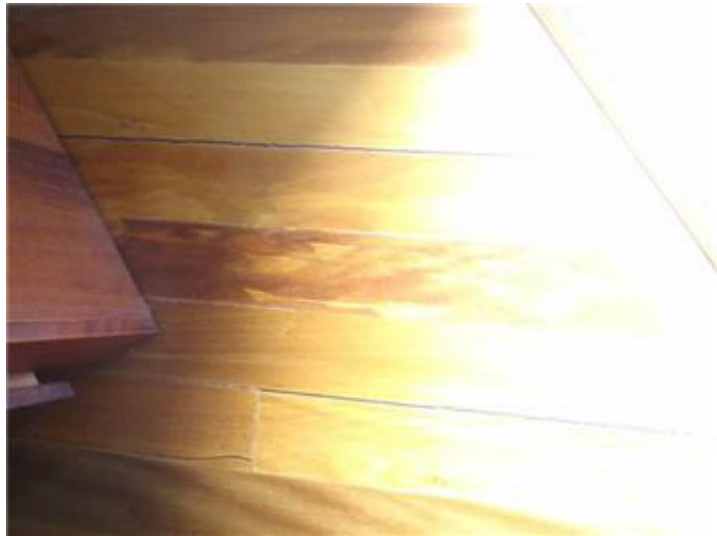
Master Bedroom

Large gaps between floor boards and is due to timber shrinkage over time, if to be filled then with a flexible sealant as flooring may expand back over time
Direct sunlight causes shrinkage to flooring

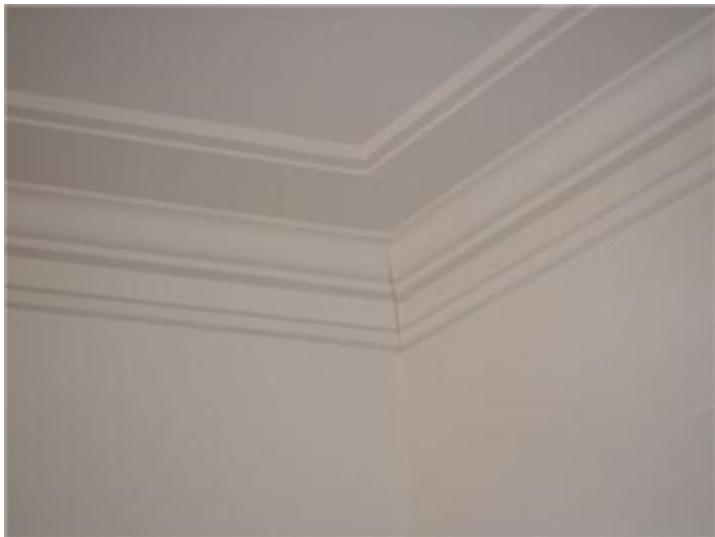
Lounge

Ceilings	Plaster	Cornice is open at internal joins and is due to the timber frame shrinkage over time, this is quite common and once filled with a flexible material usually dont return
----------	---------	---

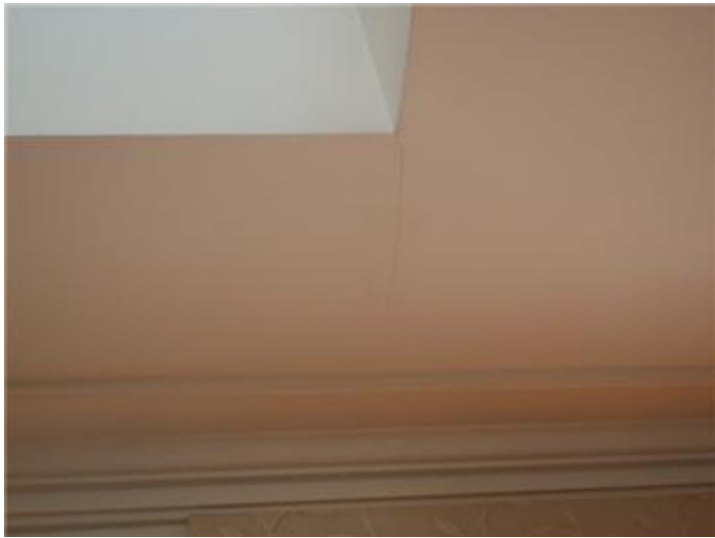
Meals

Ceilings	Plaster	Minor movement noted between plaster sheets at join, minor repairs required and is unknown if they will return
-----------------	---------	--

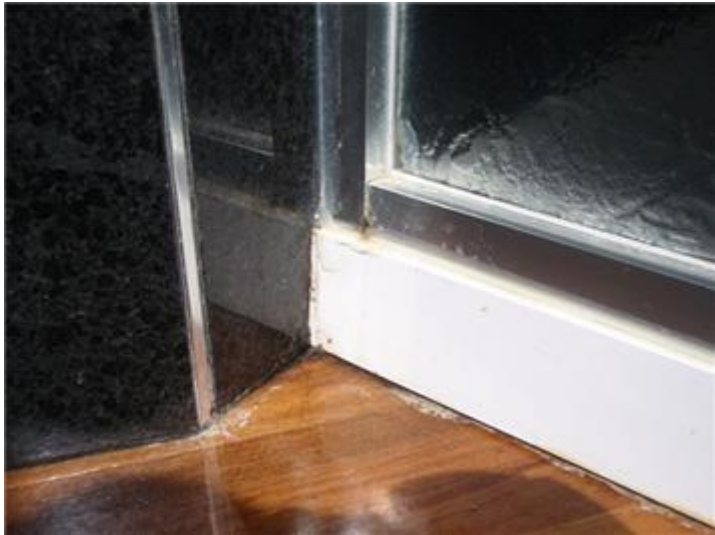
Ensuite

Shower Screen	Glass pivot door and panel	Some water was noted on floor next to shower base, further investigation is required to see if there are leaks present
----------------------	----------------------------	--

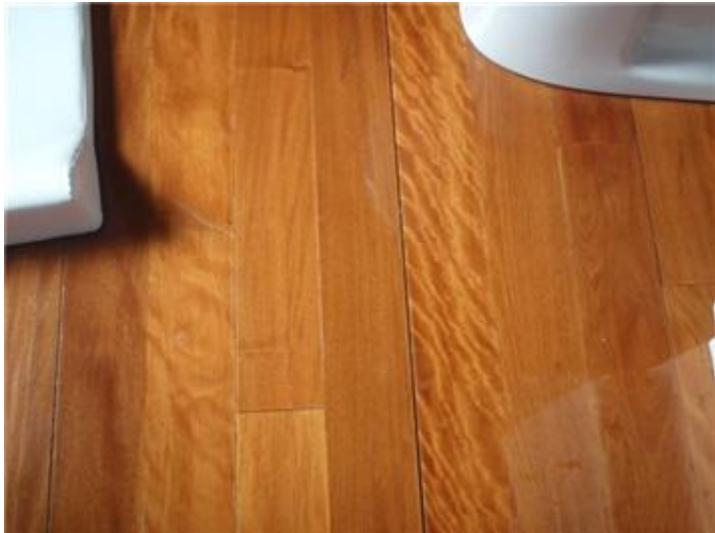
Bathroom

Floors	Polished hardwood floor boards	Large gaps between floor boards and is due to timber shrinkage over time, if to be filled then with a flexible sealant as flooring may expand back over time Direct sunlight causes boards to shrink more than usual taking all the moisture out of timbers
---------------	--------------------------------	--

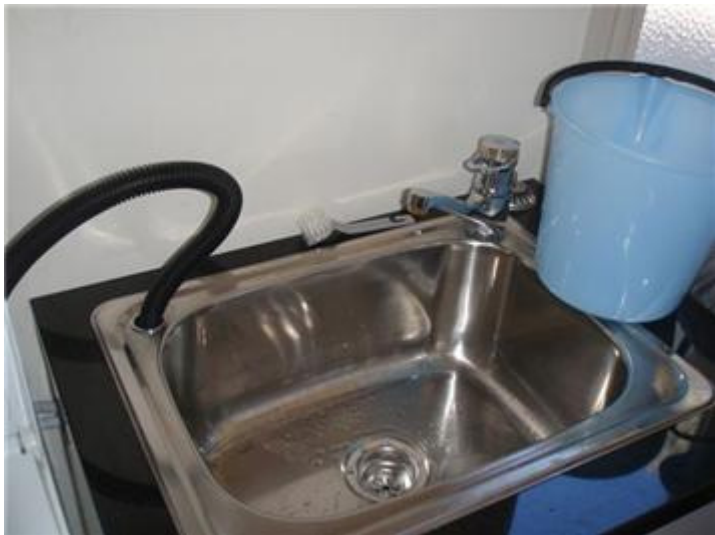
Laundry

Tub/Sink	Stainless steel trough	Not fixed to bench properly Tiles should be installed to wall above bench
----------	------------------------	--

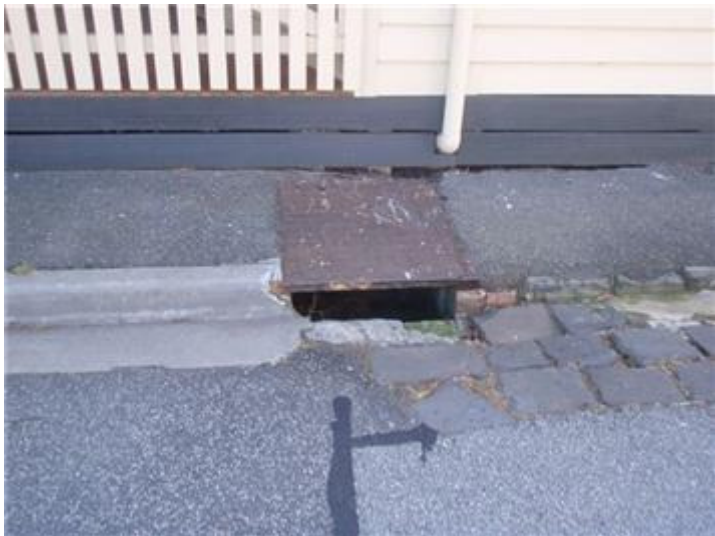
Services

Drainage	Surface drainage, Underground pipes	The retention of water from surface run off could have an affect on the foundation material which in turn could affect the footings to the dwelling. Best practice is to monitor the
----------	--	--

flow of surface water and stormwater run off and have the water directed away from the dwelling or to storm water pipes by a licensed plumber/drainier.

Unable to comment on storm water or sewer pipes under ground, a licensed plumber can only report on these areas

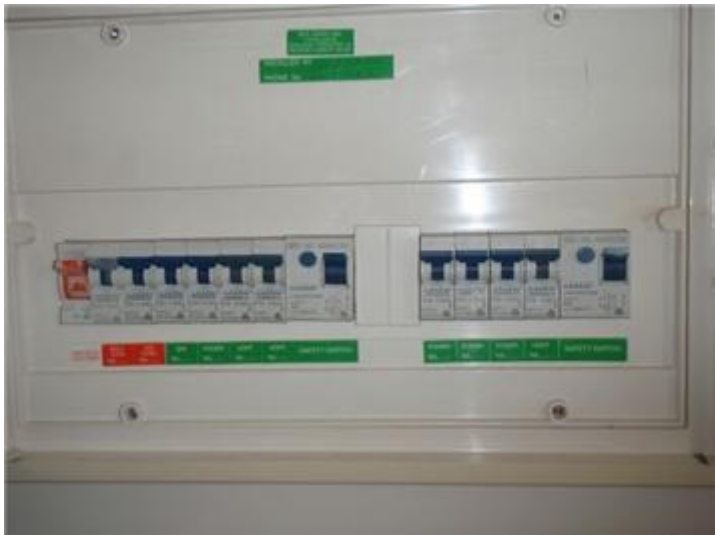
Electrical	Residual current device (safety switch) and circuit breakers provided to fuse box	A licensed electrician can only report on all electrical services Safety switch protecting power points and lighting circuits only

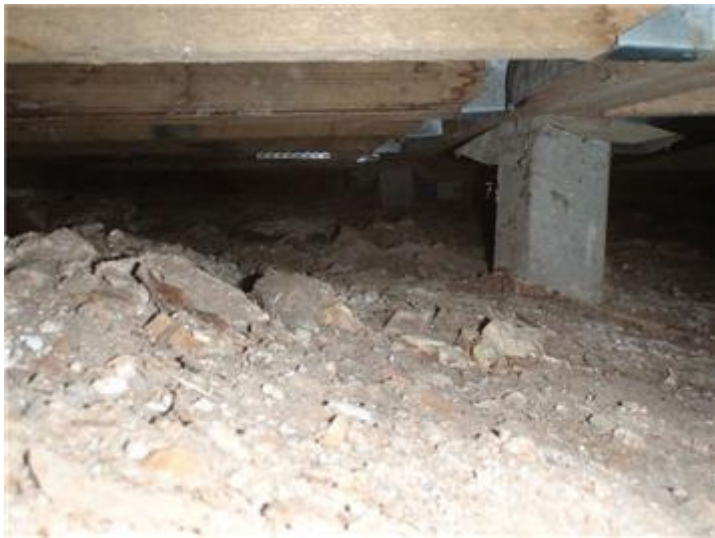
Under Floor Space

Ant Capping	Metal	Ant caps will not stop termites gaining access to timbers but will make them more noticeable from a termite inspection
Stumps	Concrete	Not all stumps were visible due to restrictions No access was possible to sub floor space

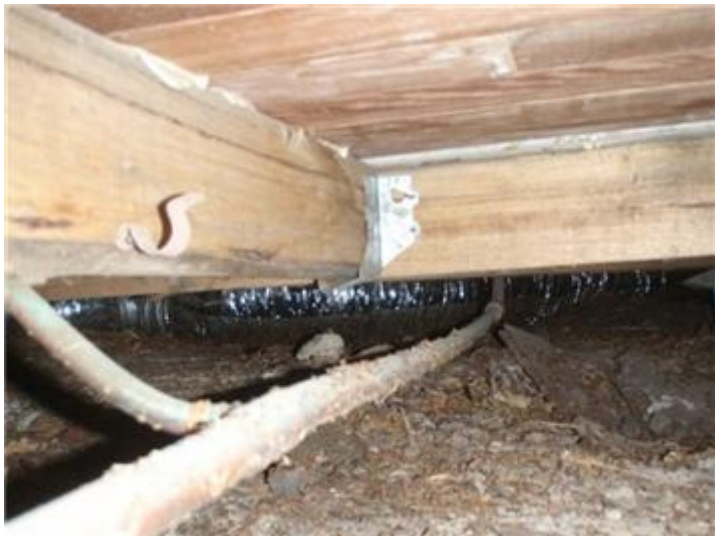
Timbers	Hardwood bearers and joists, Hardwood floorboards	<p>Not all timbers were visible at time of inspection</p> <p>All flooring is fixed directly to floor joists so excess moisture to ground for long periods will cup floor boards slightly</p> <p>Timber bearers in some areas are too close to the ground, dirt should be remove to create additional clearance for maintenance and inspections Cost \$2000-\$3000</p> <p>This will increase to cross flow ventilation when additional vents and increasing to front gap is increased</p> <p>Dirt should be removed when back tiled landing is removed, 200mm should be adequate so creating 400mm from ground to under side of bearer</p> <p>Ducting should not restrict air flow as much when soil is removed</p>
---------	---	--

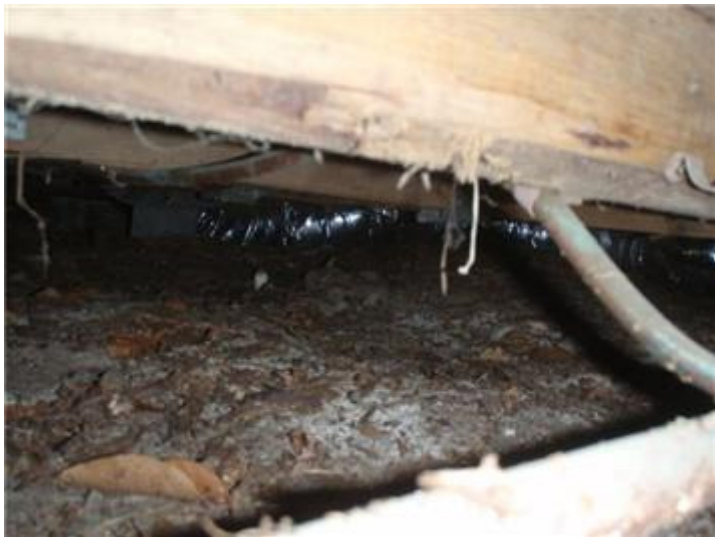
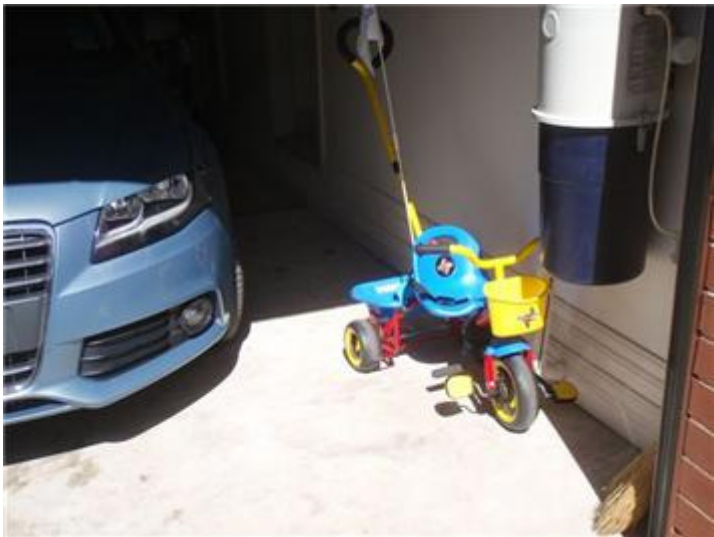
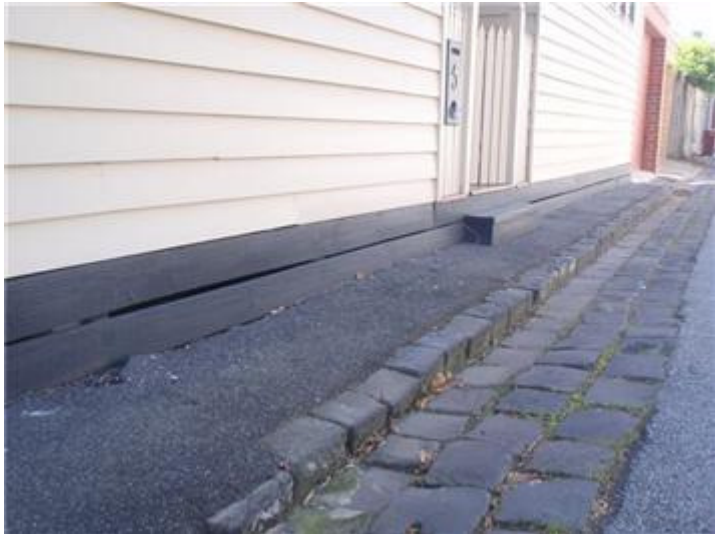
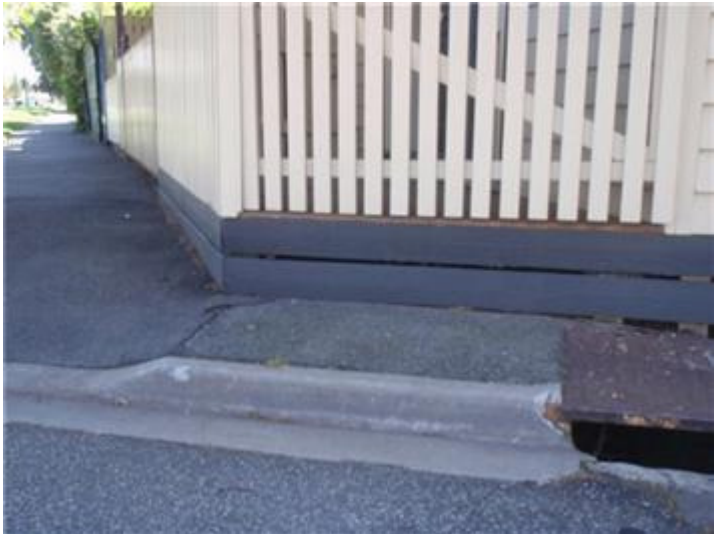
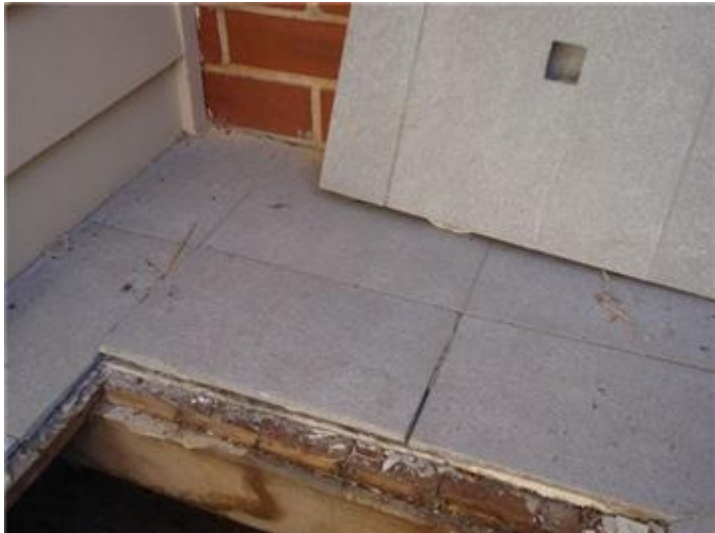
Ventilation	Gaps between base boards under weatherboards	<p>Ground was damp to most areas and requires attention</p> <p>Evidence of fungal decay was noted on ground, ventilation should be improved to external walls as this can be a health issue</p> <p>Better ventilation required to all external walls by adding vents to wall between dwelling and garage and back dividing boundary wall Cost \$400</p> <p>Gap at front between base boards should be increased to three times the size, as much as possible Cost \$400</p> <p>Ducting is restricting air flow to most areas of sub floor</p> <p>Removing soil so clearance is 400mm will help a lot</p> <p>The only ventilation to half of floor space is through the back trap door</p> <p>We have experienced higher than average rain fall over the last 6 months, once all these recommendations are done and we do experience flooding again then ground will dry out a lot quicker and not be such a health issue</p> <p>Floor boards should not alter in size as much as well</p>

Comments	No access to sub floor area was possible due to limited clearance We strongly recommend that access be gained to all inaccessible areas
-----------------	--

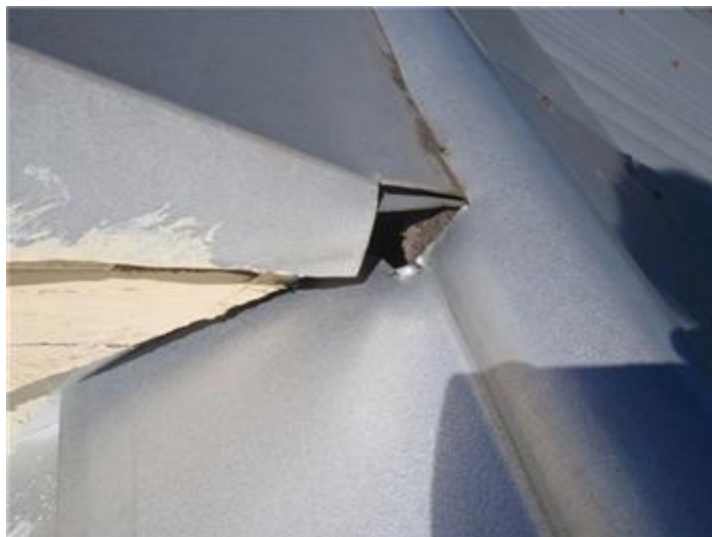
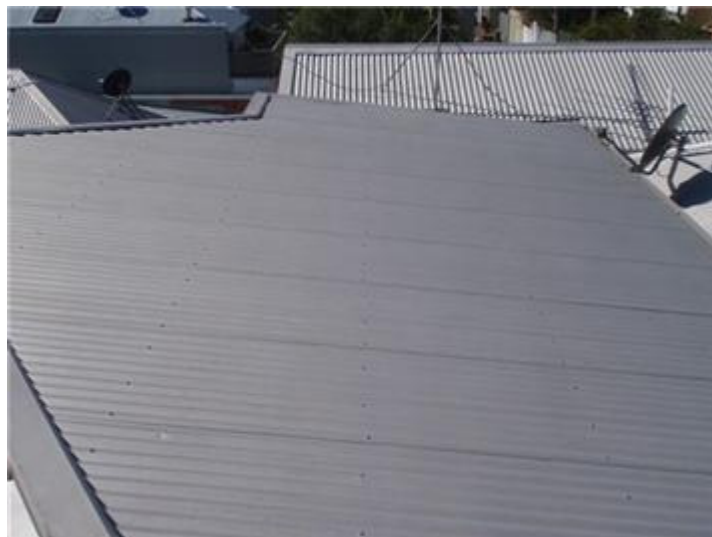
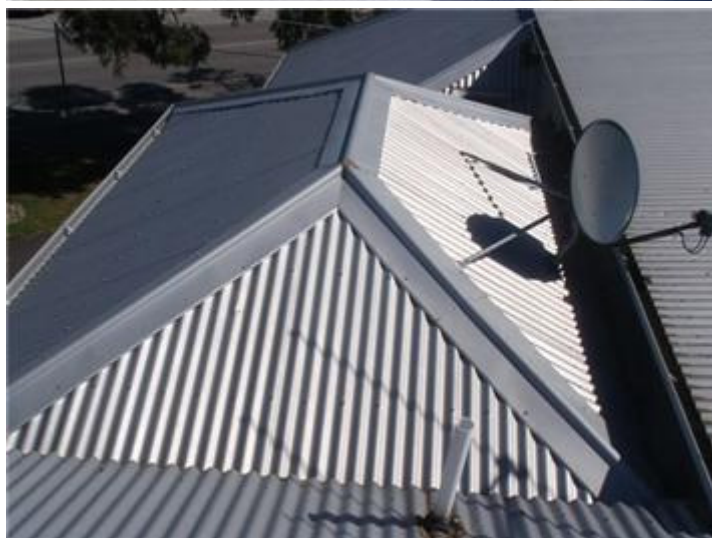
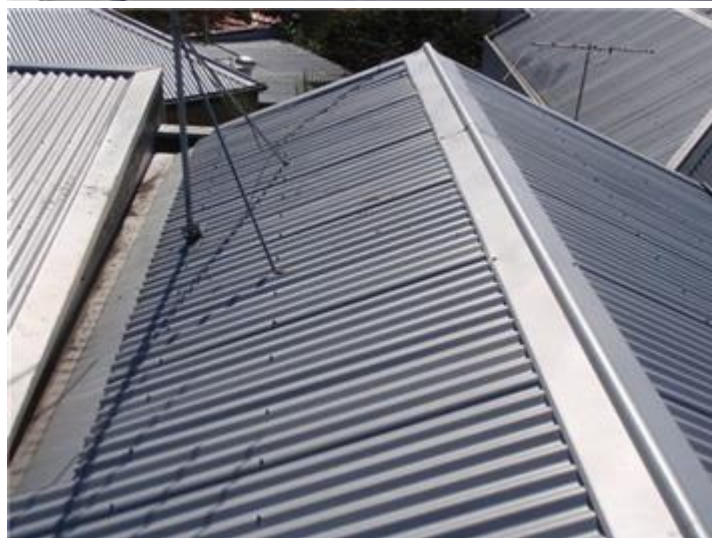
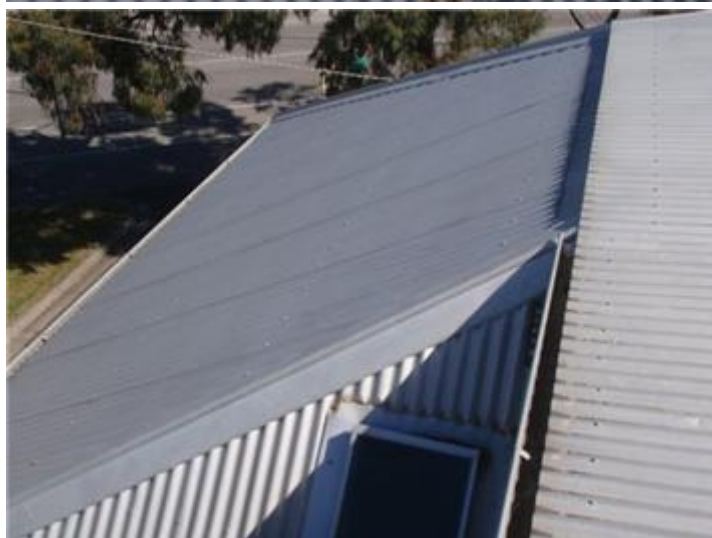
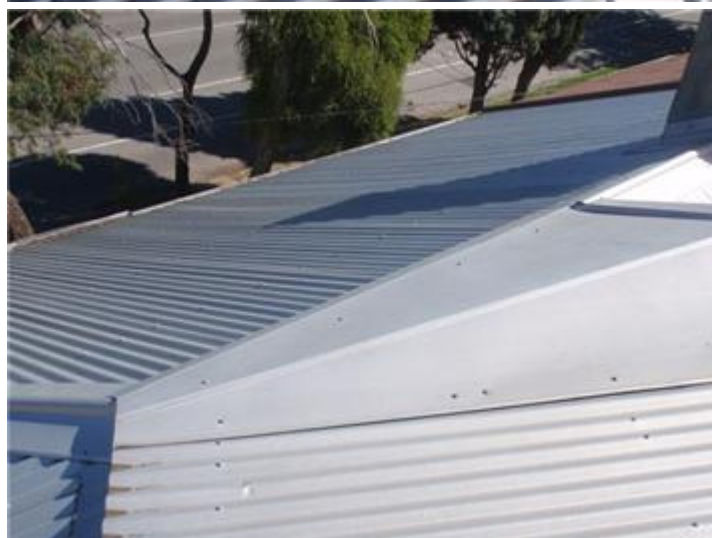
Roof coverings	Corrugated iron roofing	A gap was noted between flashings and require attention by plumber All appears to be in good condition with little to no maintenance required It is possible that top ends of roof sheets are not weathered (turned up under top flashing) and rain is running over tops of corrugated iron, it may pay to remove this flashing when weather boards are being replaced and check
-----------------------	-------------------------	--

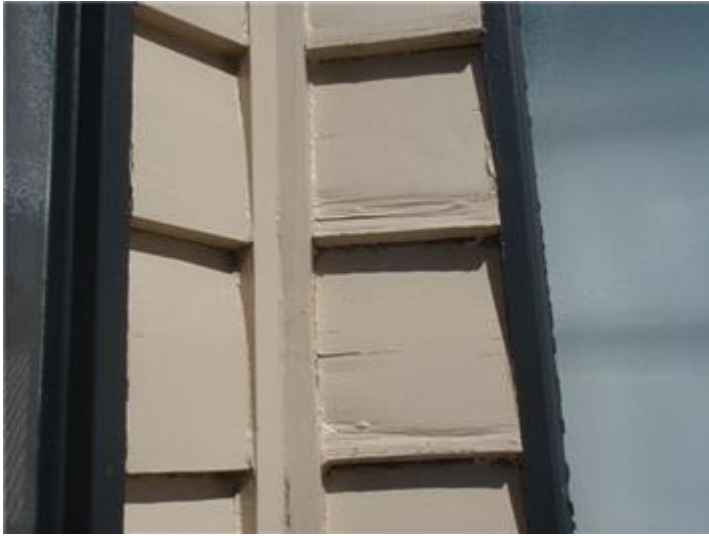
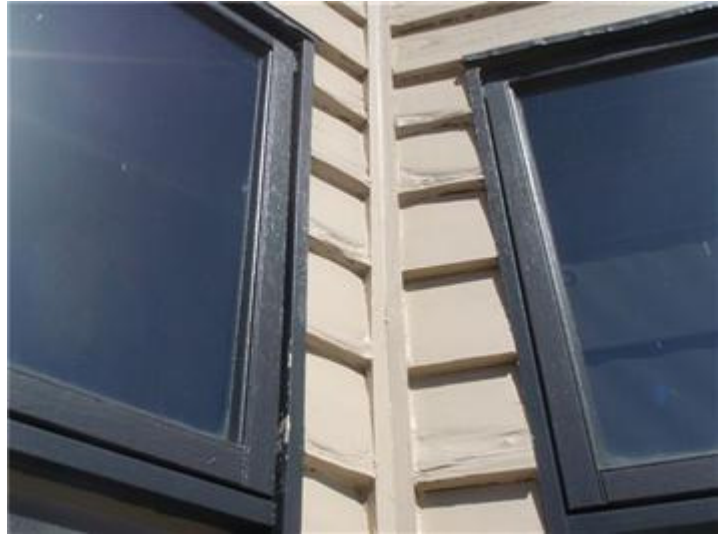
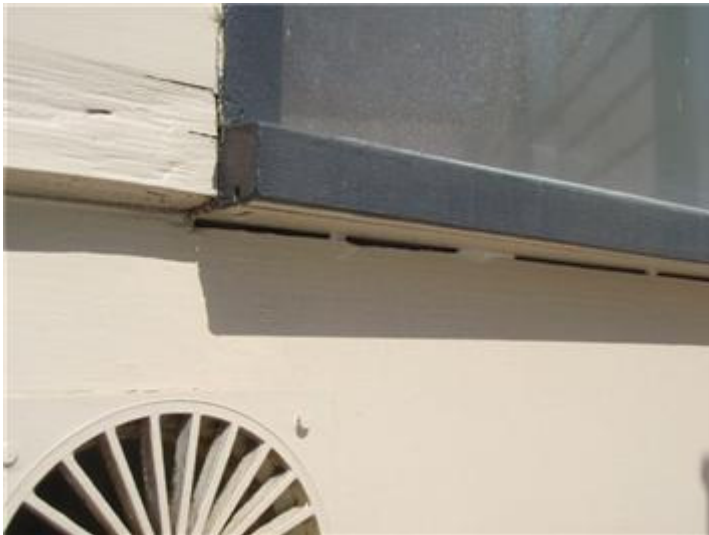
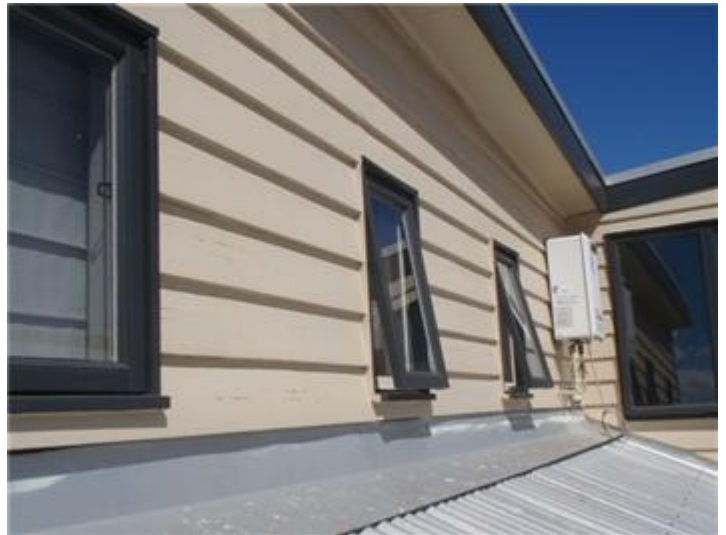
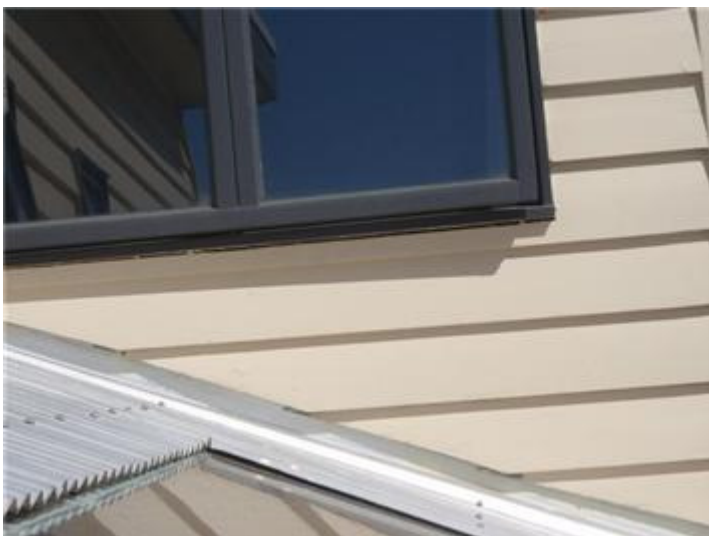
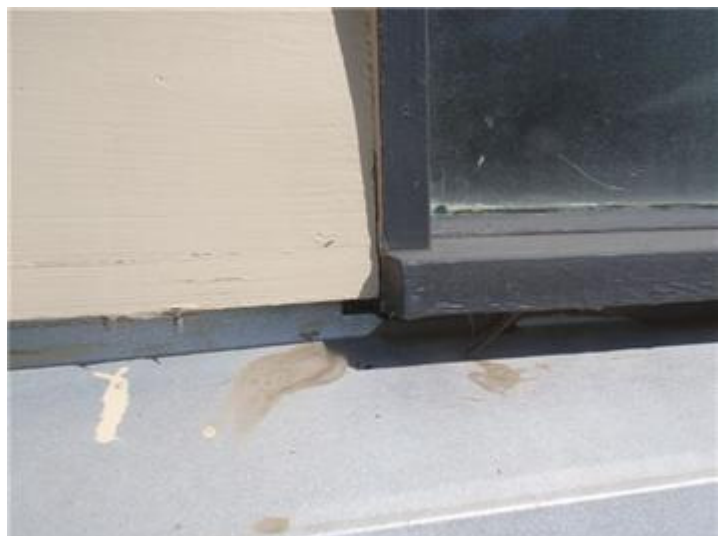
**Walls**

Rot noted to weather boards at back and will require replacing

Rot noted to ends of these weather boards, this is common as ends of weather boards are probably not sealed, recommend painting all ends of new boards before installed

There are gaps between verandah roof flashings and window sills, in my opinion windows are slightly to low and a window sill flashing should have been installed that goes over roof flashing

There is also a gap between timber fascia and top weather board, when boards are replaced there should be no gap for water to enter

Windows may require additional flashings at sides and

under sill

Weather boards on boundary wall require painting

Hole around pipe at back requires filling

Once weather boards are replaced properly and with correct flashings then there should be no leaks

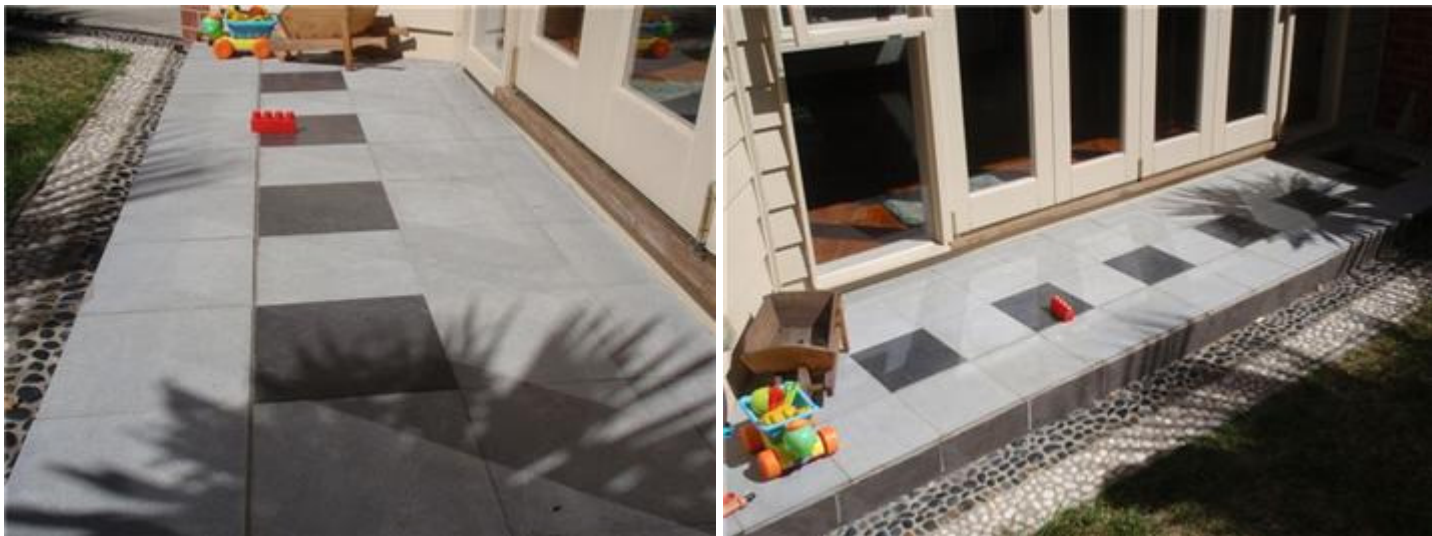
General Exterior

Patio	Tiled	Landing at back is in poor condition, timbers are in contact with the ground Better ventilation should be incorporated with new deck Soil from sub floor should be removed when landing is removed
-------	-------	--

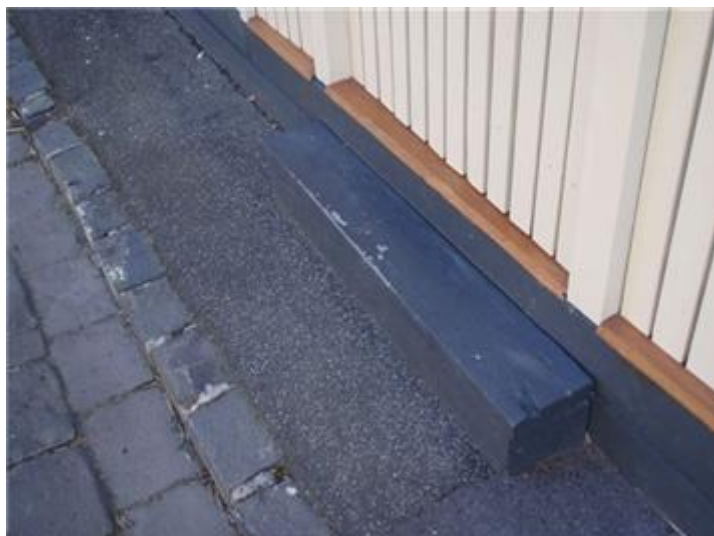
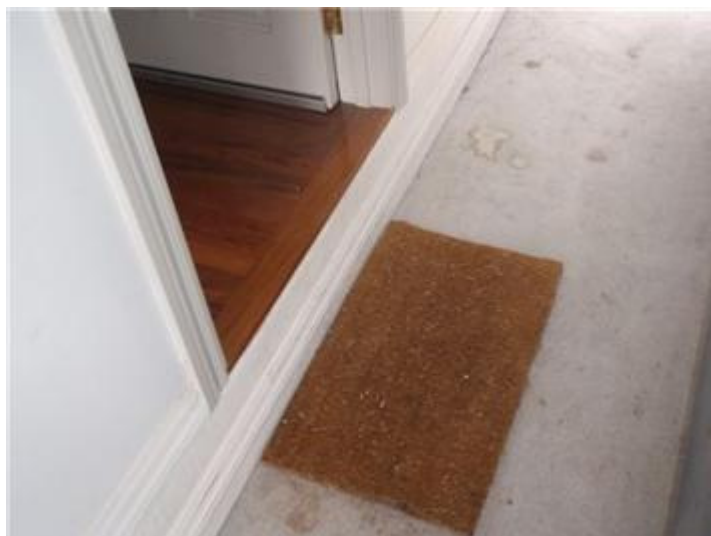
Stairs	Timber steps	Step does not comply to current regulations as tread size is under 240mm in length, this should be rectified for safety reasons Step required in garage as height is over 190mm current height requirements, this should be rectified for safety reasons
--------	--------------	---
