Buy-Wise Pre Purchase Building & Pest Inspections P/L

MAJOR STRUCTURAL BUILDING REPORT

Inspected Property Address:	5 Parkland Close Frankston	
Client Details:	Name: Sample	
	Address:	
	Phone:	Mobile:
	Email:	
	Client Attended Inspection: No	Contract Details: Major Structural Defect and Termite Infestation
Inspection Date & Time:	Monday, 1 February 2016 8:30:00 AM	
Building Consultant:	Peter Hearn DB-U12617	Phone: 9775 7188
Agent:	No agent	Phone:

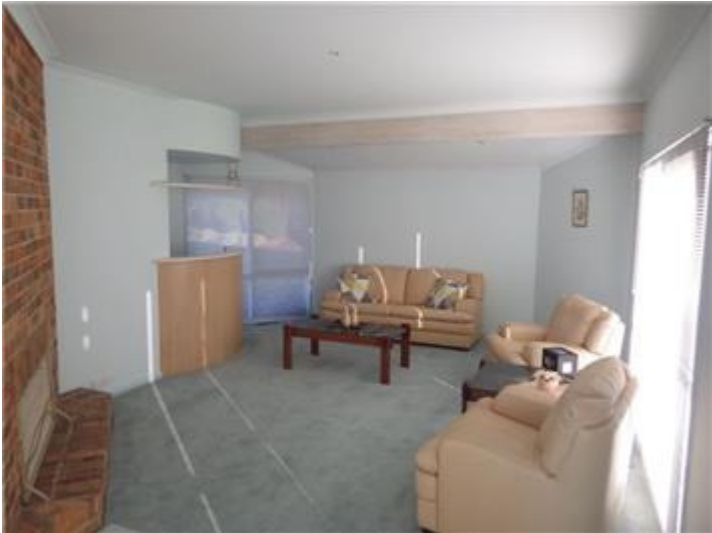
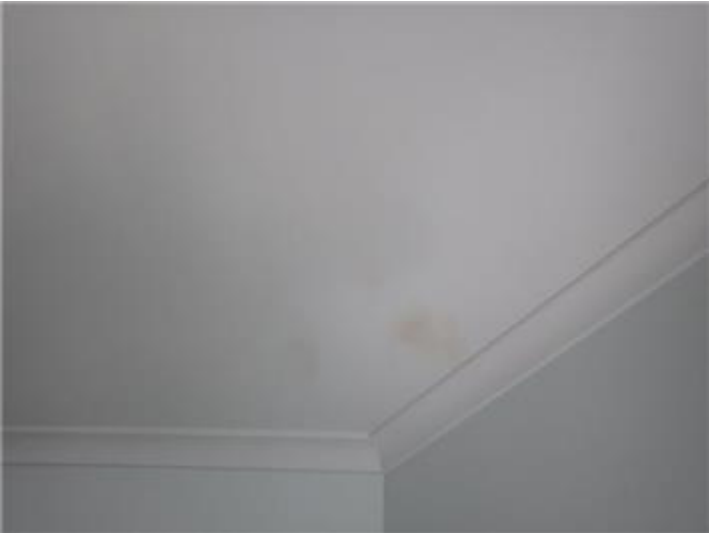
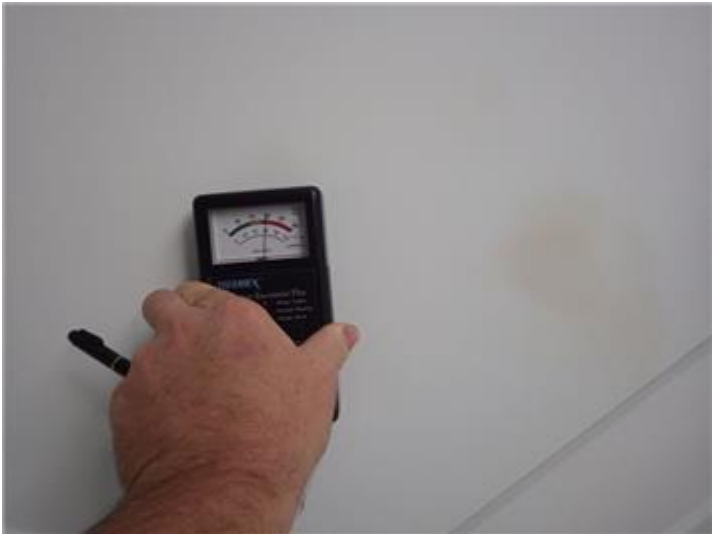
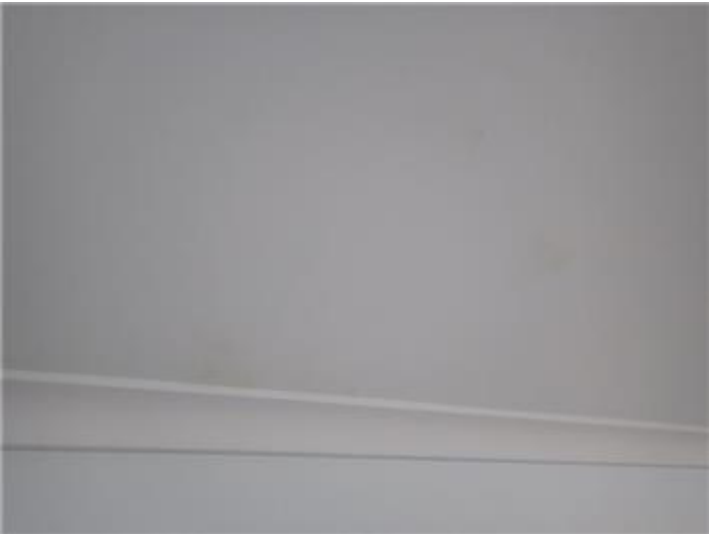
Water mark noted and moisture recorded, requires further investigation
Most likely from rodents, treatment required

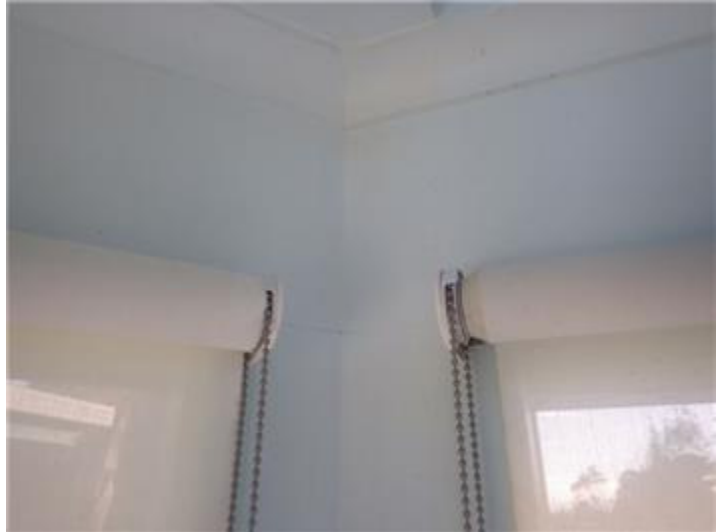
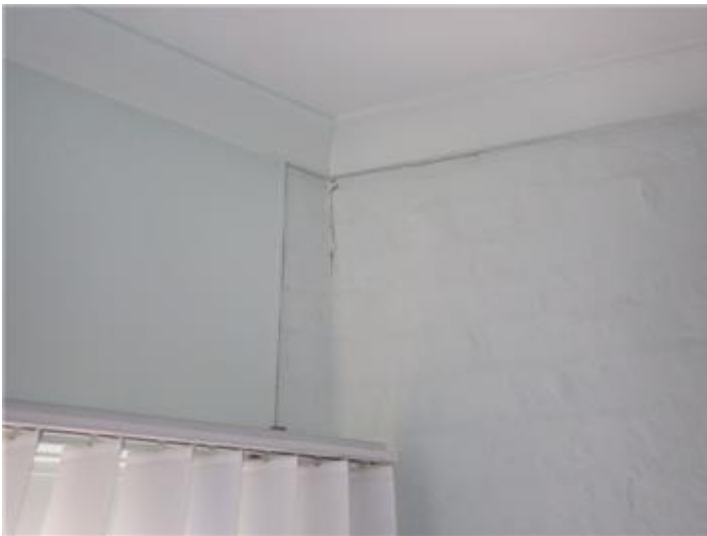
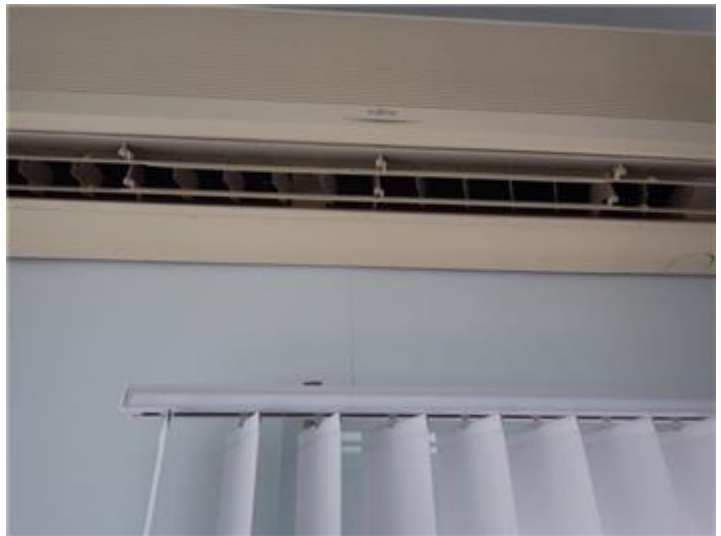
Minor movement noted in areas

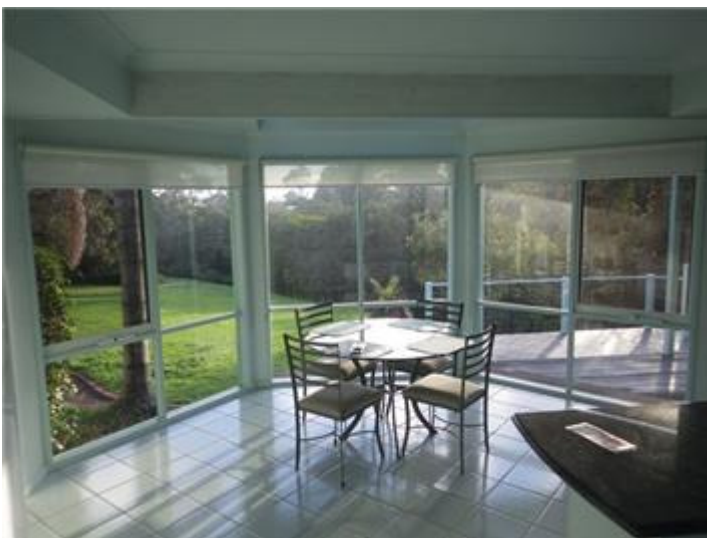
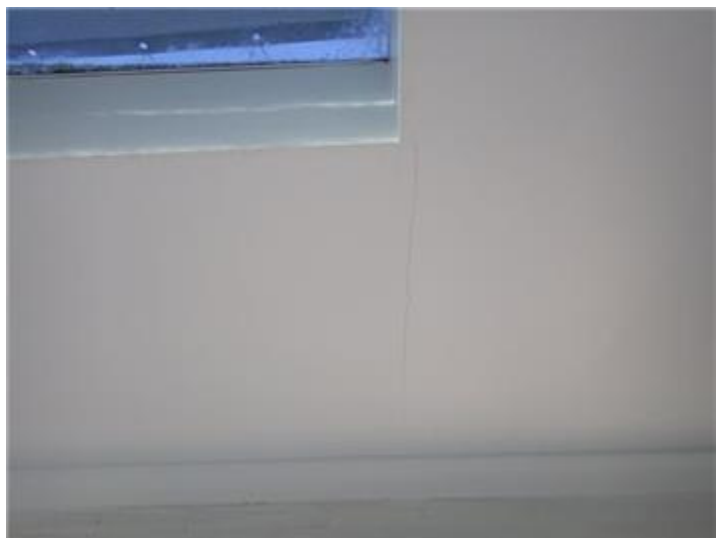
Minor movement noted between plaster sheets at join, minor repairs required and is unknown if they will return

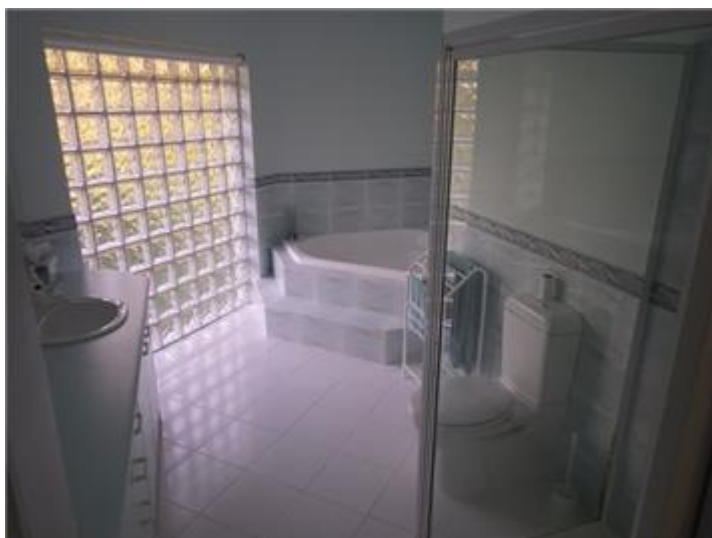
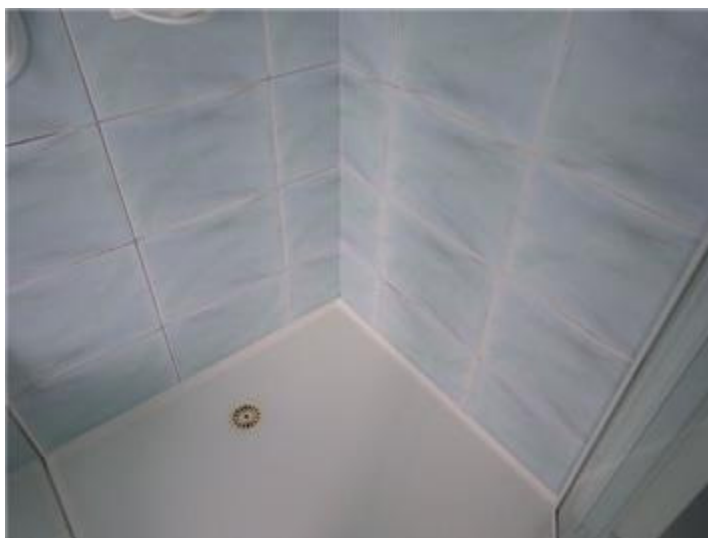
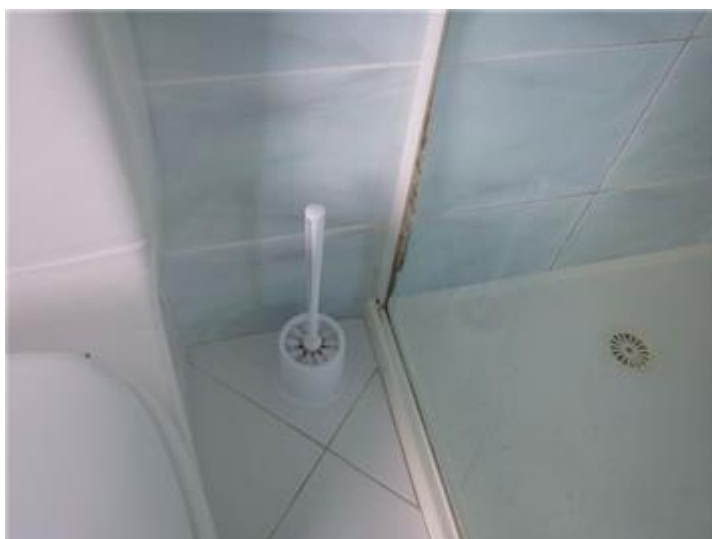
High moisture recorded behind tiles of shower, this is a very common problem and can cause tiles to dislodge over time and depends on what adhesive was used and how well applied
 High moisture was also recorded to tiles next to shower enclosure, this will continue if tiles are not sealed or possible leaks fixed

Tiles and grout should be well dried and then sealed in shower, this is to manufactures recommendations. The sealer is clear and can not be seen once dry Cost \$200

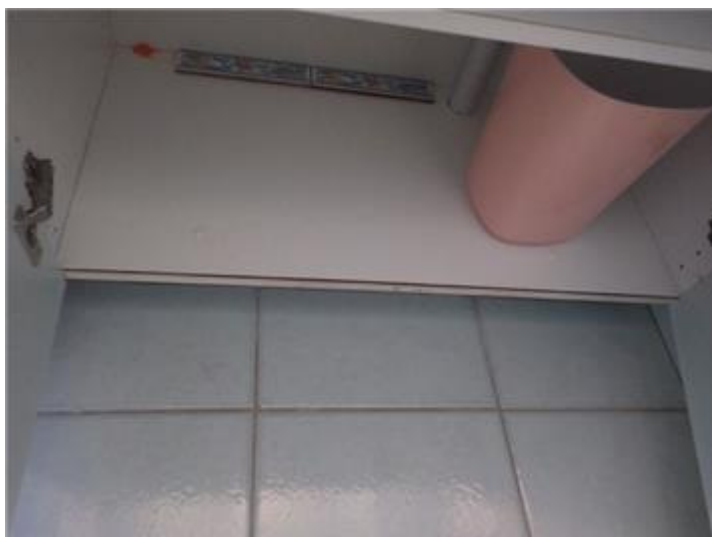
Water damage noted to shelves under basin, waste has been leaking and may require attention

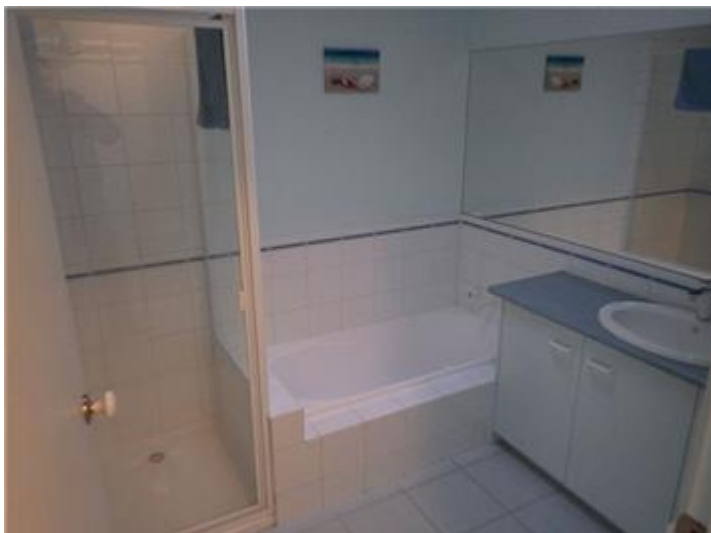
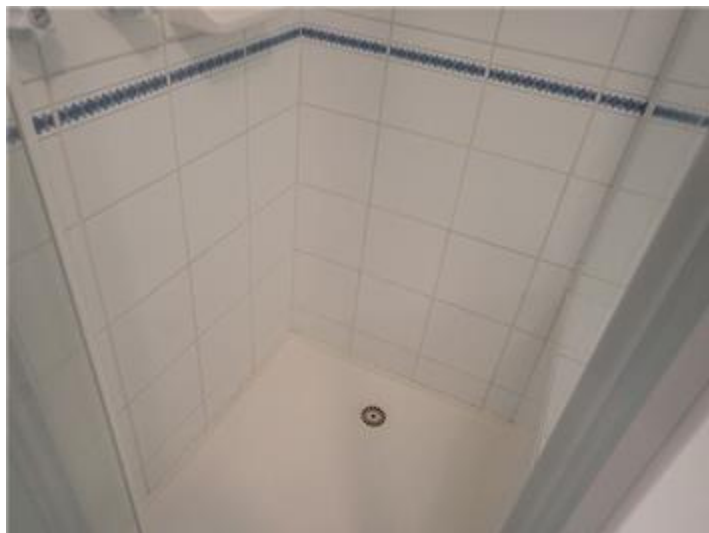
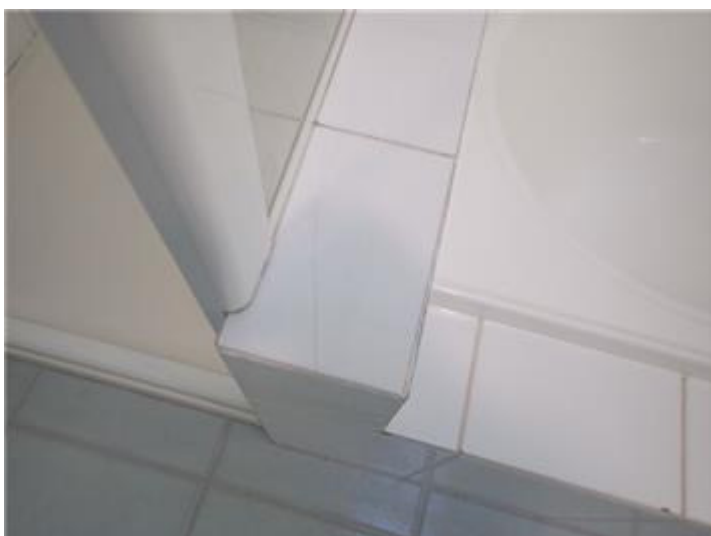
High moisture recorded behind bottom row of tiles of shower, this is a very common problem and can cause tiles to dislodge from wall over time and depends on what tile adhesive was used and how well applied
No high moisture was recorded out side shower enclosure at time of inspection
Cracked tiles noted around bath

Tiles and grout should be well dried and then sealed in shower, this is to manufactures recommendations. The sealer is clear and can not be seen once dry Cost \$200

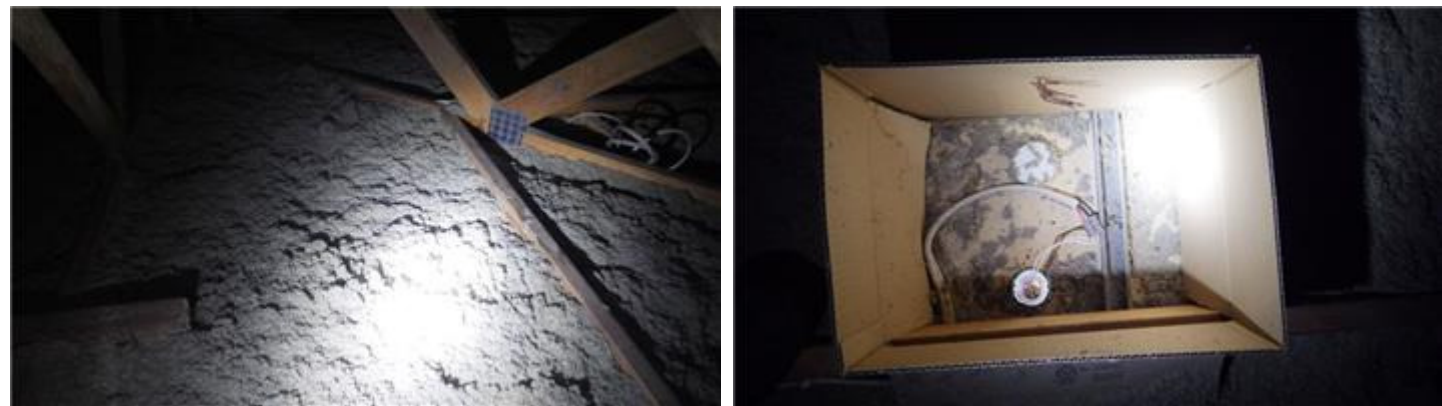
All down lights should be clear of insulation as they can generate enough heat for insulation to smoulder, they should be 200mm clear from any combustible material

Cardboard around 12 volt down lights is not a current approved surround on its own

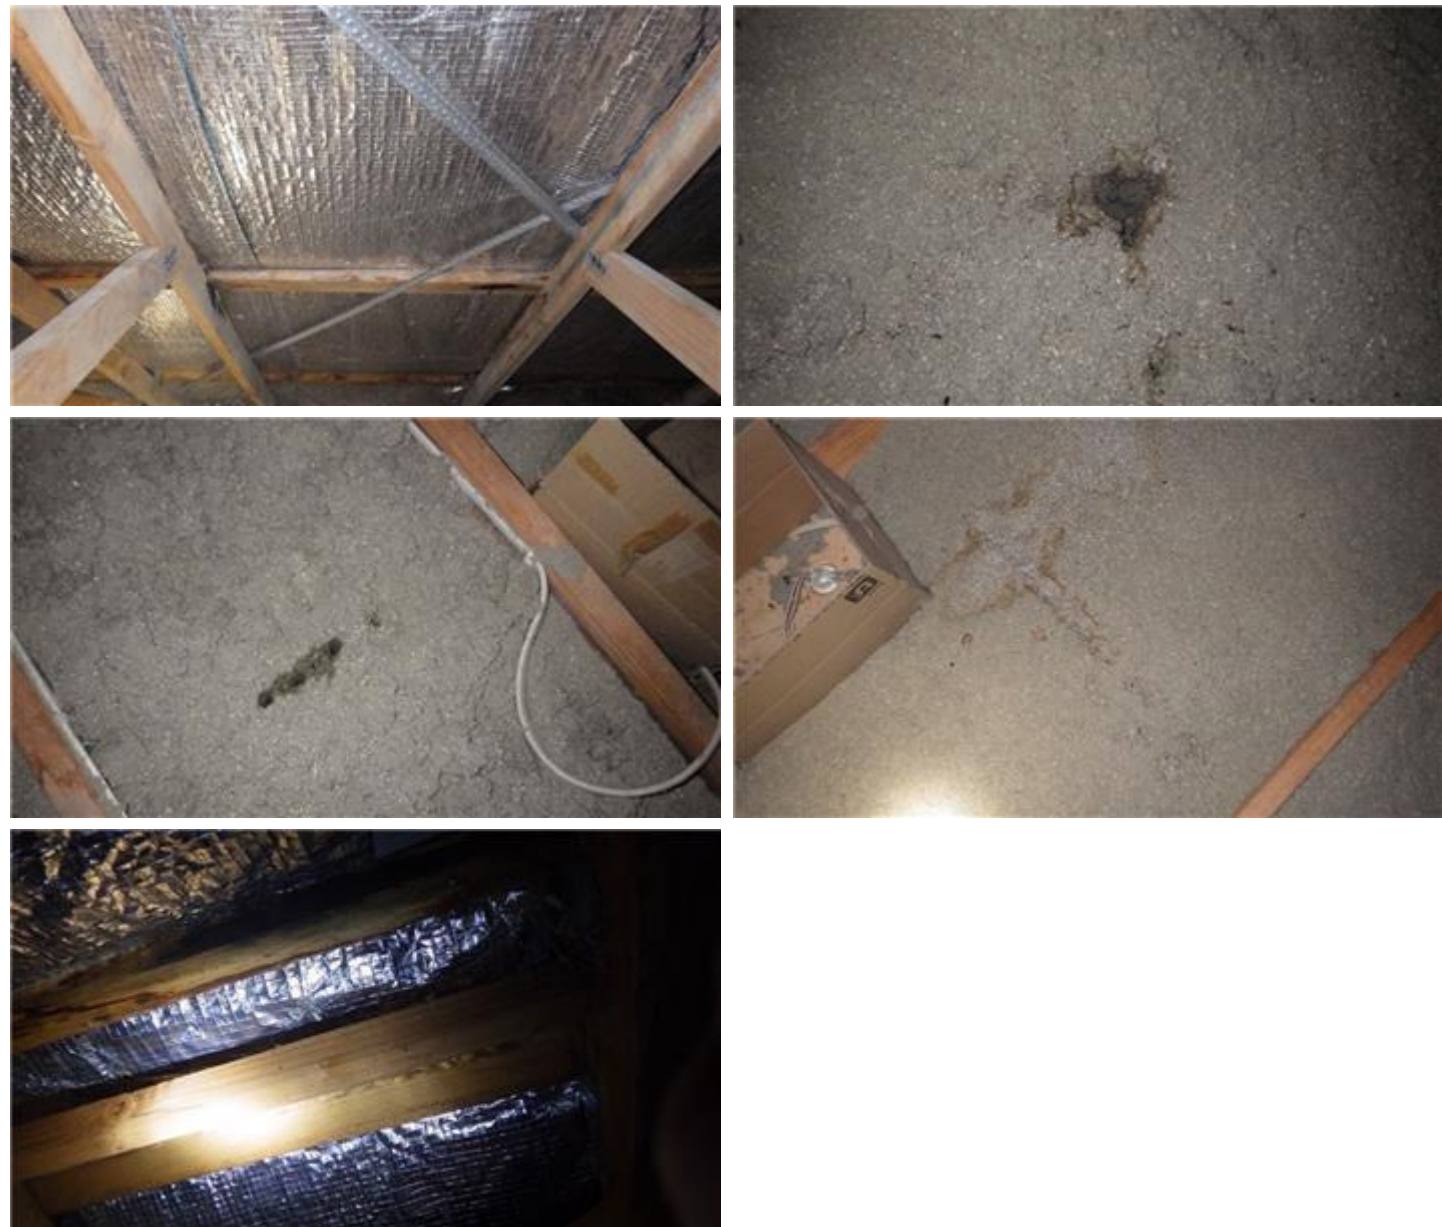
Some leaks noted at ridge line of roofing, plumber to investigate further

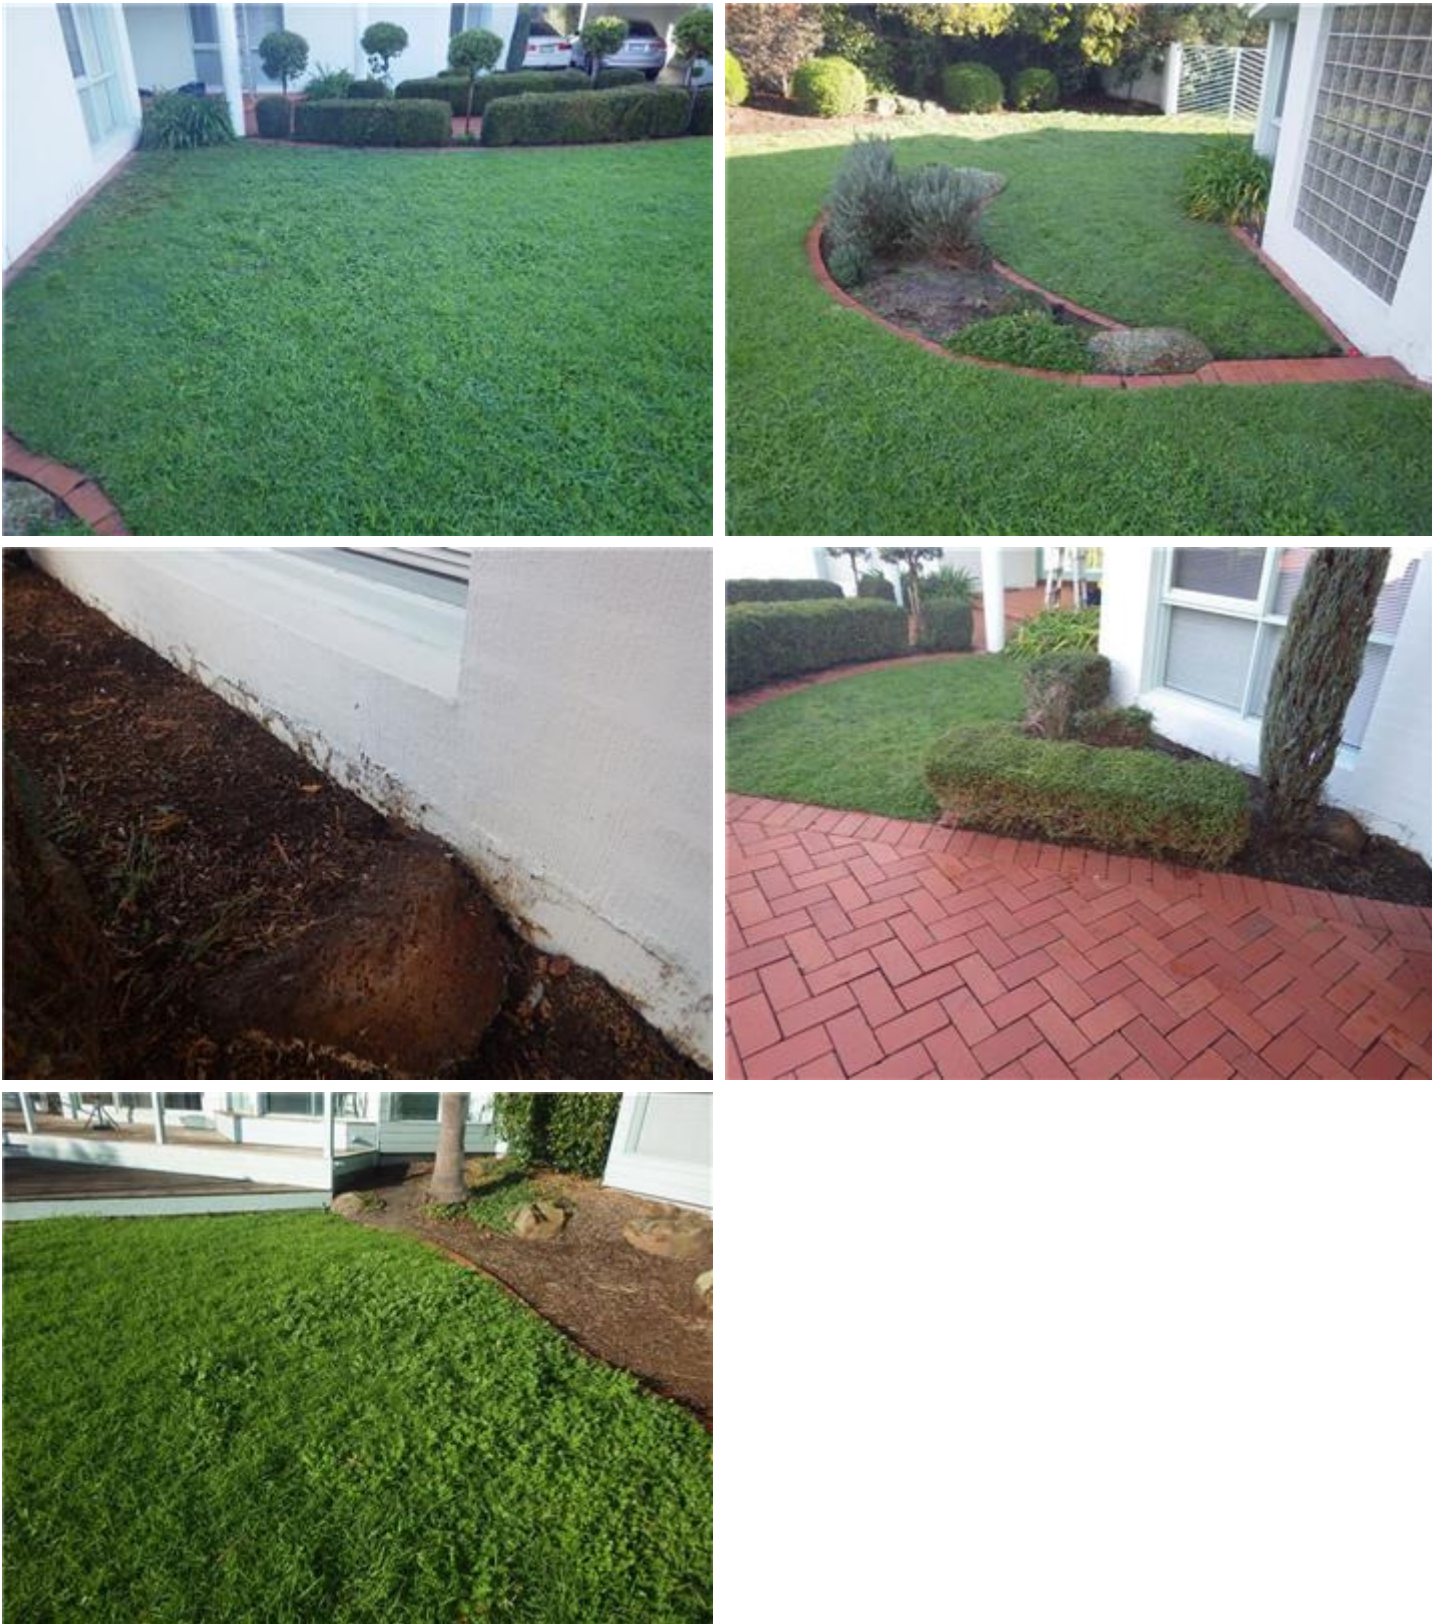
Surface water drainage requires improving at front, agi drain required at front of dwelling, Estimated cost \$4000
Plumber to quote properly
High moisture was noted to walls up to damp course level only
The ground around the dwelling should be kept consistently dry all year.

The retention of water from surface run off could have an affect on the foundation material which in turn could affect the footings to the dwelling.
Best practice is to monitor the flow of surface water and stormwater run off and have the water directed away from the dwelling or to storm water pipes by a licensed plumber/drainier.

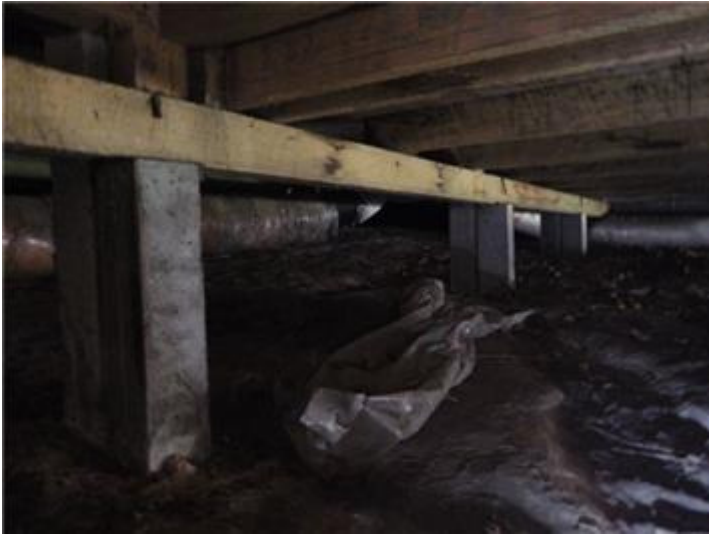
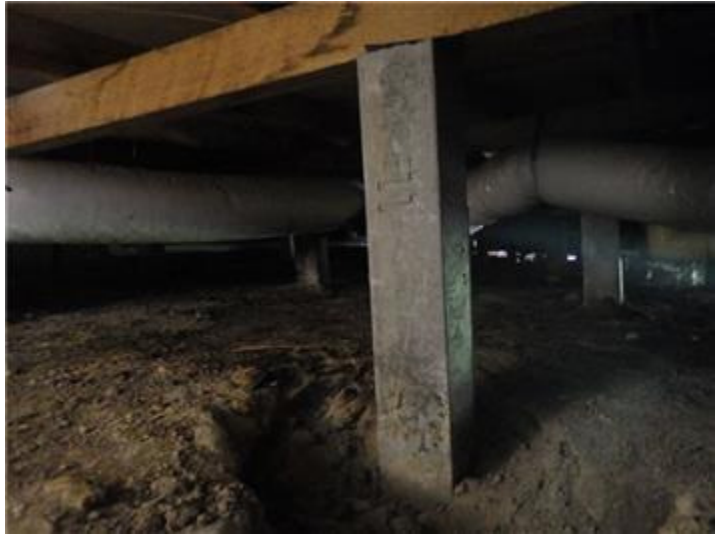
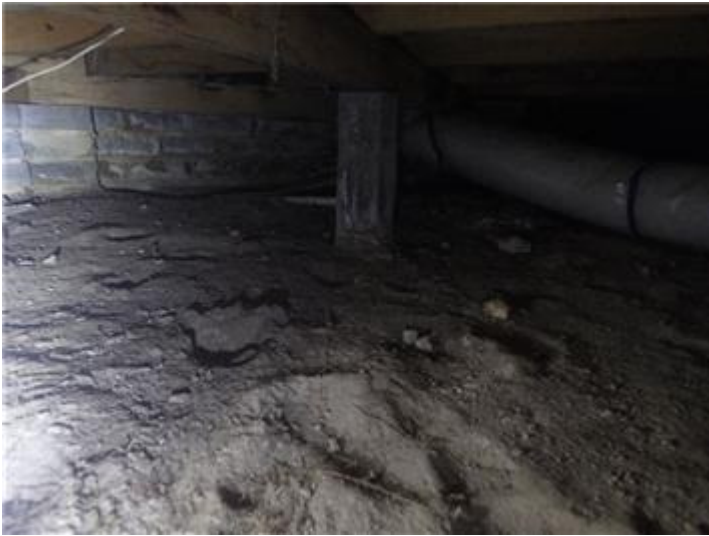
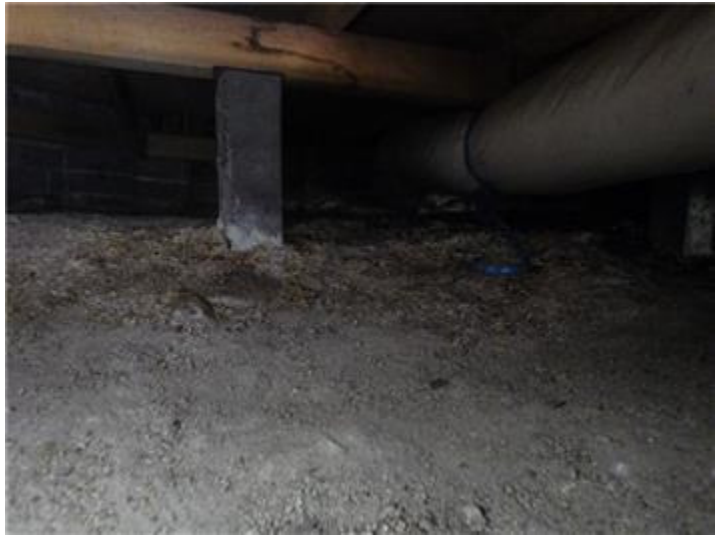
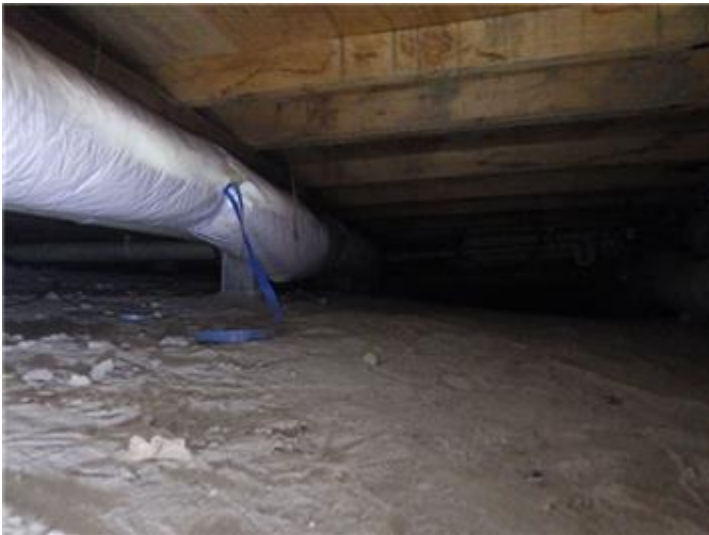
The concrete stumps appear to be in good condition from a visual inspection and floor levels were fairly consistent. Some settlement has occurred to concrete stumps in areas, this is quite normal for a house of this age and type of construction but should be monitored.

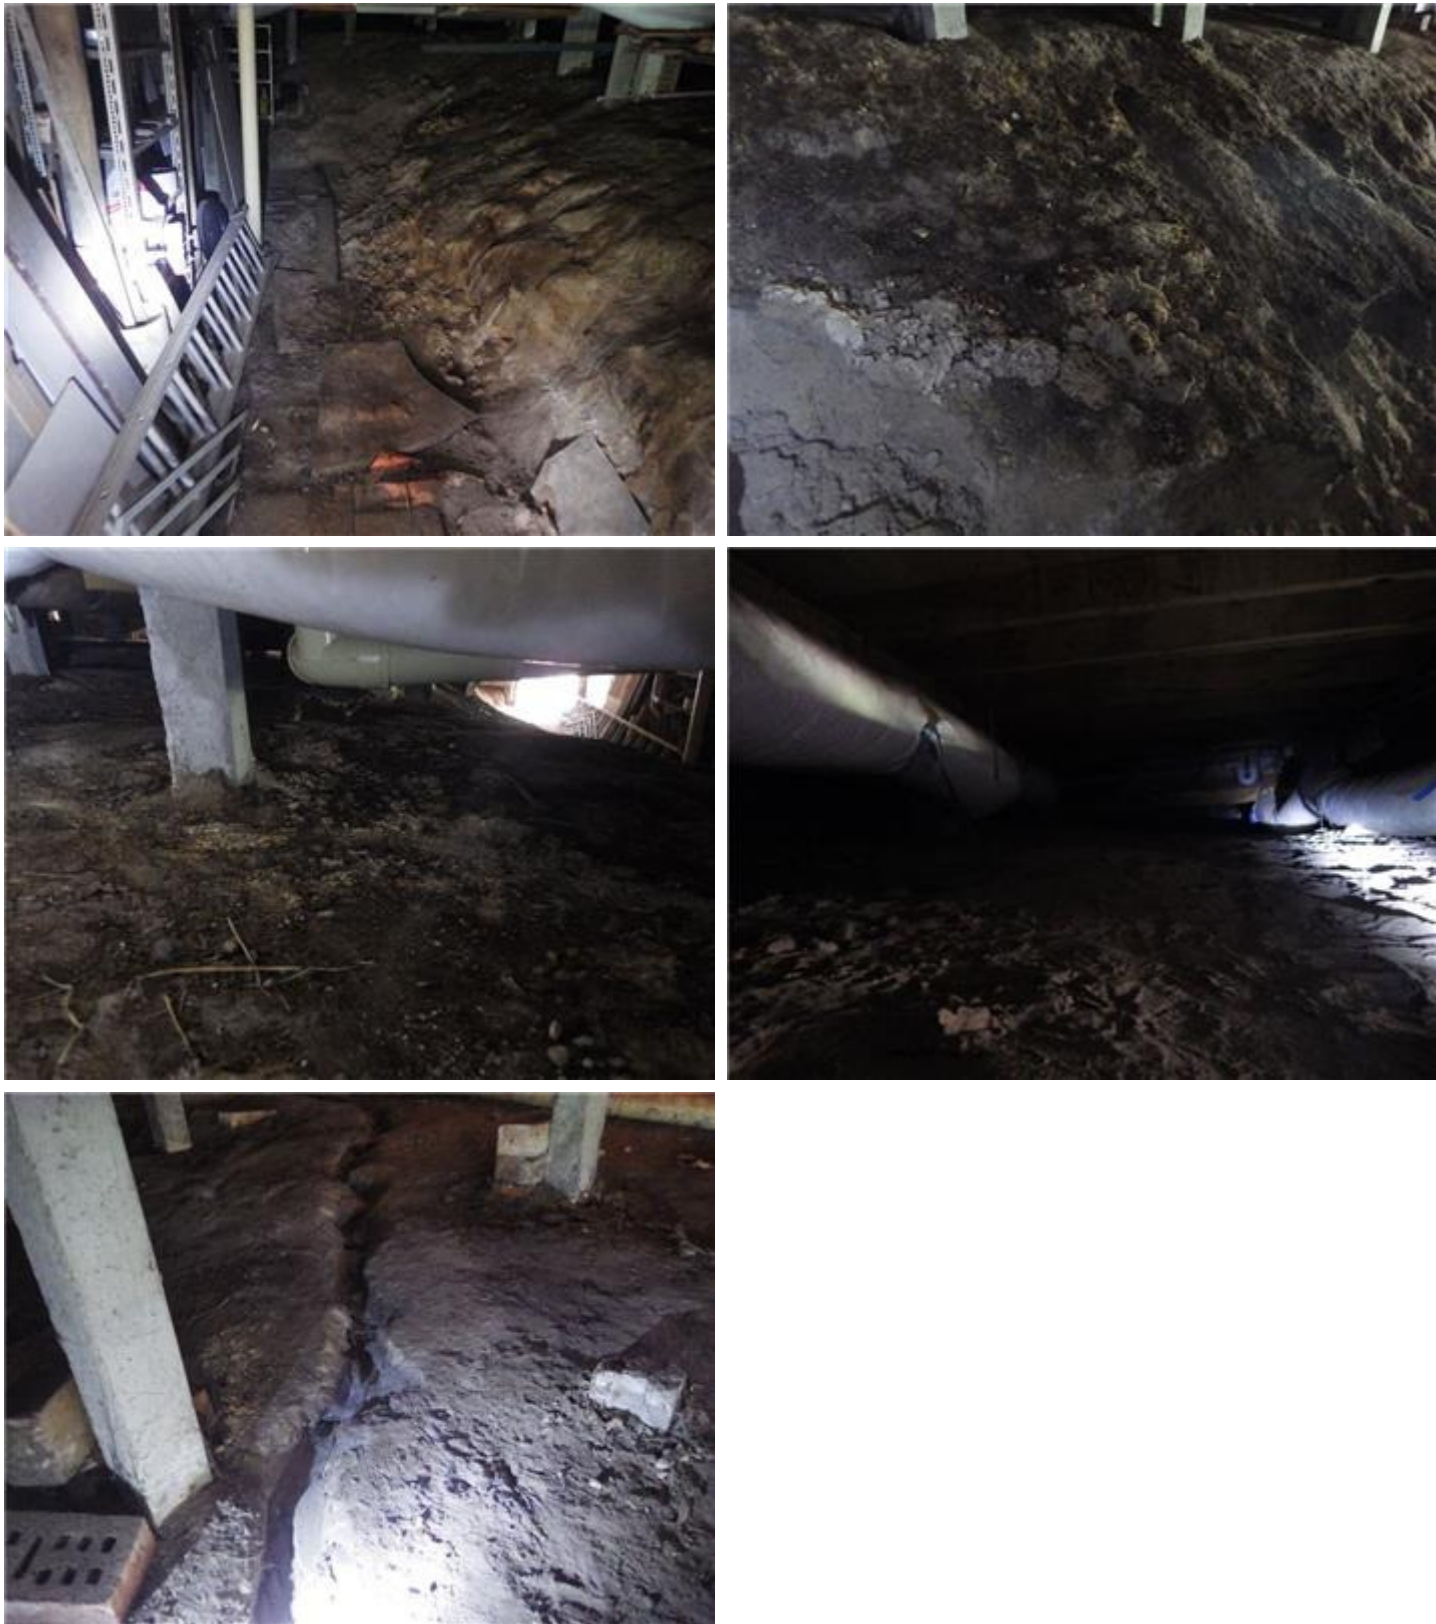
Ground was damp in areas and requires attention

Evidence of fungal growth was noted on ground, ventilation should be improved to external walls as this can be a health issue

Water trail noted across the dwelling coming from a pipe under laundry area, plumber to assess

Surface drainage will require improving around dwelling and would be contributing to the damp conditions, plumber to assess.

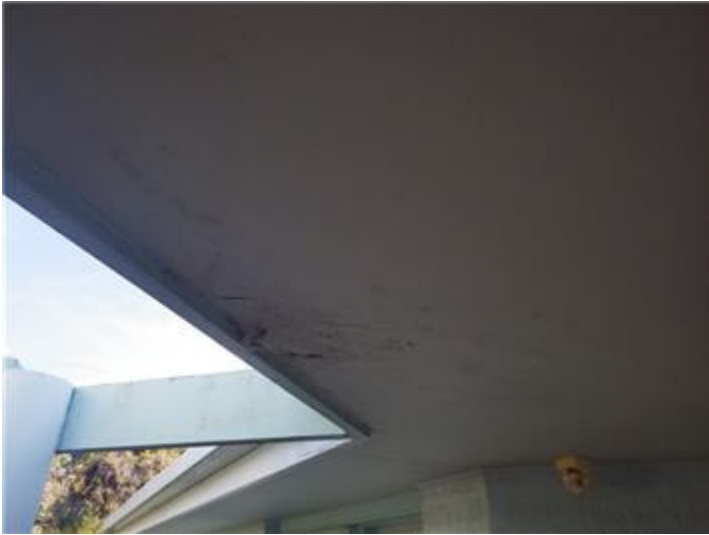
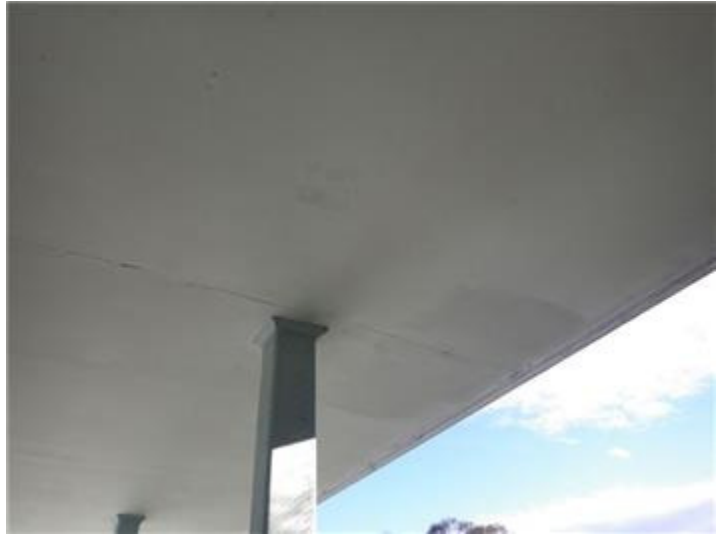
Water marks and damage noted to cement sheet eaves in areas, this usually means that gutters have over flowed, plumber required to evaluate

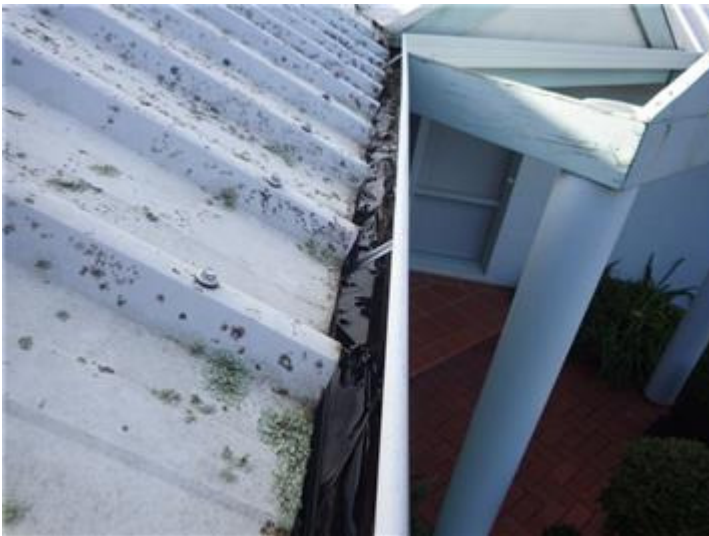
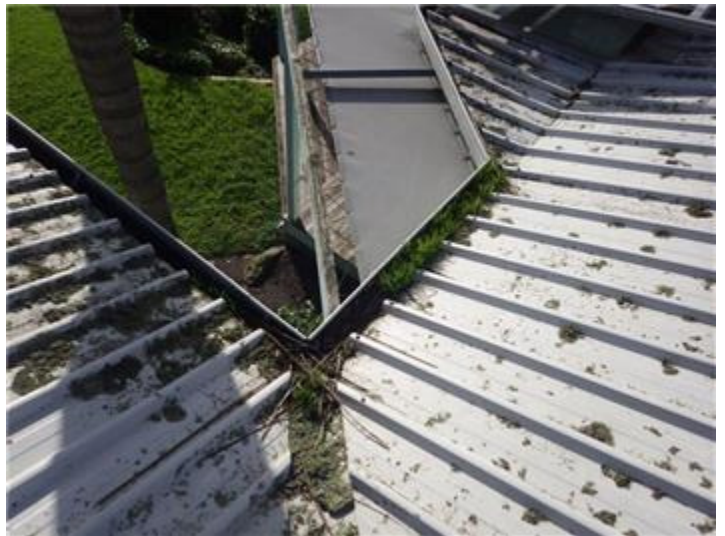
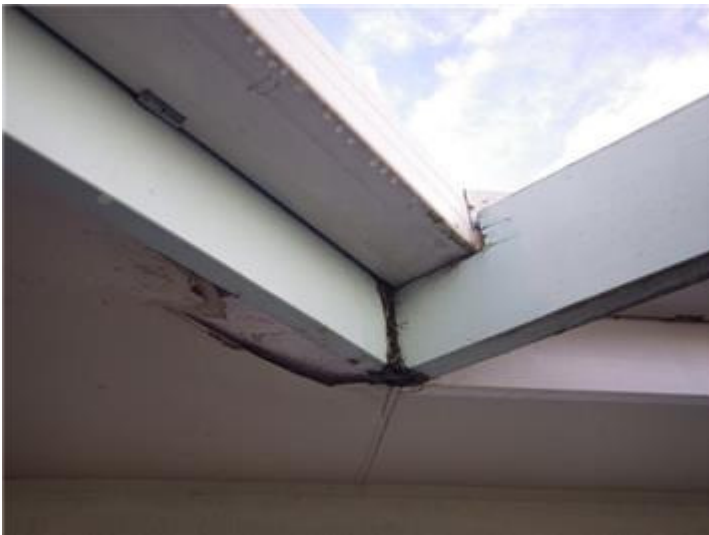
Urgent cleaning of gutters is required as water can run over the back of guttering and enter the wall cavity

Leak noted at front right, plumber required to evaluate

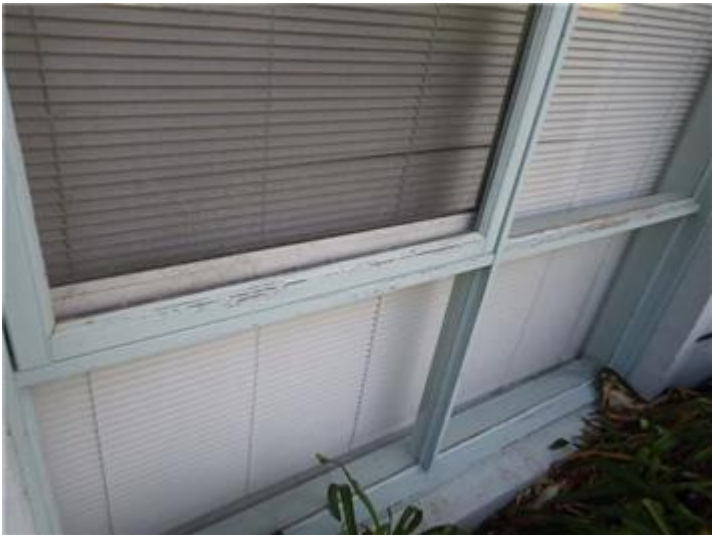
Painting required to some external timbers to protect them from further deterioration

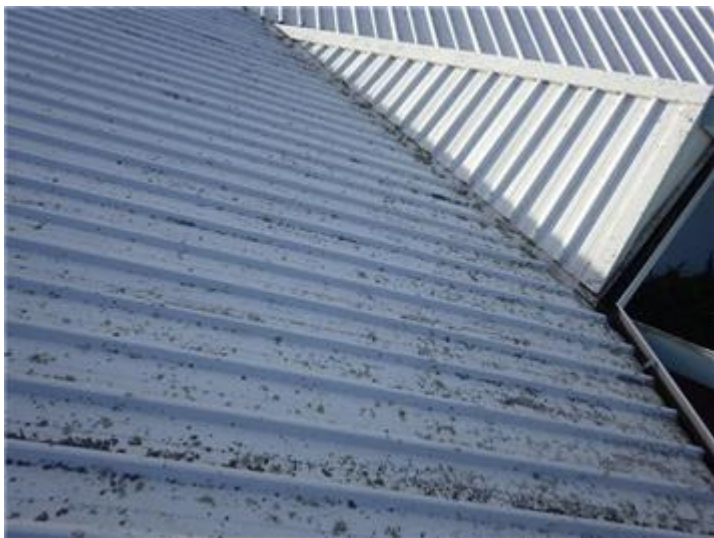
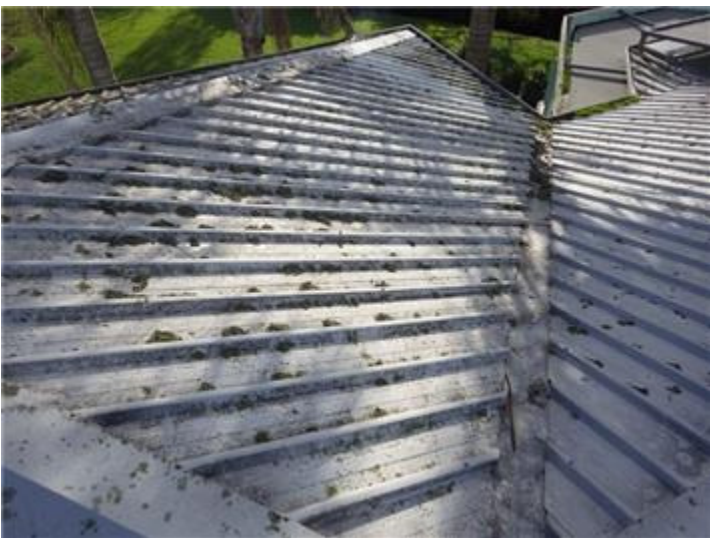
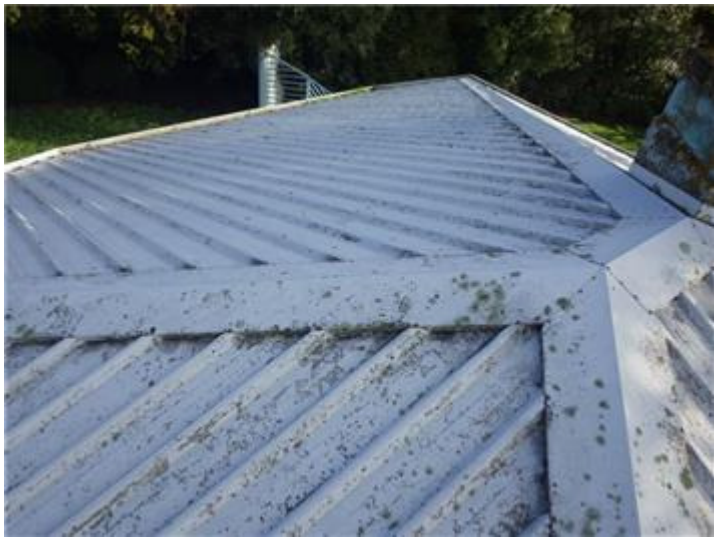
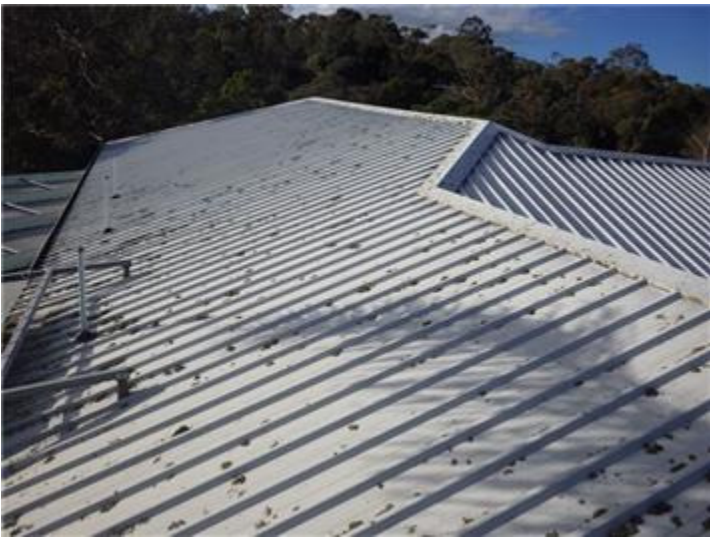
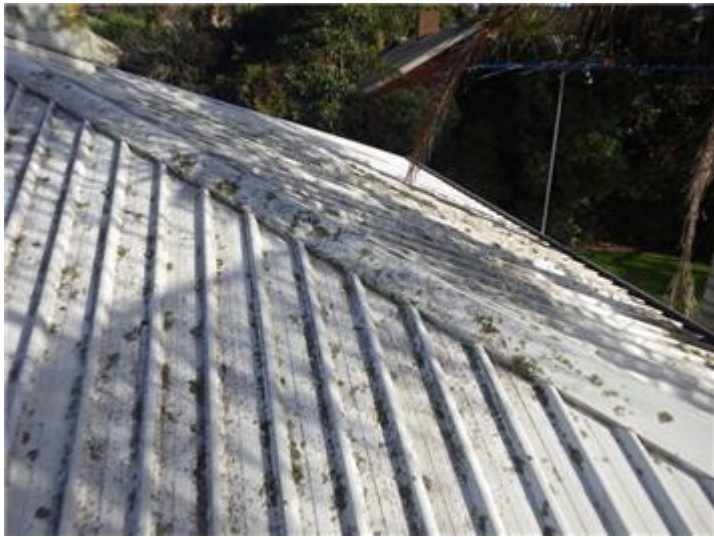
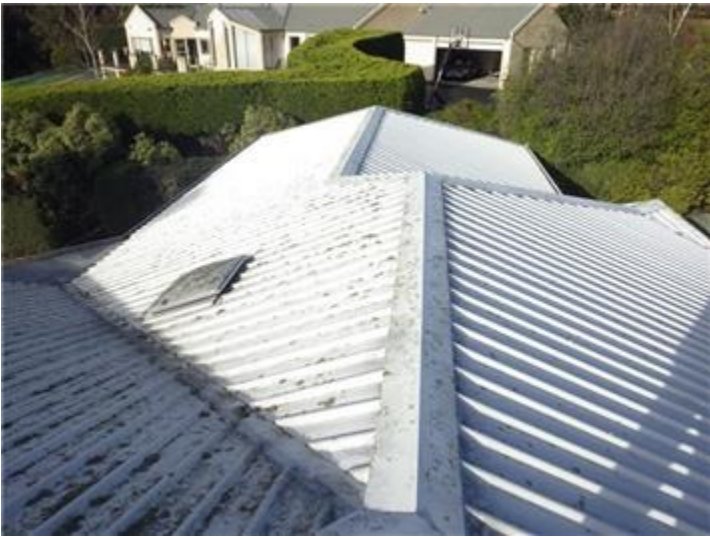
Roof Coverings	<p>Moss noted to areas of roofing, this can cause leaks and should be removed by pressure cleaning. Estimated costs can vary between \$500 - \$1000 depending on if safety rail required and time taken to remove moss</p> <p>Some surface rust noted around sky light and should be protected</p> <p>Some leaks noted at ridge line of roofing, see roof space comments</p> <p>Plumber required to evaluate further regarding condition of roofing and cost of repairs</p>
----------------	---
