Buy-Wise Pre Purchase Building & Pest Inspections P/L

MAJOR STRUCTURAL BUILDING REPORT

Inspected Property Address:	5 Parkland Close Frankston	
Client Details:	Name: Sample	
	Address:	
	Phone:	Mobile:
	Email:	
	Client Attended Inspection: No	Contract Details: Major Structural Defect and Termite Infestation
Inspection Date & Time:	Monday, 1 February 2016 8:30:00 AM	
Building Consultant:	Peter Hearn DB-U12617	Phone: 9775 7188
Agent:	No agent	Phone:

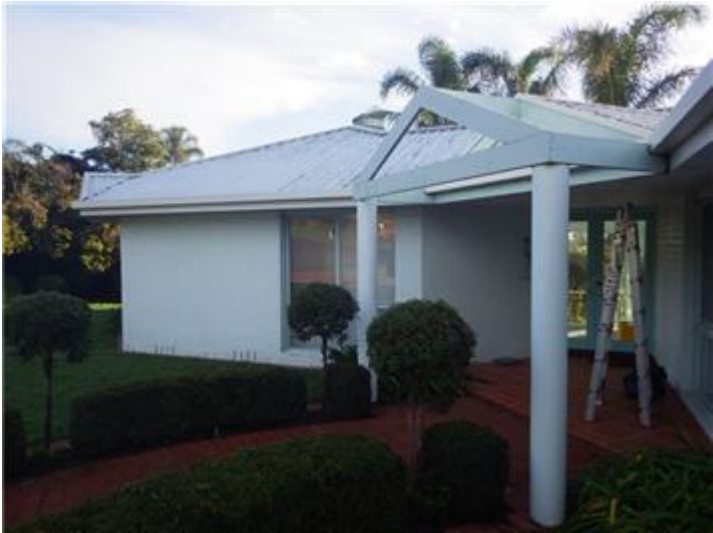
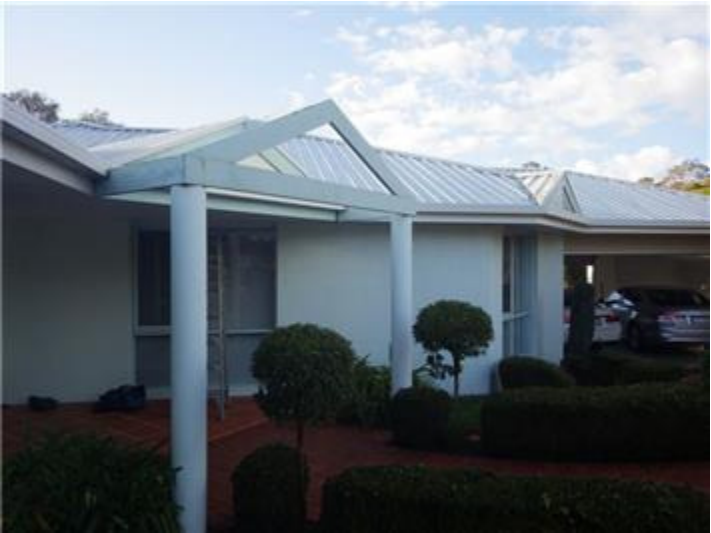
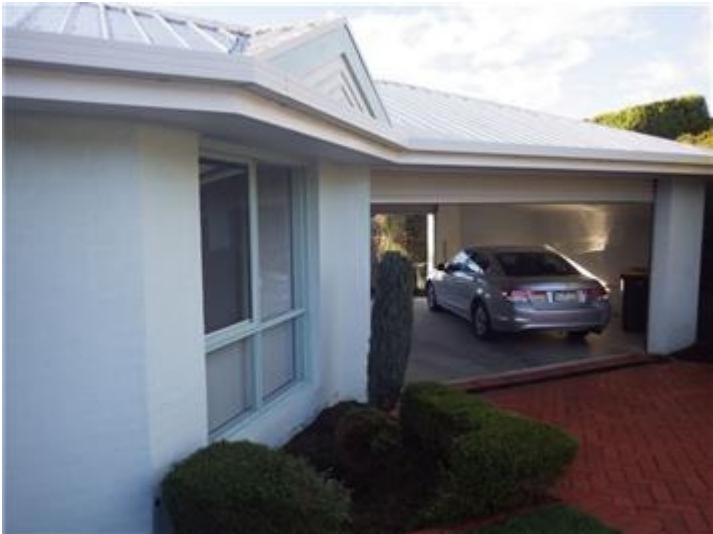
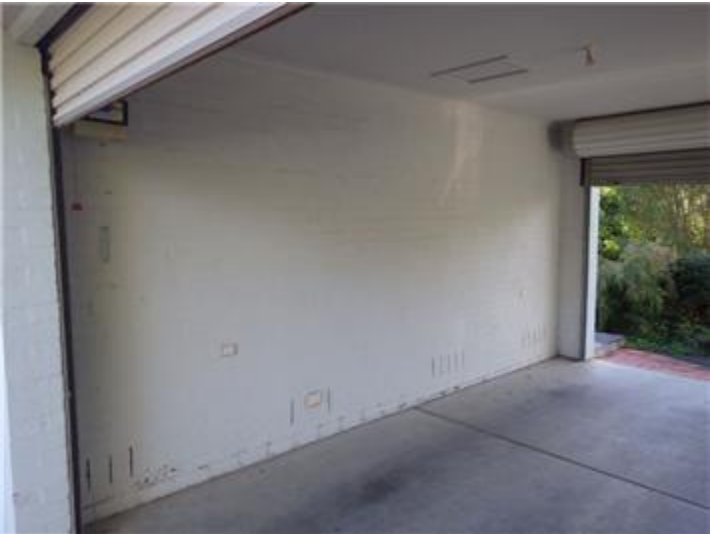
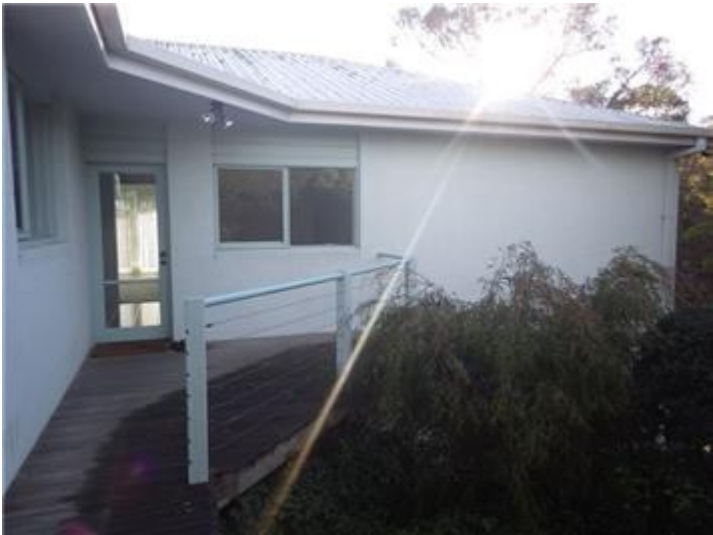
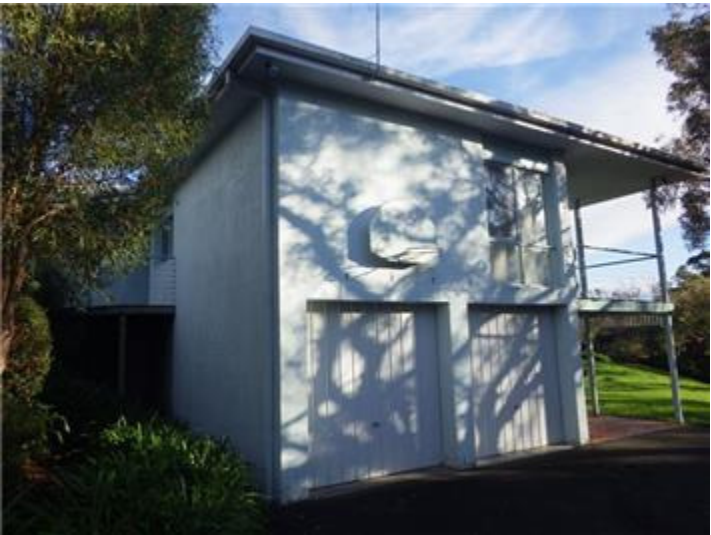
Walls	<p>Minor movement noted in areas around dwelling and should be monitored</p> <p>The amount of movement is slightly below average with other dwellings of the same type and age but this does not mean that they are not increasing and should be monitored</p> <p>If you are concerned about movement increasing in size or further movement to the dwelling then a geotechnical report (soil report) will have to be commissioned. It is unrealistic for us to comment on conditions that can not be determined from a visual inspection, in other words what is happening under the dwellings foundations.</p> <p>Where drainage or gutter/downpipe problems exist around a dwelling, these can have an affect on the dwellings foundations due to changing soil conditions</p> <p>Where trees are to close to the dwelling this could affect the performance of the footing as the moisture levels change in the ground. A Geotechnical Inspection can determine the foundation material and advise on the best course of action with regards to trees. large trees have been known to affect house foundations up to 1.5 times their height.</p> <p>High moisture was recorded to front brickwork under the damp course level not above</p> <p>See drainage notes</p>

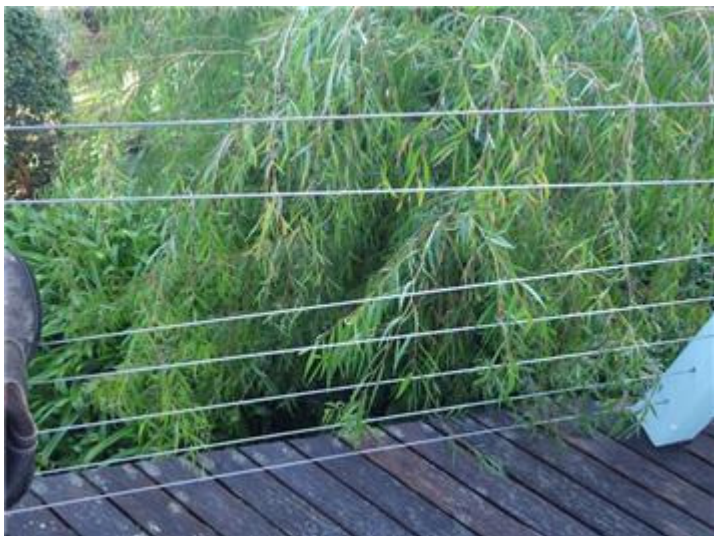
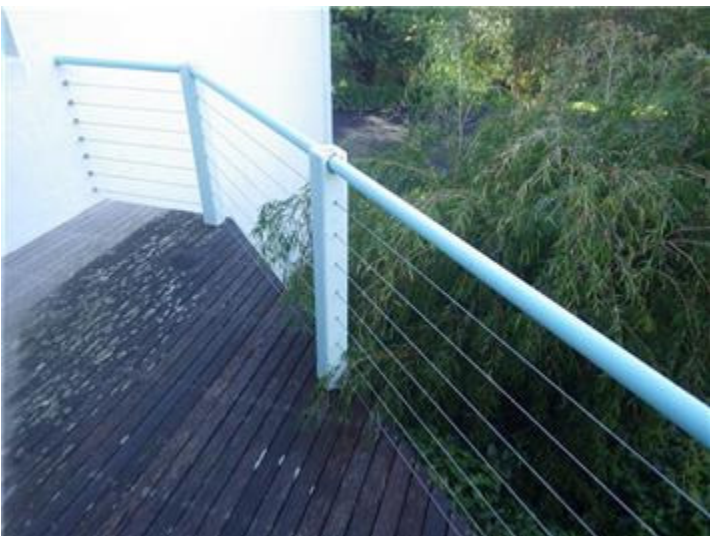
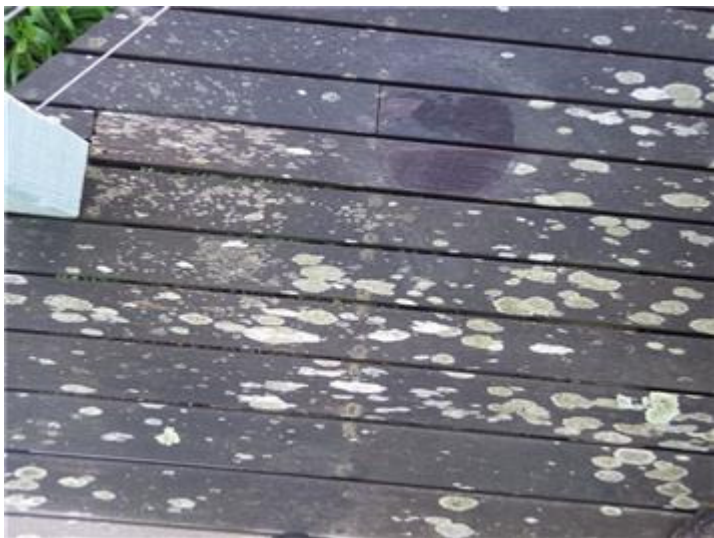
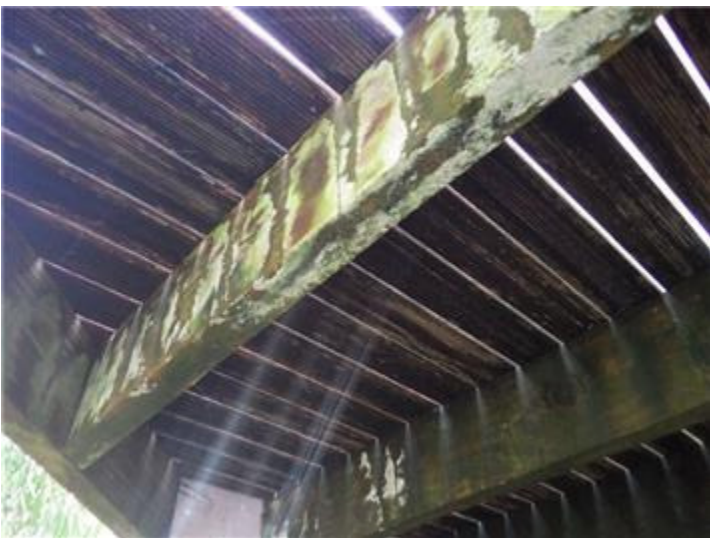
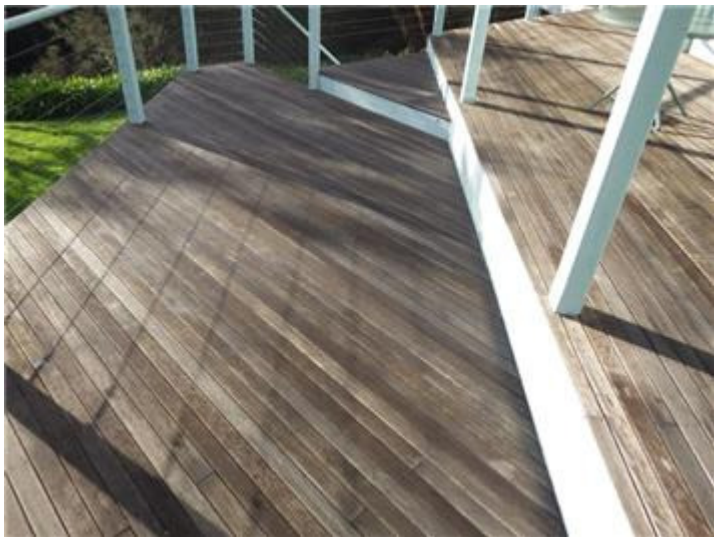
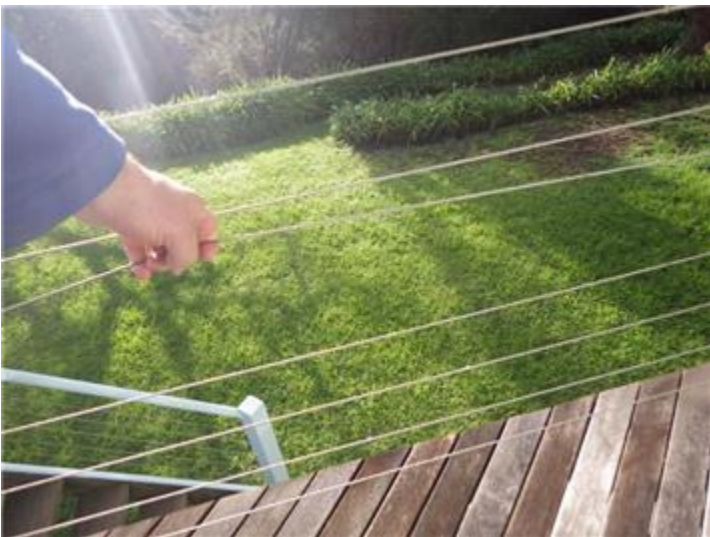
Decks	<p>Balustrade wire requires tensioning so a gap of more than 125mm can not be achieved, this is for safety reasons</p> <p>There were a number of areas where timber bearers were not supported properly to rear deck, either additional stumps or metal brackets required, last 4 pictures</p> <p>Estimated cost \$2000 Major Structural Defect</p> <p>Proper quotes should be obtained</p> <p>Unknown if a permit was issued for this structure and should be checked at local council, if not then a 137B owner builder report should be commissioned to ascertain if fully complies to current standards and regulations.</p> <p>Timber joists have some rot and is due to being exposed to the weather, they should be protected or will require replacement in the near future</p> <p>A flashing should be installed over all exposed timbers, this will protect them from rot as they are exposed to the weather</p>
-------	--

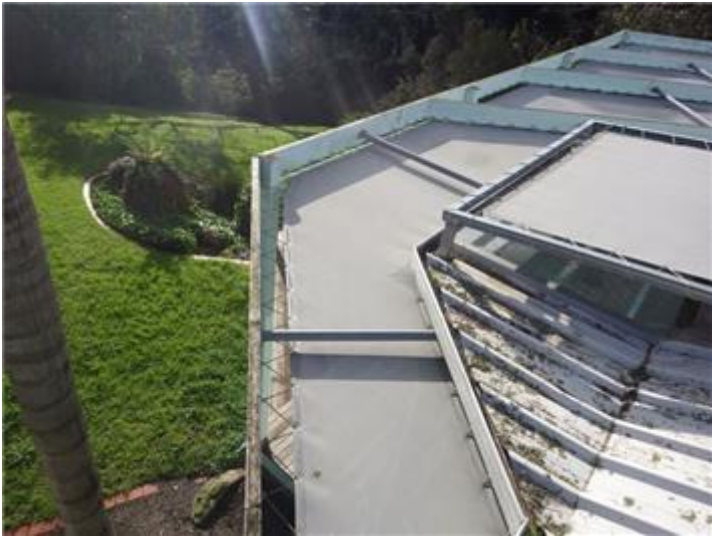
Uncovered timbers have a limited life due to being exposed to the weather, they should be protected

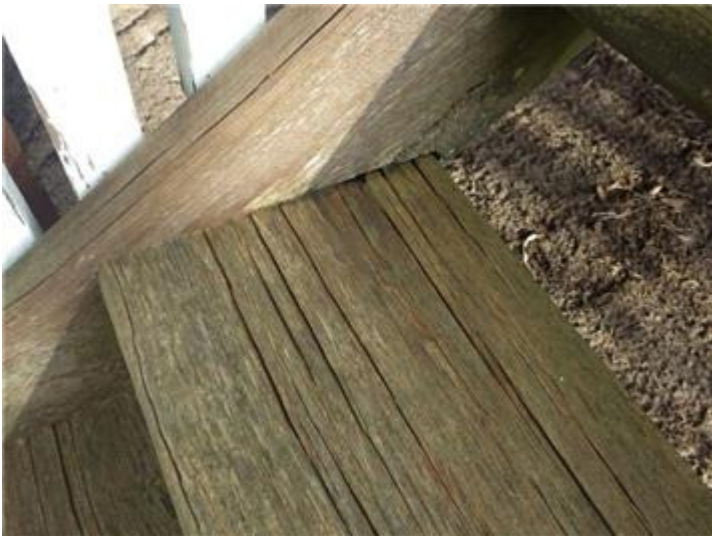
Rot noted to timber treads and will require replacing

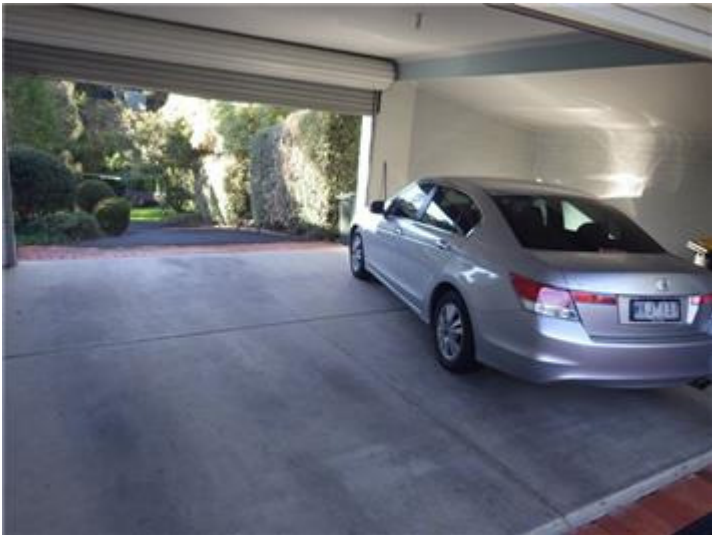
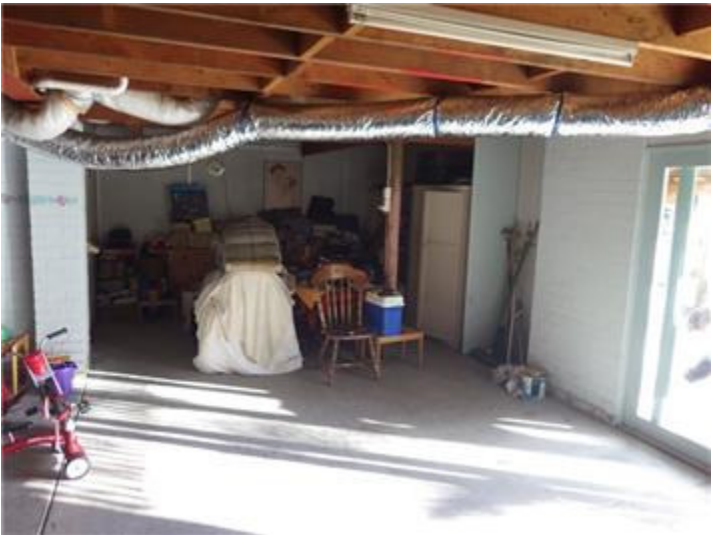
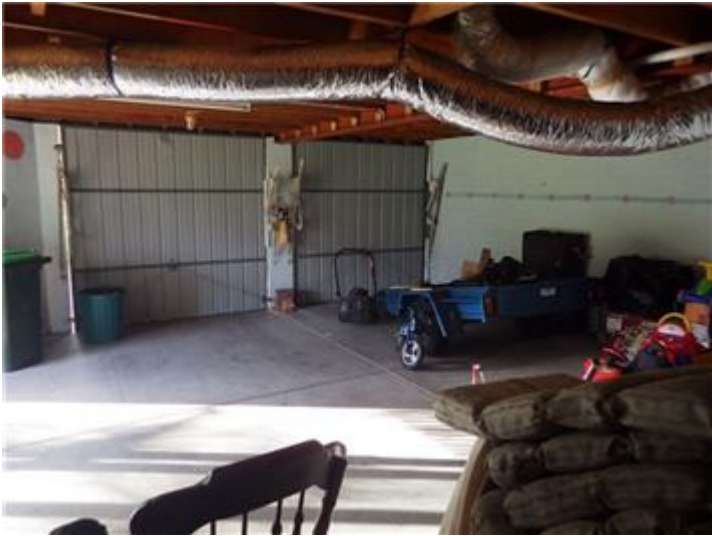
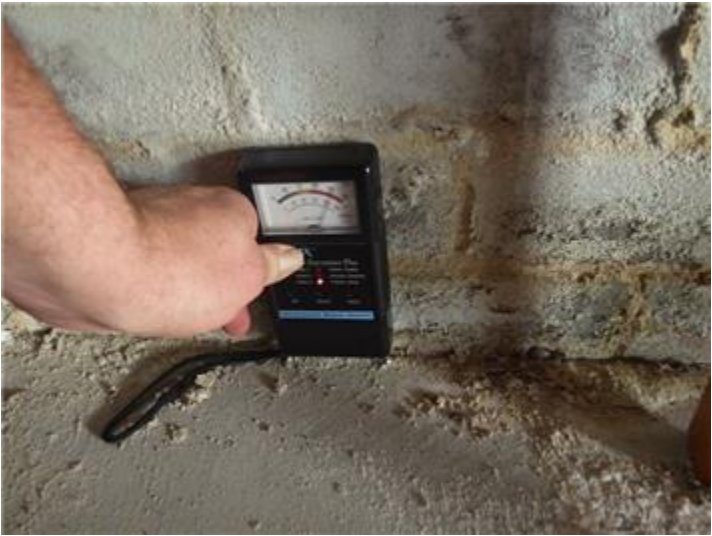
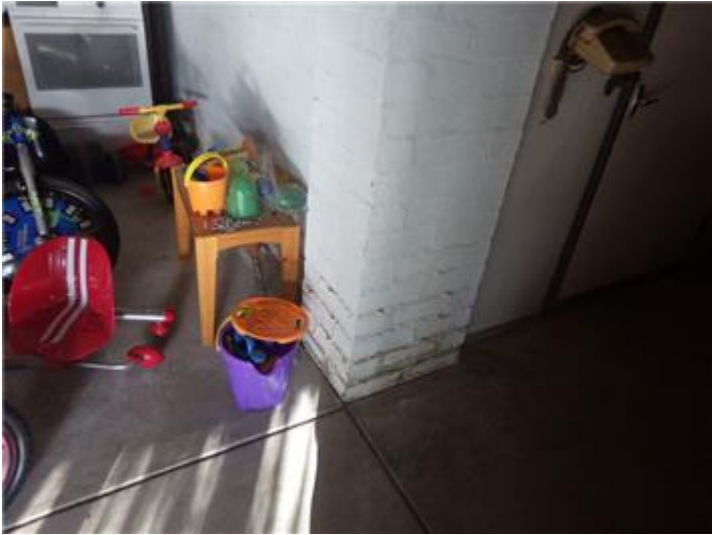
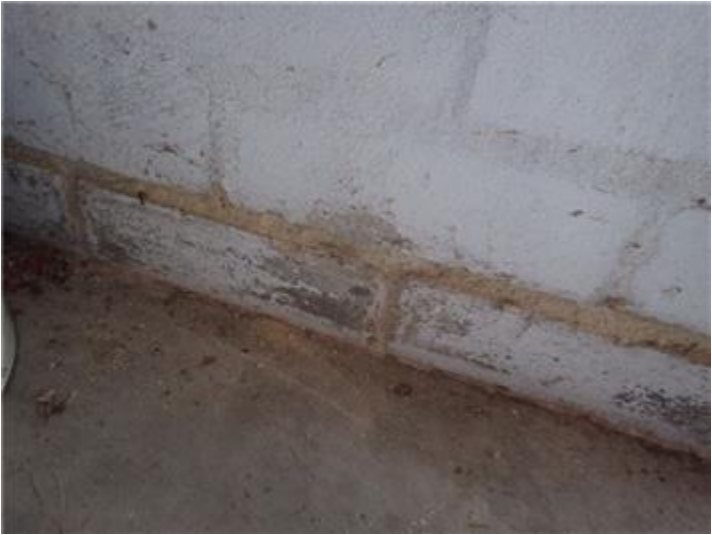
Dampness noted to brickwork in areas and is due to soil being to high against walls, see drainage and ventilation notes

Mortar appeared weak due to long periods of moisture

An agi drain could be installed behind brick wall to stop any moisture coming through walls
