Buy-Wise Inspection Services P/L

SPECIAL PURPOSE INSPECTION REPORT

MOVEMENT AND CONDITION OF DWELLING

Inspected Property Address:	Carrum Downs	
Client Details:	Name: Sample Report	
	Address:	
	Phone:	Mobile:
	Email:	
	Client Attended Inspection: No	Contract Details: N/A
Inspection Date & Time:	Monday, 30 May 2011 1:30:00 PM	
Building Consultant:	Peter Hearn DB-U12617	Phone: 9775 7188
Agent:	Michelle	Phone:

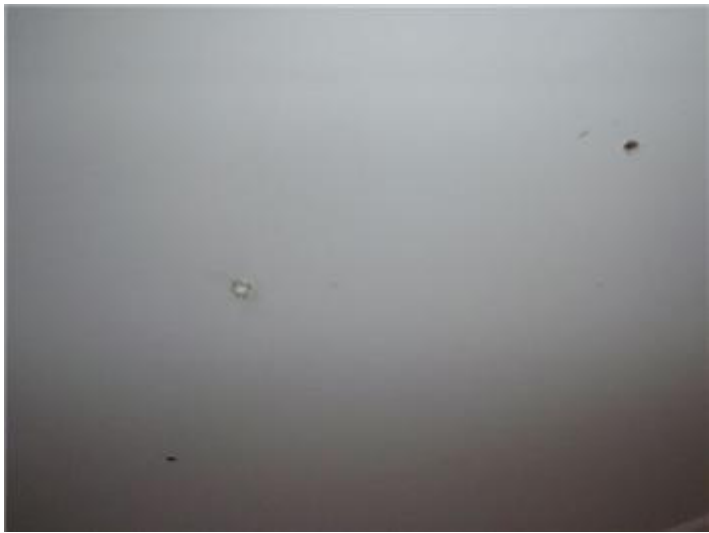
Bedroom 2

Ceilings	Plaster	Nail popping noted to plaster sheets in areas, extra screws may be required to support plaster sheets
----------	---------	---

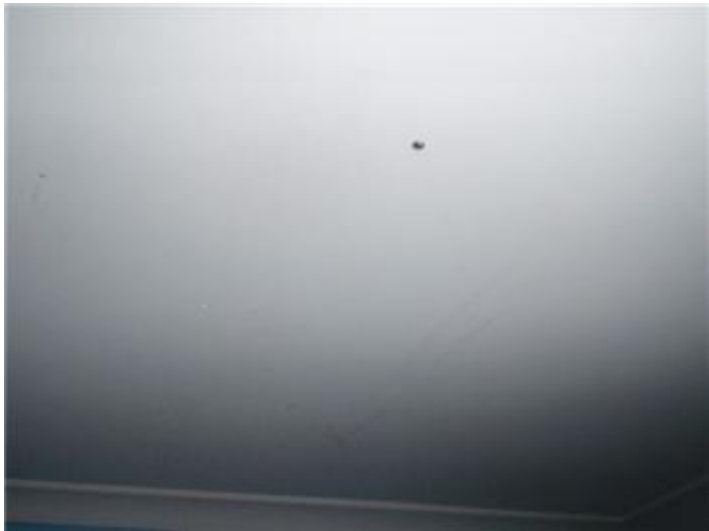
Bedroom 3

Ceilings	Plaster	Nail popping noted to plaster sheets in areas, extra screws may be required to support plaster sheets
-----------------	---------	---

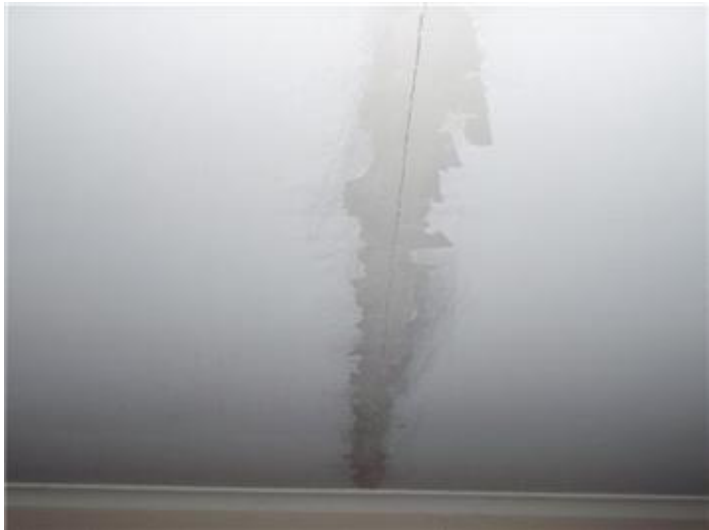
Lounge

Ceilings	Plaster	Movement noted between plaster sheets at join, minor repairs required and is unknown if they will return Ceilings in roof space have not been back blocked which prevents movement between sheets See comments in roof space
----------	---------	--

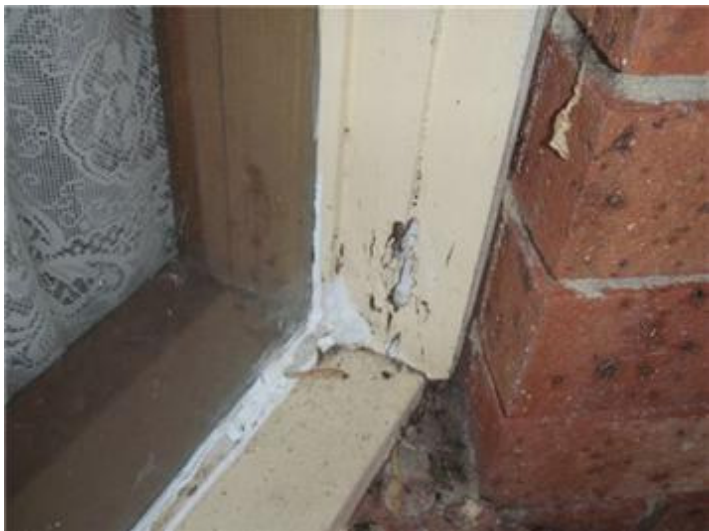
Windows	Timber awning	Rot noted to window frame, repairs required and painting Cost \$300
---------	---------------	--

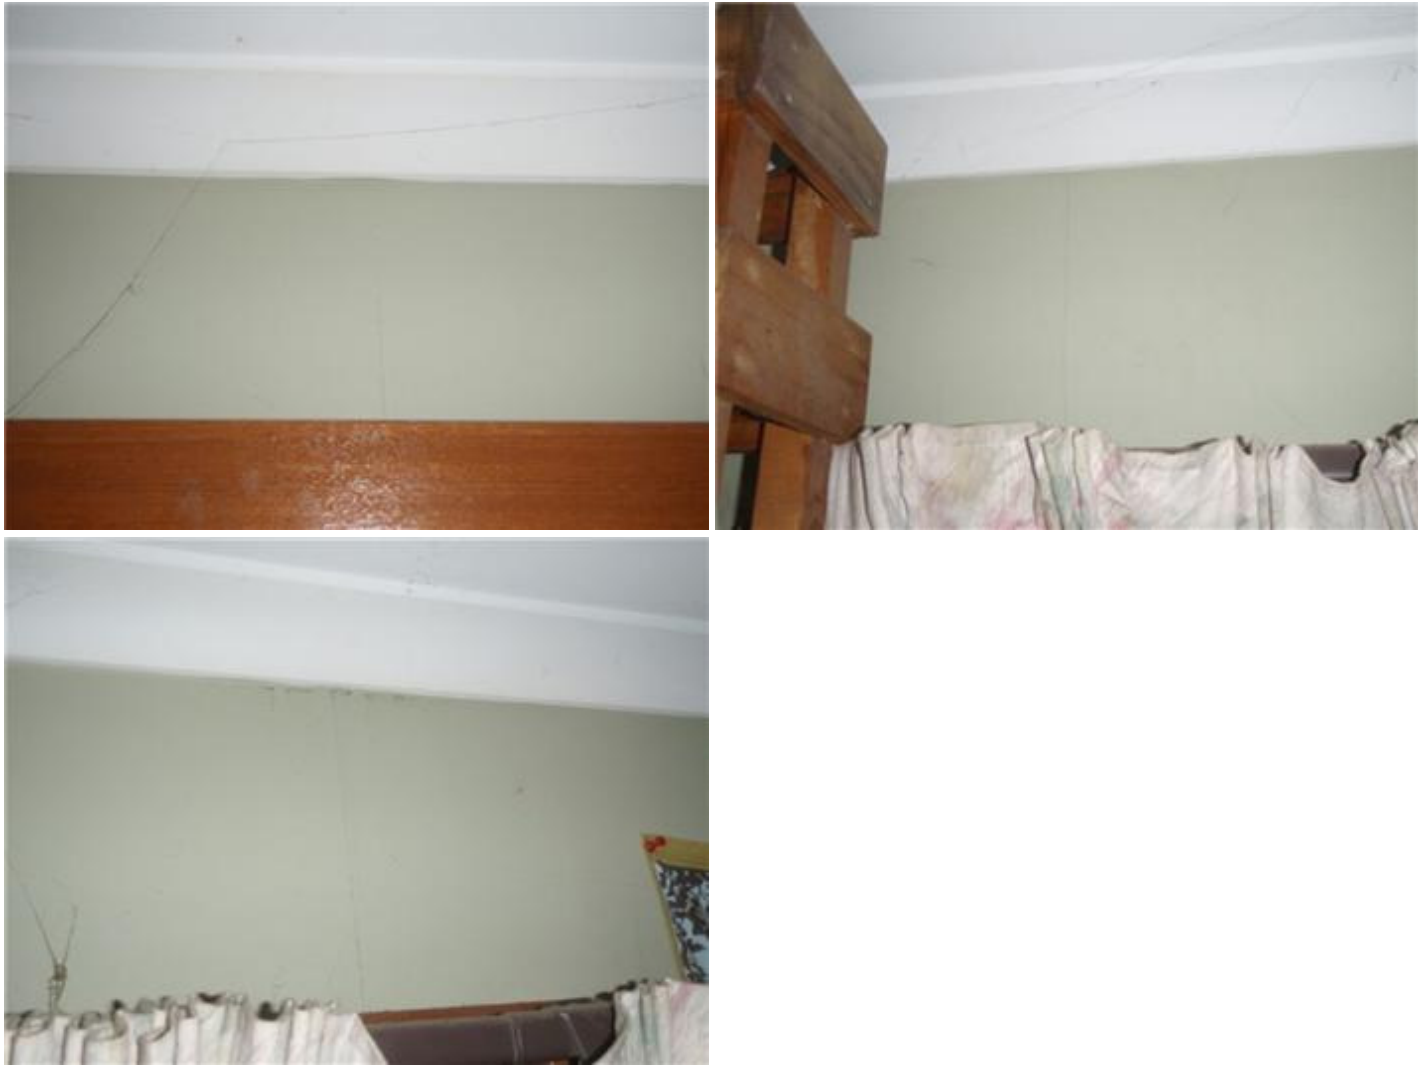
Meals

Walls	Plaster	Minor movement noted in areas
-------	---------	-------------------------------

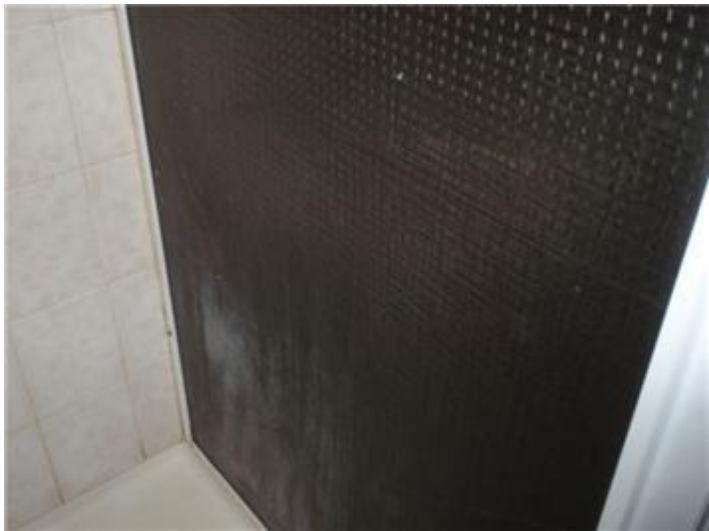
Ensuite

Shower Screen	Glass sliding door and panel	Crack noted in glass panel and should be replaced
----------------------	------------------------------	---

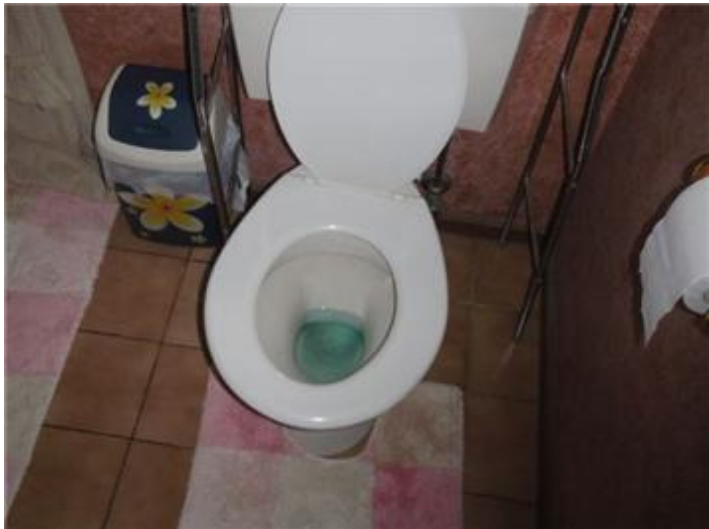
Toilet Suite	Porcelain pan and plastic cistern	Toilet pan not fixed to floor properly and requires attention, silicon can be used to stick bowl to floor
---------------------	-----------------------------------	---

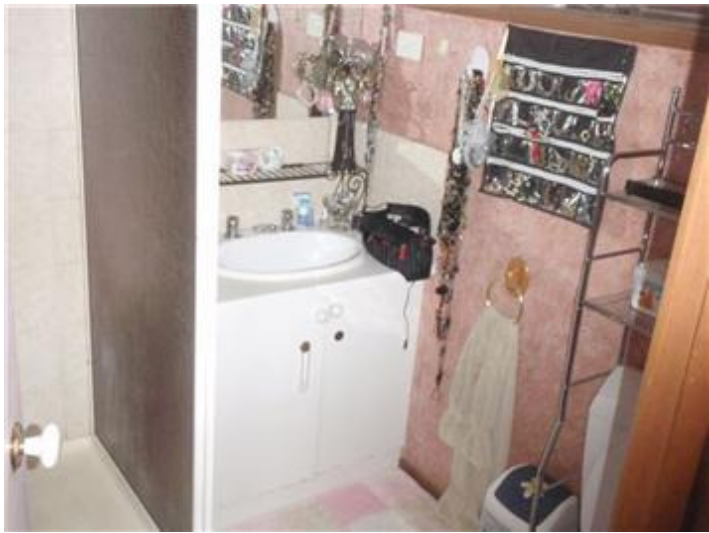
Vanity Unit	Laminate	Doors have some water damage
Comments	All appears to be in fair to good condition with some maintenance required

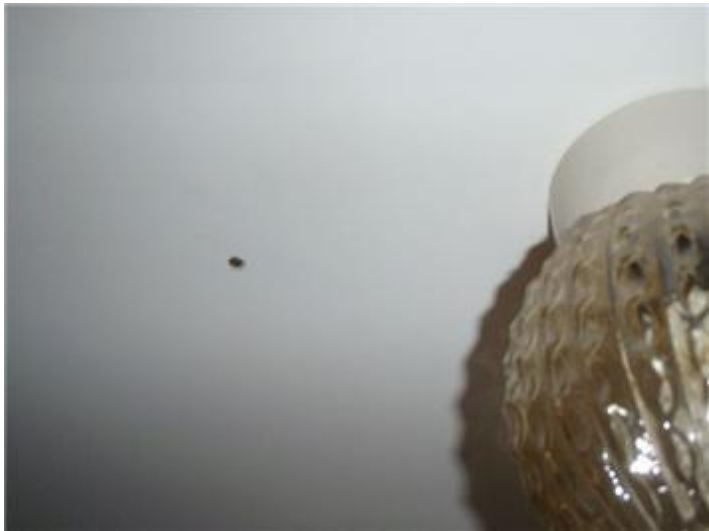
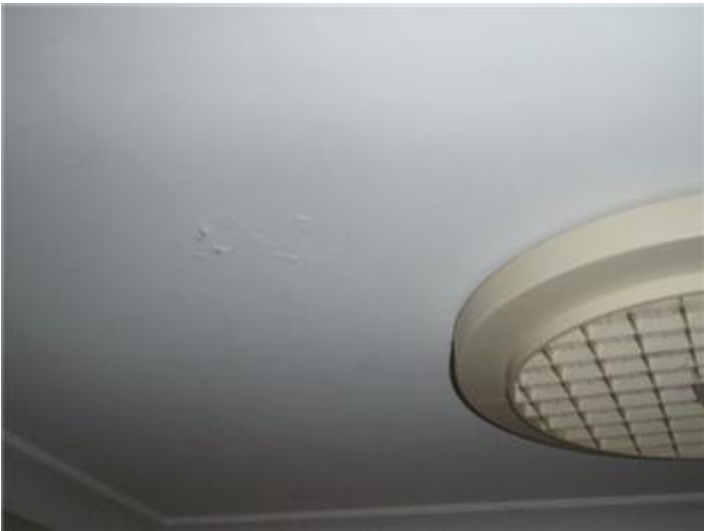
Bathroom

Ceilings	Plaster	Nail popping noted to plaster sheets in areas, extra screws may be required to support plaster sheets Paint peeling in areas, painting required
----------	---------	--

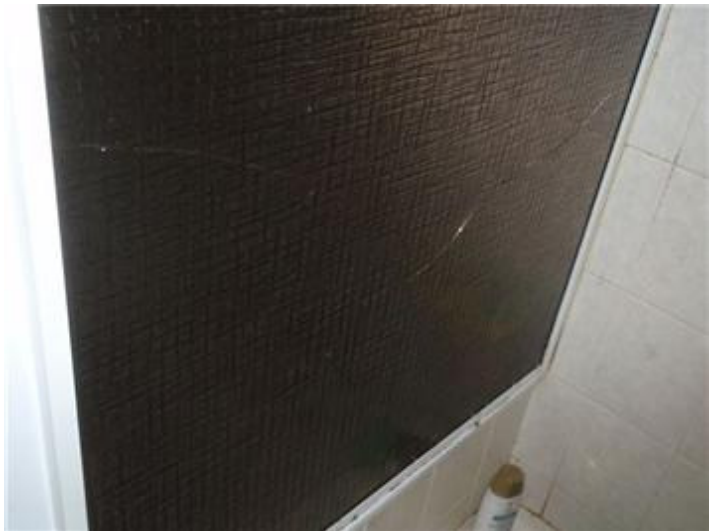
Shower Screen	Glass sliding door and panel	Crack noted in glass panel and should be replaced
---------------	------------------------------	---

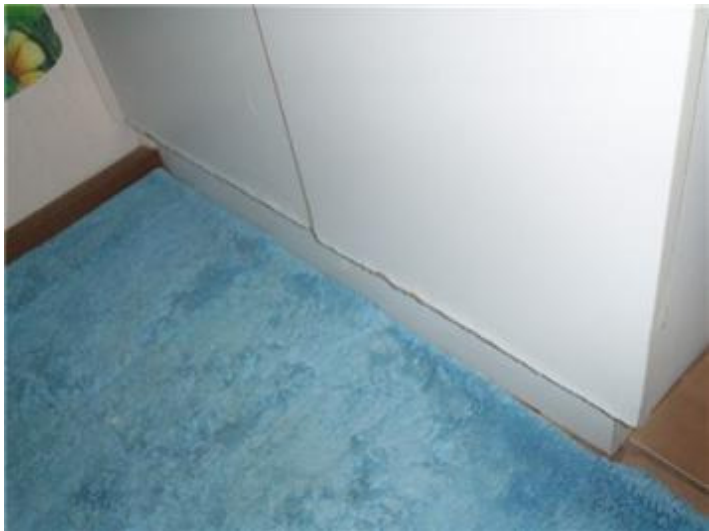
Vanity Unit	Laminate	Doors have some water damage
-------------	----------	------------------------------

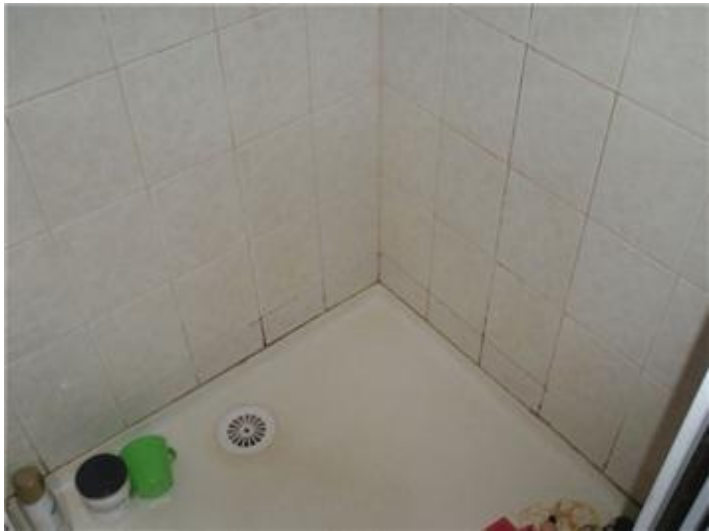
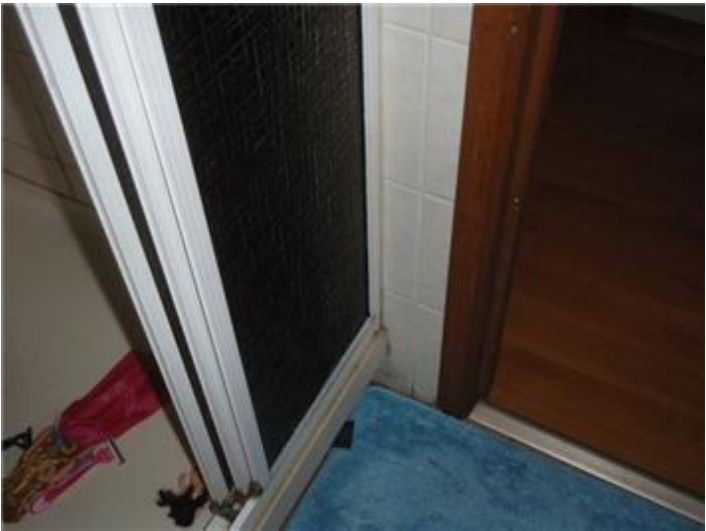
Wall tiles Ceramic High moisture recorded behind tiles of shower, this is a very common problem and can cause tiles to dislodge over time and depends on what adhesive was used and how well applied
High moisture was also recorded to timbers next to shower enclosure, this will continue if tiles are not sealed or leaks fixed
Tiles and grout should be well dried and then sealed in shower, this is to manufactures recommendations. The sealer is clear and can not be seen once dry Cost \$200

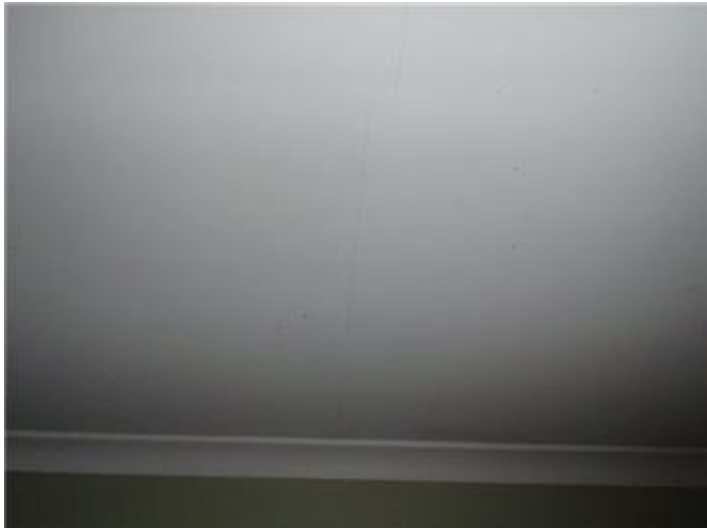
Kitchen

Ceilings Plaster Minor movement noted between plaster sheets at join,

minor repairs required and is unknown if they will return

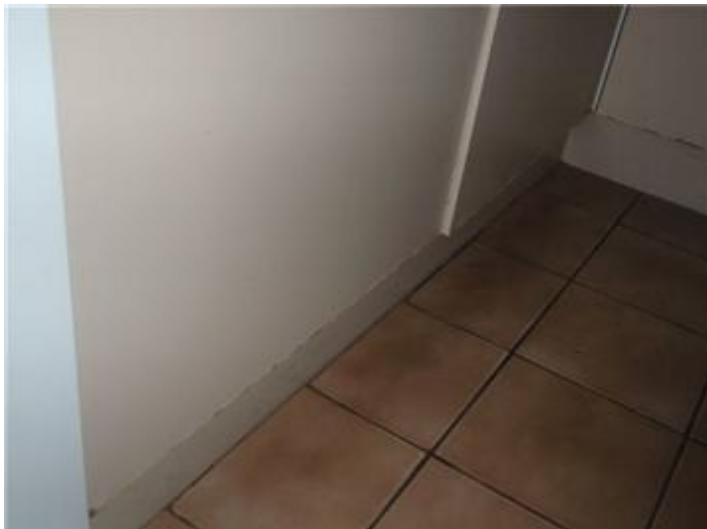
Some water damage noted to bottom of doors under sink

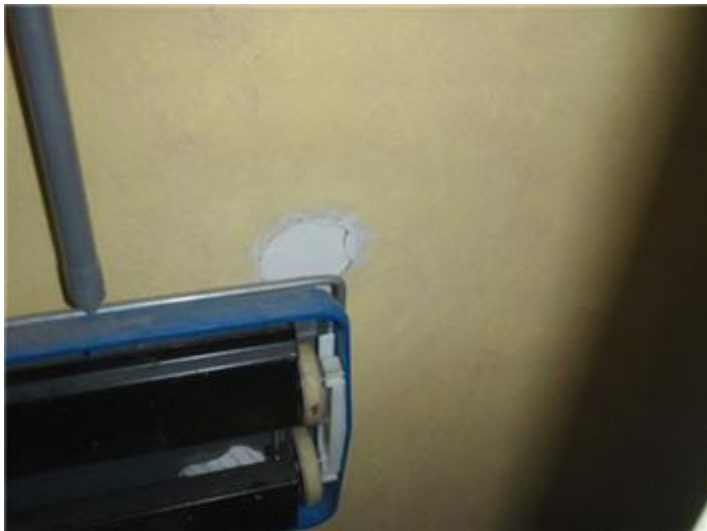
Laundry

Ceilings	Plaster	Nail popping noted to plaster sheets in areas, extra screws may be required to support plaster sheets
Walls	Plaster	Hole noted to plaster behind door that has been filled, repairs required

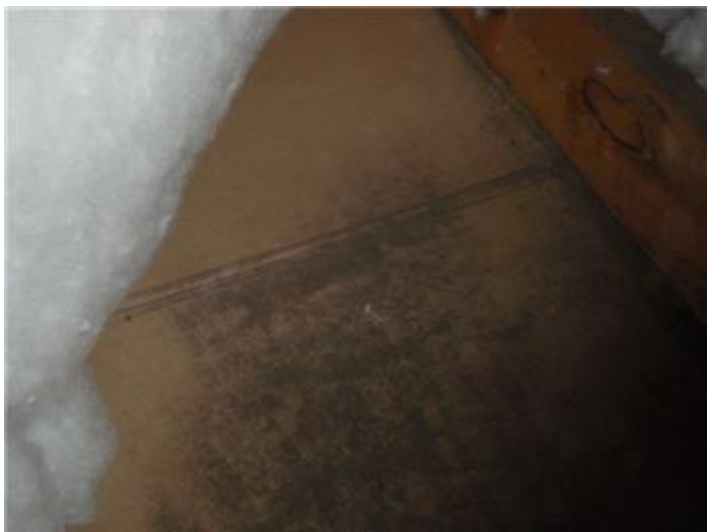
Comments Plaster ceilings are not back blocked on top of joins of plaster sheets, this is good practice and can eliminate movement or further movement between plaster sheets and can be installed Cost \$400

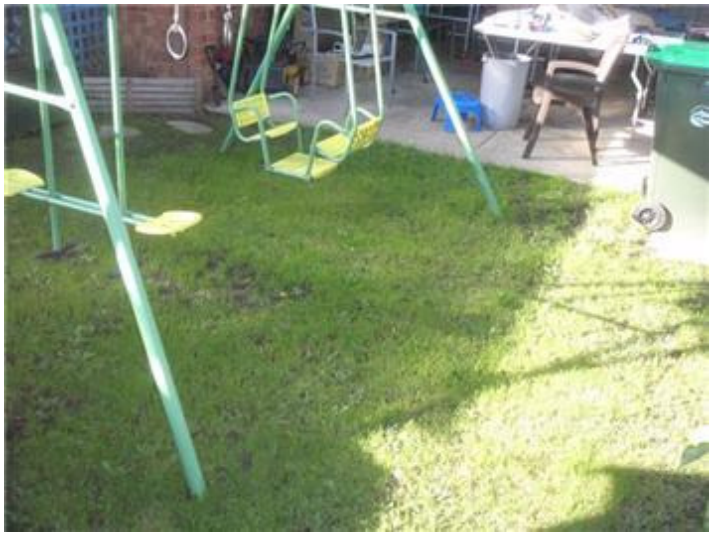
Drainage	Surface drainage, Underground pipes	<p>Surface water drainage may appear to be adequate but then during periods of heavy rain, may be found to be inadequate</p> <p>Ground at back of garage was saturated and would not be as wet if gutter was installed to pergola</p> <p>The retention of water from surface run off could have an affect on the foundation material which in turn could affect the footings to the dwelling. Best practice is to monitor the flow of surface water and stormwater run off and have the water directed away from the dwelling or to storm water pipes by a licensed plumber/drainier.</p> <p>Unable to comment on storm water or sewer pipes under ground, a licensed plumber can only report on these areas</p>
----------	--	--

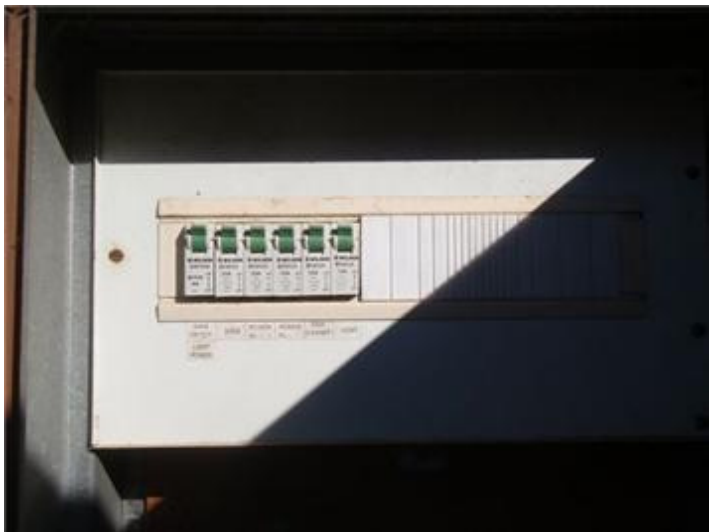
Electrical	Circuit breakers, No safety protection provided	A licensed electrician can only report on all electrical services Residual Current Device (Safety Switch) should be installed for your own safety Cost \$500
-------------------	---	---

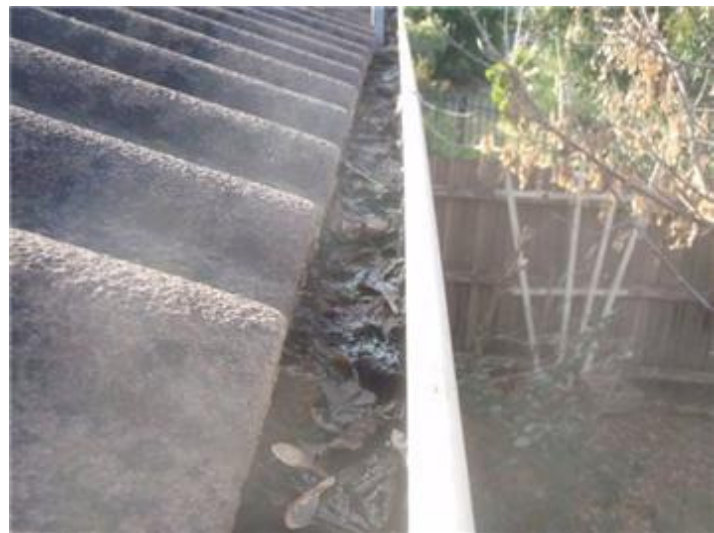
Gutters require cleaning, this will prevent rust and will last longer

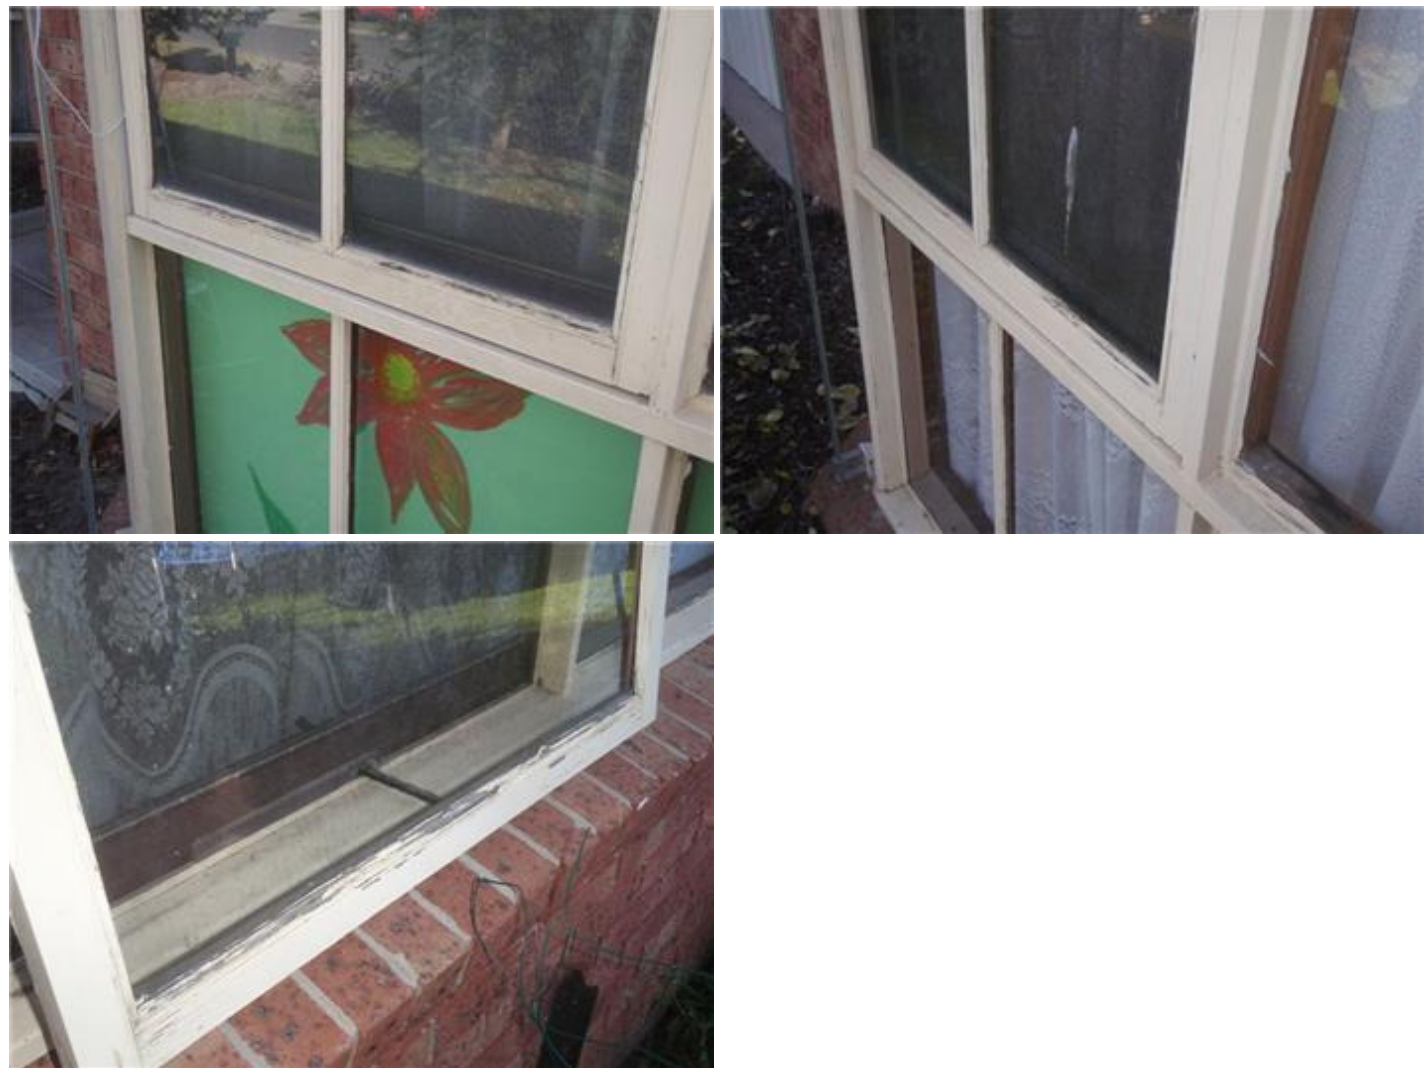
Painting required to most external timbers to protect them from further deterioration

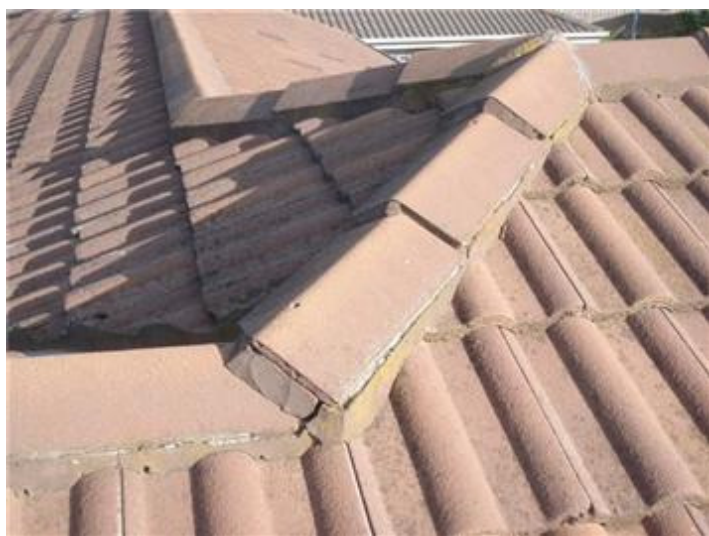
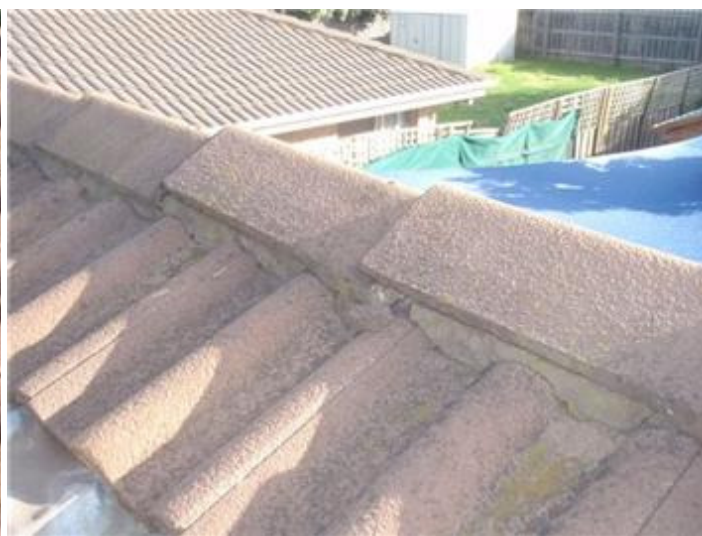
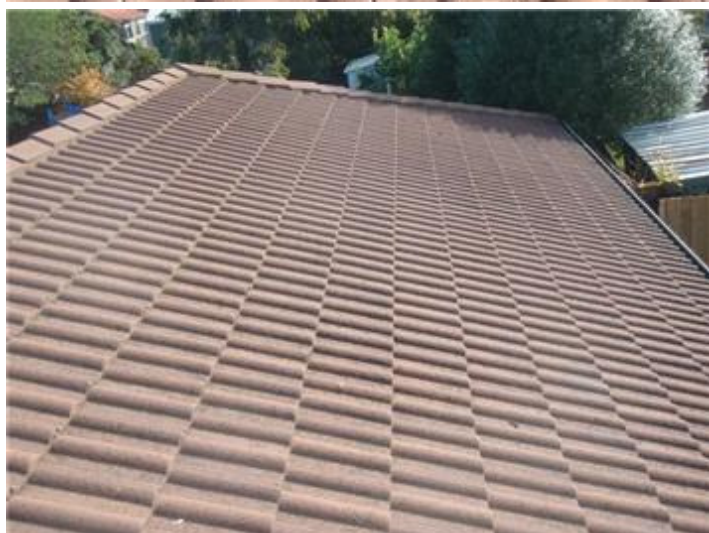
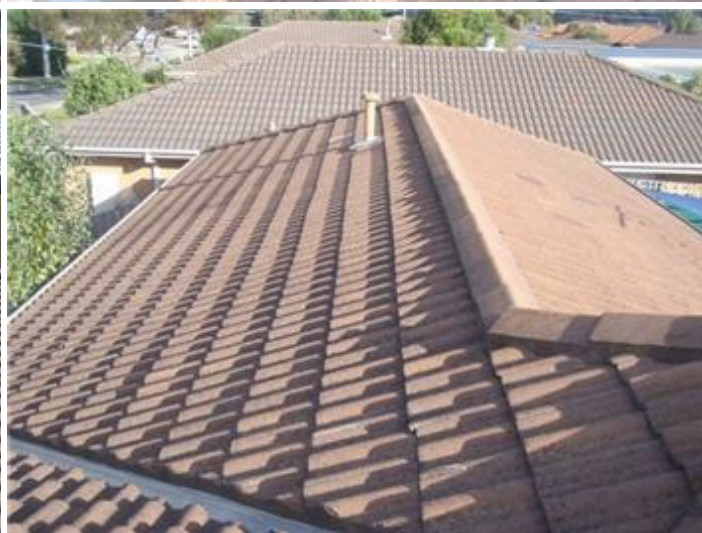
Some minor re pointing required to roof tiles in areas Cost \$300
The possibility of the roof leaking soon in an average rainfall is low

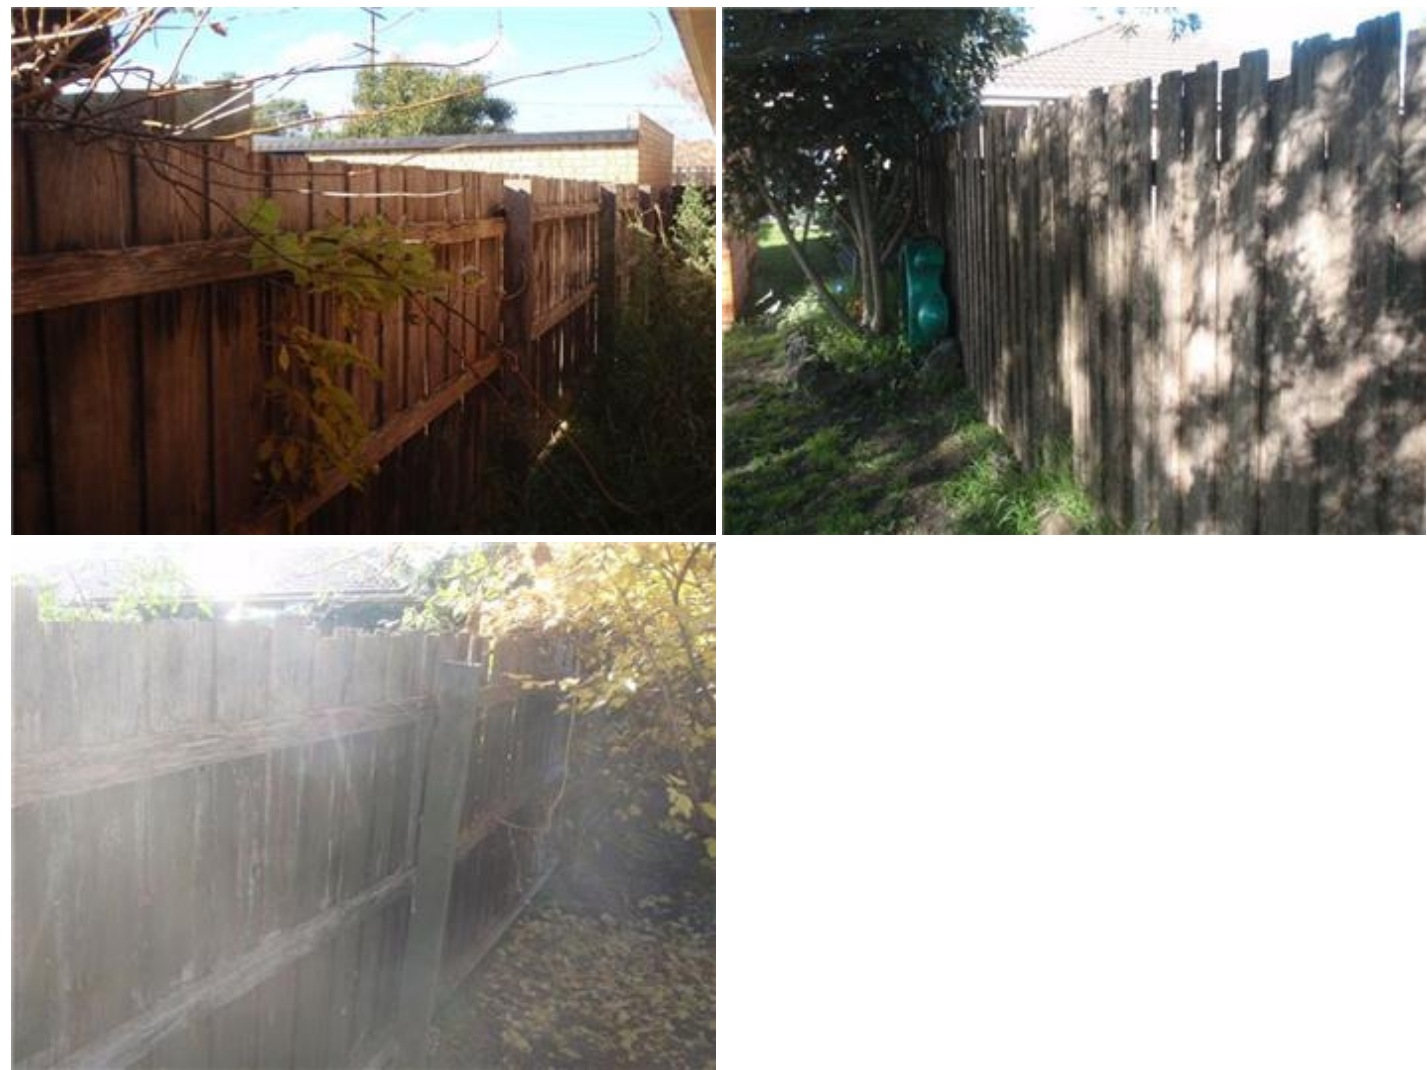
Fences	Timber	Require replacing at sides and back due to rot in the next years
--------	--------	--

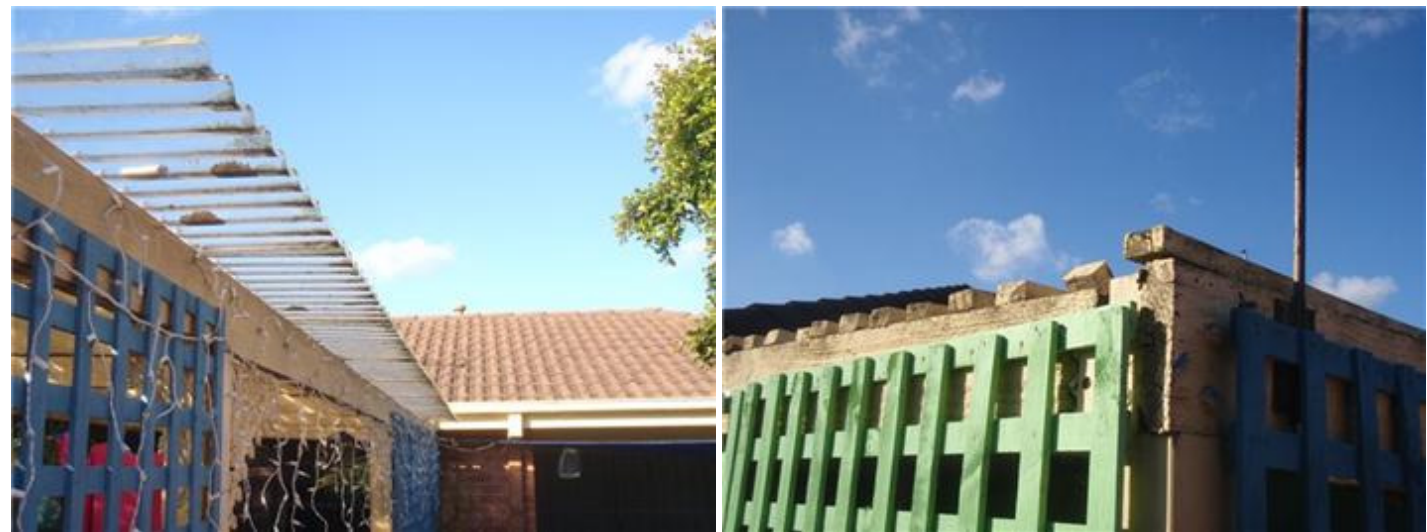
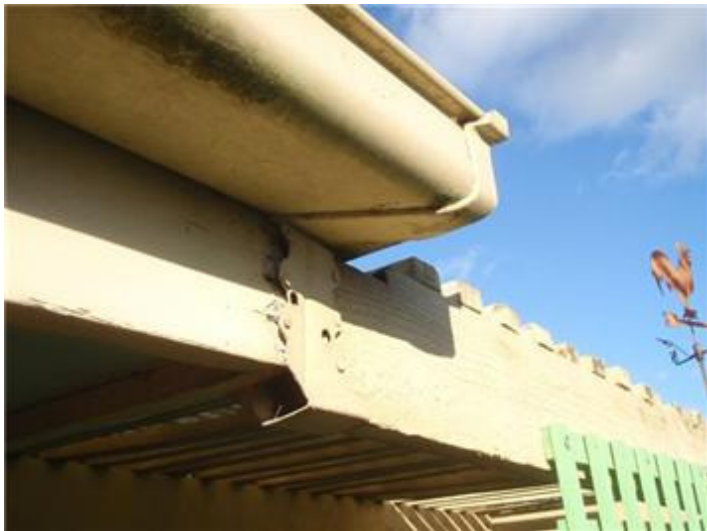
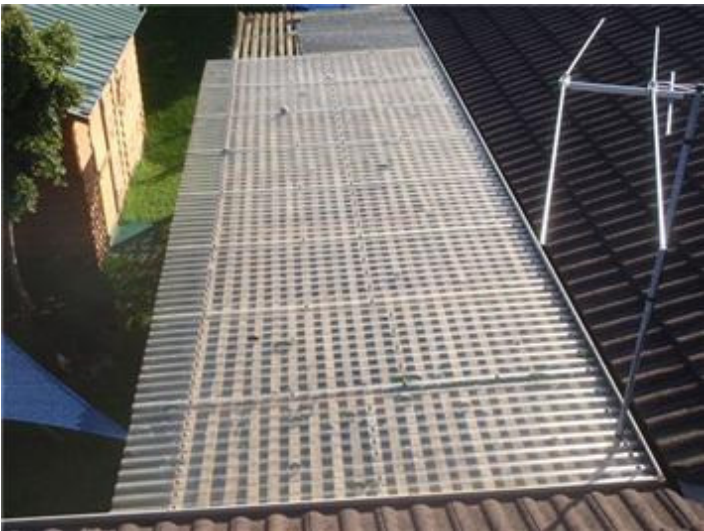
Pergola	Timber construction, Polycarbonate roofing	No guttering or downpipe with storm water connection noted, this should rectified as excess water on ground can have an affect on foundations Rot noted to timbers where uncovered End metal bracket requires attention Uncovered timbers have a limited life due to being exposed to the weather, they should be protected
---------	---	--

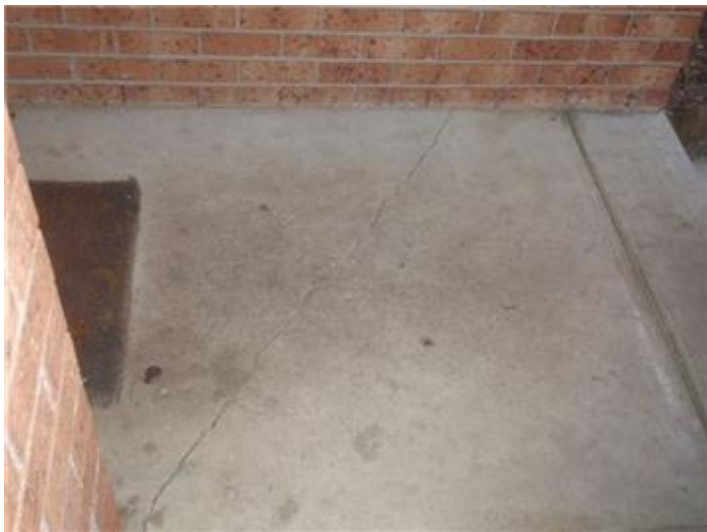
Porch Concrete Movement noted in concrete infill slab
Concrete is not connected or is part of the dwellings foundations
No concern

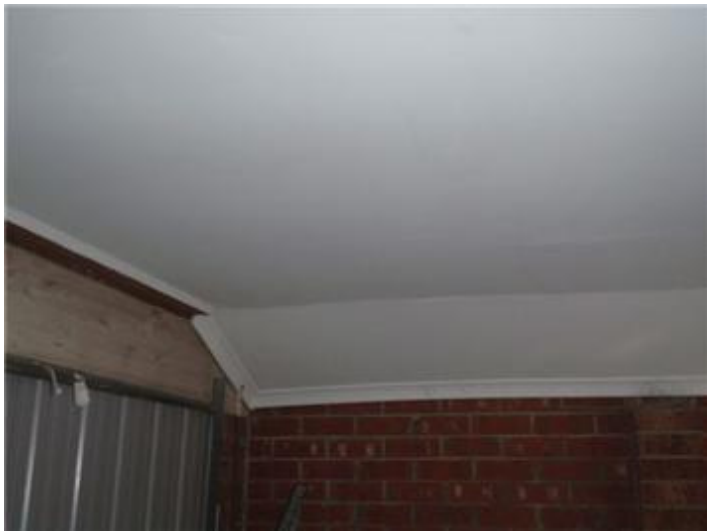
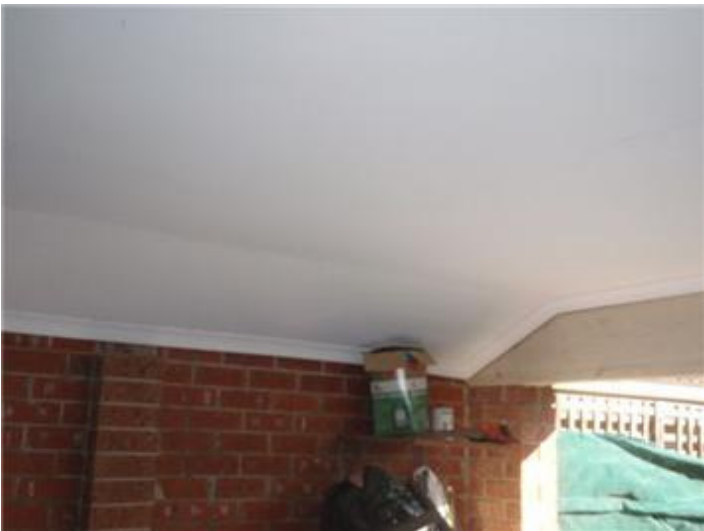
Garage
Ceilings Plaster Minor movement noted between plaster sheets at join,
minor repairs required and is unknown if they will return
Ceiling has come away from ceiling joists in areas and may
require re fixing in the near future Cost \$300

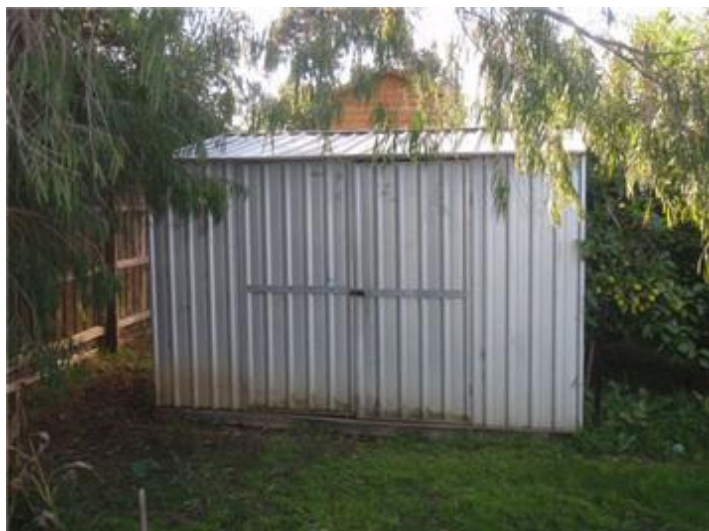
Shed

Roof very dented and will leak
