Buy-Wise Pre Purchase Building & Pest Inspections P/L

BUILDING INSPECTION REPORT

Inspected Property Address:		
Client Details:	Name: Sample 2	
	Address:	
	Phone:	Mobile:
	Email:	
	Client Attended Inspection: No	Contract Details: No Contract
Inspection Date & Time:	Tuesday, 28 April 2015 12:45:00 PM	
Building Consultant:	Peter Hearn DB-U12617	Phone: 9775 7188
Agent:	None	Phone:

Building Type:	Residential House
Description:	Single Storey, Addition, 10 Squares of living, Pergola, Garage, Deck
Estimated Age:	60 years old
Foundation Type:	Timber stumps, Concrete stumps
Walls External:	Vinyl cladding over Cement sheet
Roof:	Corrugated iron
Furniture:	Yes
Weather Condition:	Overcast

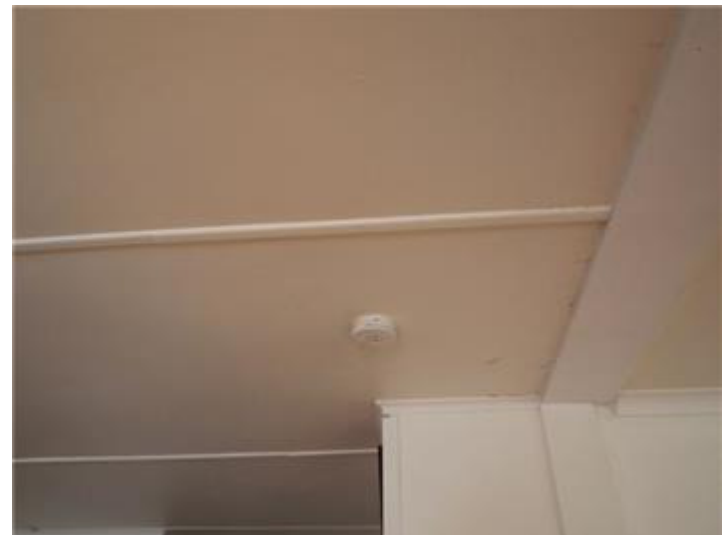
Master Bedroom

Repairs required to window due to rot \$600

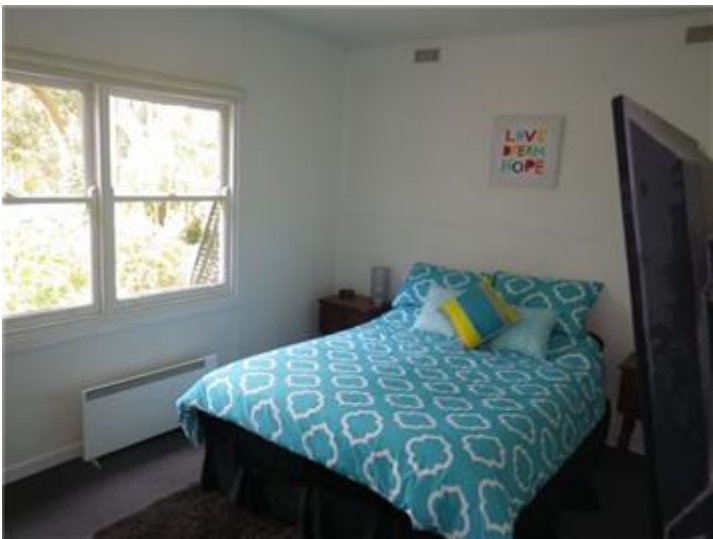
Bedroom 2

Windows Repairs required to window due to rot \$600

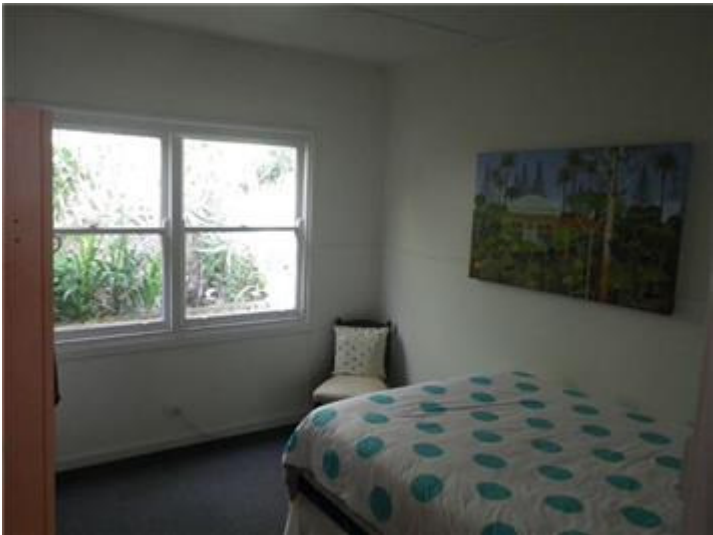
Study

Ceilings Cement sheeting that contains asbestos
All cement sheeting containing asbestos should be well sealed, it appears to be well painted

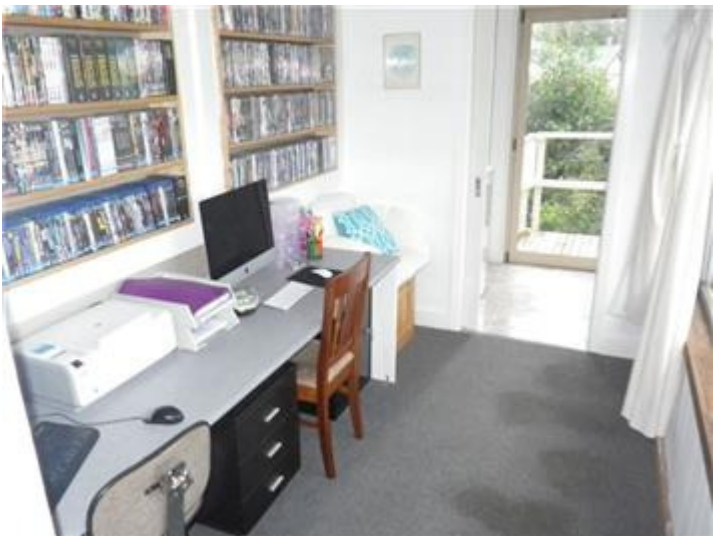
Lounge

Floors Floor level is uneven and out of level, refer to under floor space comments

This room has been altered since being built, may require further investigation
 Support to roof has been removed where addition starts, Major Structural Defect
 Repairs are required
 See roof structure comments

Support has been removed between lounge and kitchen causing roof to dip Major Structural Defect

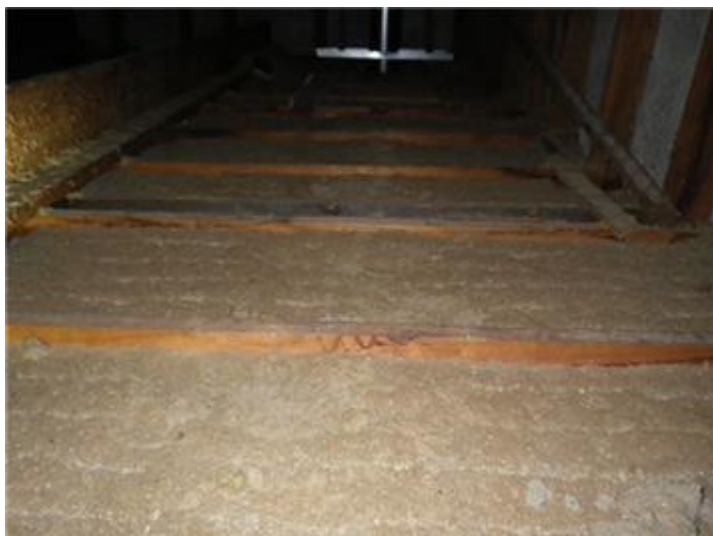
Sisalation/Sarking None noted, condensation has been dripping in insulation
Recommend installing sisalation under roofing, roofing will require removing to do this

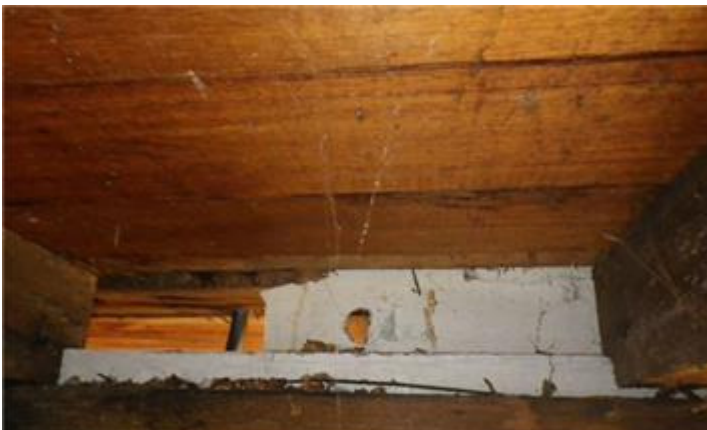
General Exterior

Vinyl cladding has been installed over cement sheeting that would most likely contain asbestos
Broken sections could be seen at bottom of walls and is a health risk
