Buy-Wise Pre Purchase Building & Pest Inspections P/L

MAJOR STRUCTURAL BUILDING REPORT

Inspected Property Address:	5 Parkland Close Frankston	
Client Details:	Name: Sample	
	Address:	
	Phone:	Mobile:
	Email:	
	Client Attended Inspection: No	Contract Details: Major Structural Defect and Termite Infestation
Inspection Date & Time:	Monday, 1 February 2016 8:30:00 AM	
Building Consultant:	Peter Hearn DB-U12617	Phone: 9775 7188
Agent:	No agent	Phone:

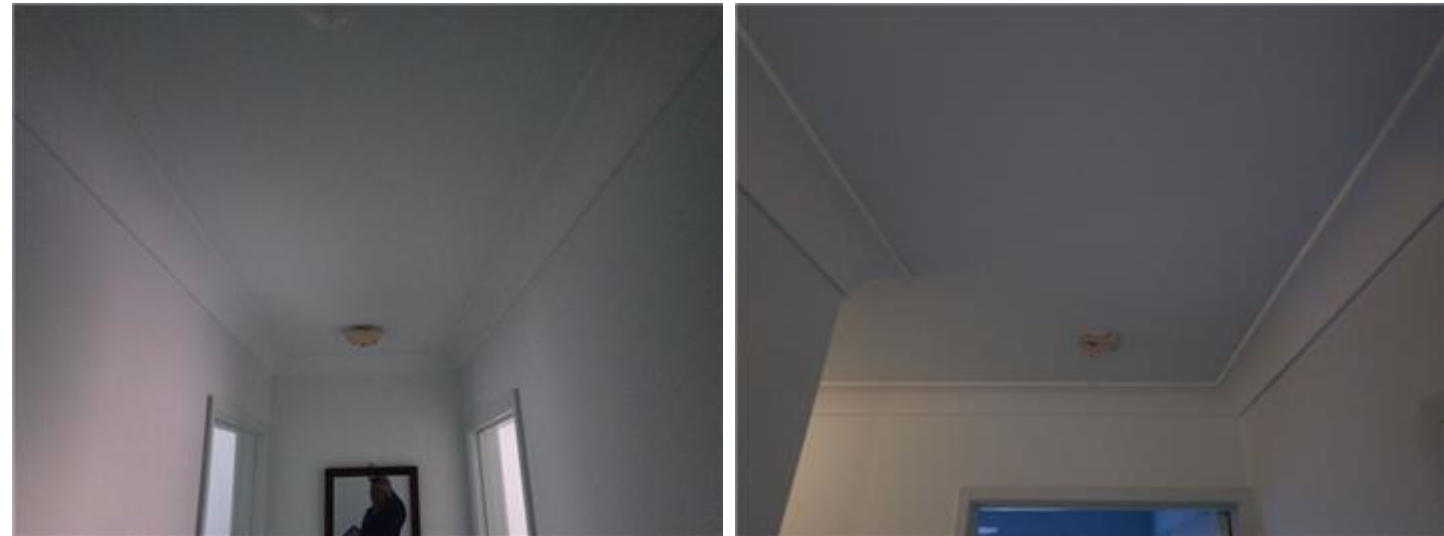
Entry/ Hallway

Comments	Smoke detection is fitted, however the positioning, operation or adequacy was not tested and is not commented on No smoke detector fitted out side bedroom 1, this is a current council requirement and should be rectified for your own safety
----------	--

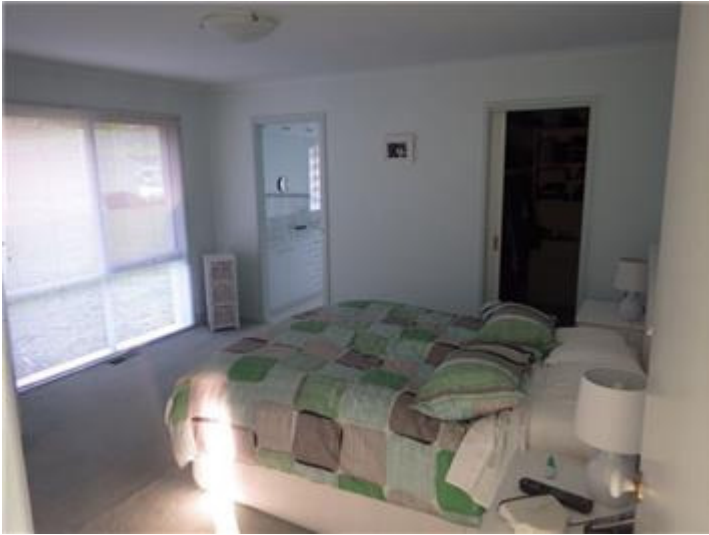
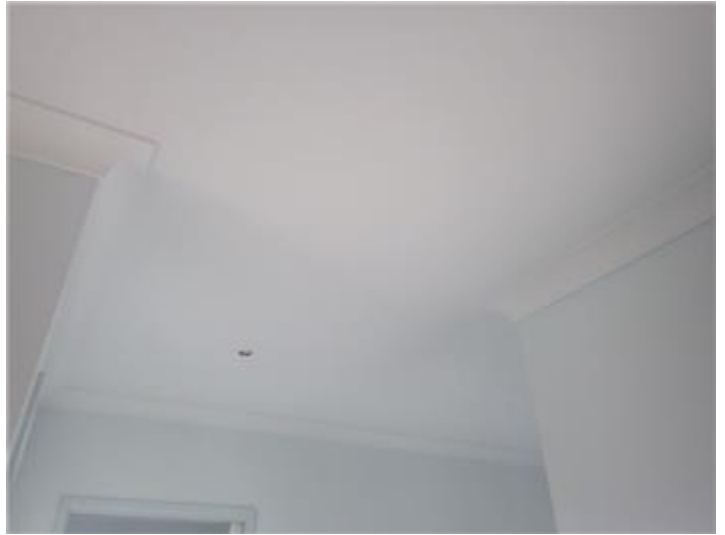
Master Bedroom

Comments	No smoke detector fitted out side bedroom, this is a current council requirement and should be rectified for your own safety
----------	--

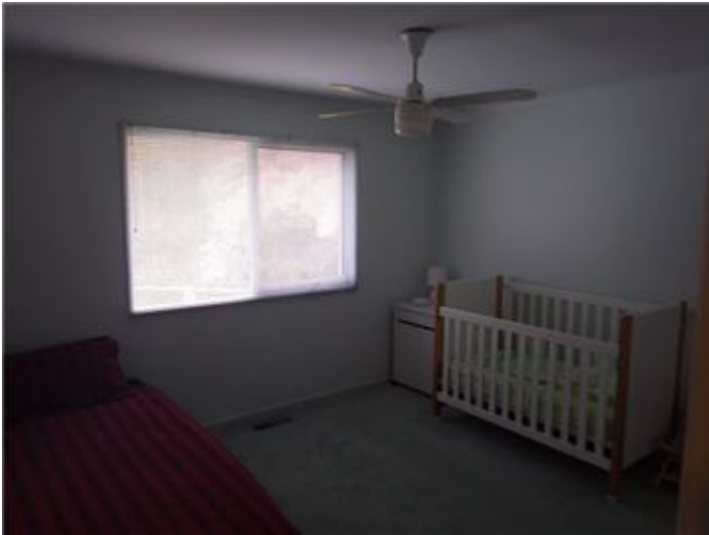
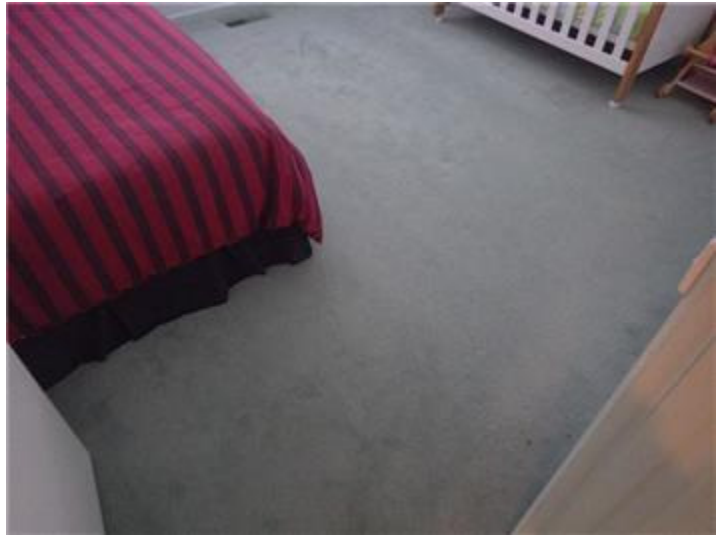
Bedroom 3

Squeaking noise is from plywood flooring, existing nailing and glue is most likely insufficient so extra nails or screws are required, carpet will require removal to do this

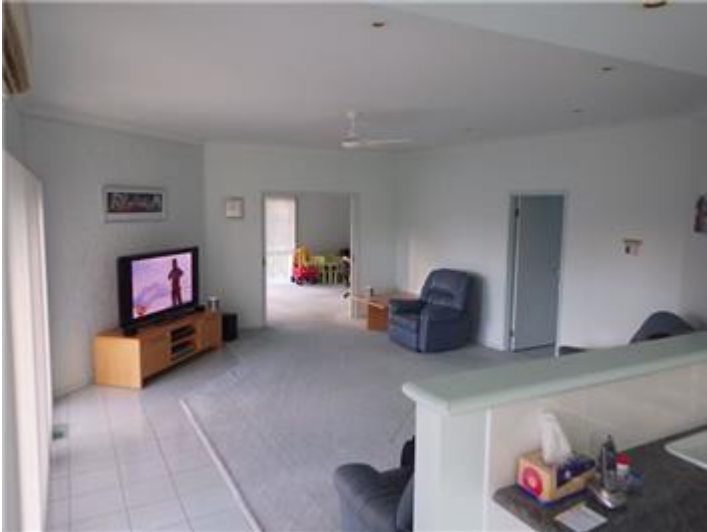
Family

Minor movement noted in areas

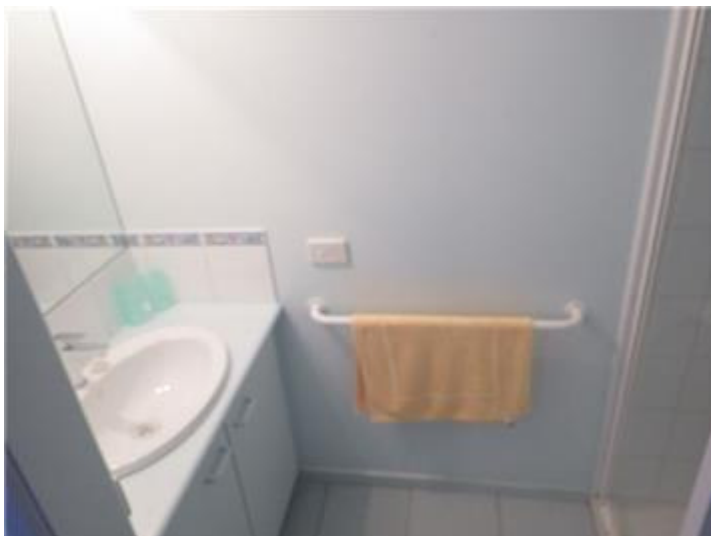
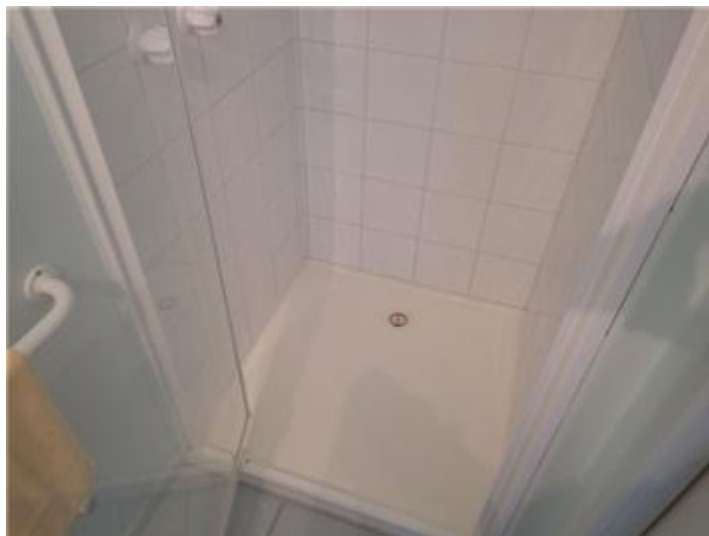
Bathroom

High moisture recorded behind bottom row of tiles of shower, this is a very common problem and can cause tiles to dislodge from wall over time and depends on what tile adhesive was used and how well applied
No high moisture was recorded out side shower enclosure at time of inspection
Cracked tiles noted around bath

Tiles and grout should be well dried and then sealed in shower, this is to manufactures recommendations. The sealer is clear and can not be seen once dry Cost \$200

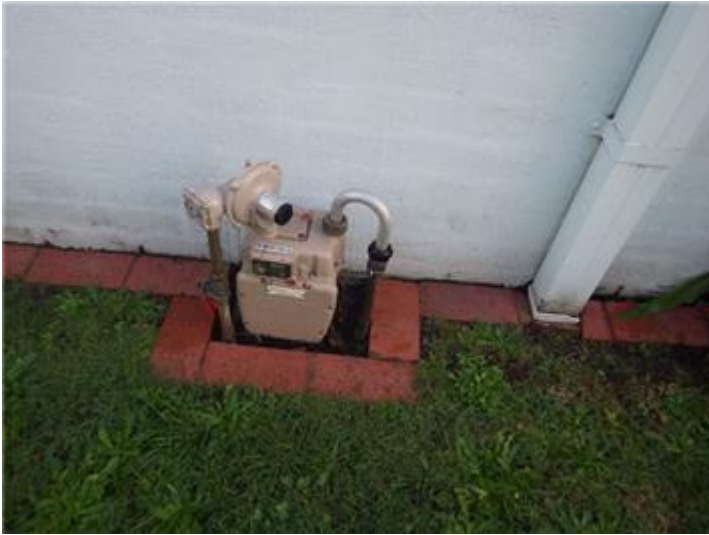
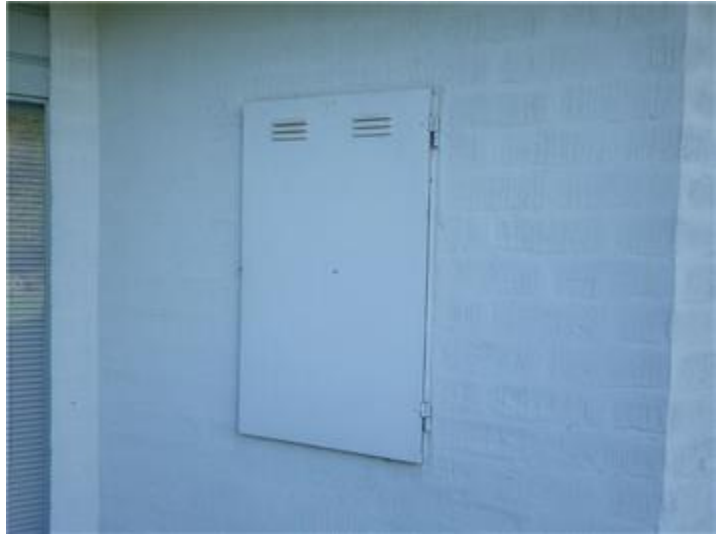
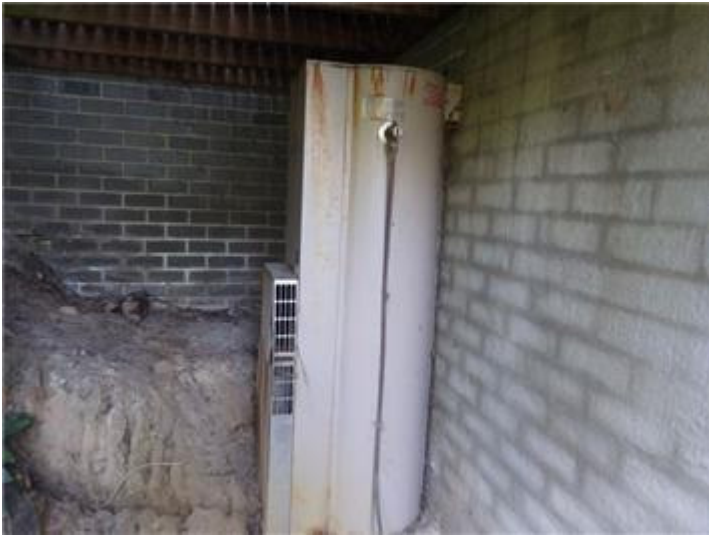
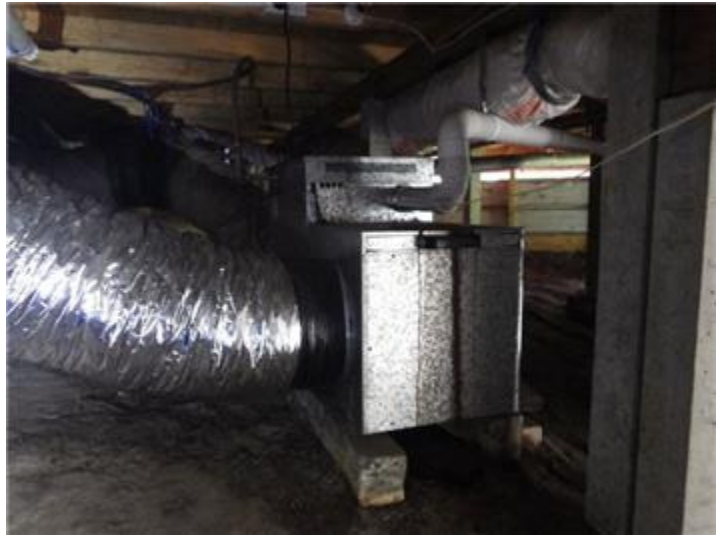
Services

Surface water drainage requires improving at front, agi drain required at front of dwelling, Estimated cost \$4000
Plumber to quote properly
High moisture was noted to walls up to damp course level only
The ground around the dwelling should be kept consistently dry all year.

The retention of water from surface run off could have an affect on the foundation material which in turn could affect the footings to the dwelling.
Best practice is to monitor the flow of surface water and stormwater run off and have the water directed away from the dwelling or to storm water pipes by a licensed plumber/drainier.

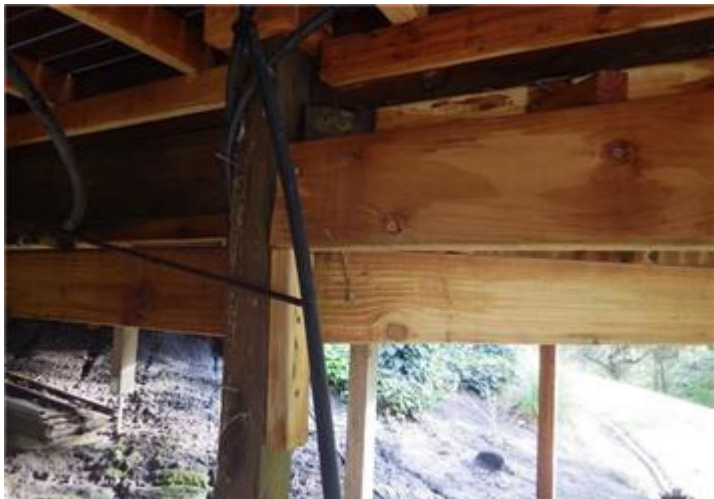
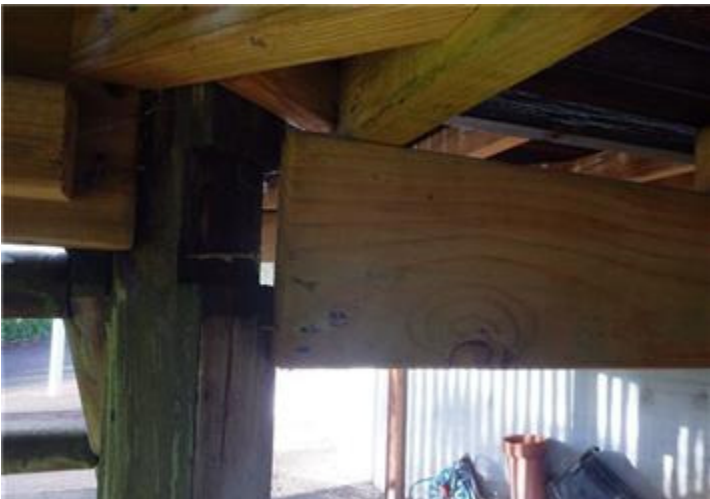
Pergola

Uncovered timbers have a limited life due to being exposed to the weather, they should be protected

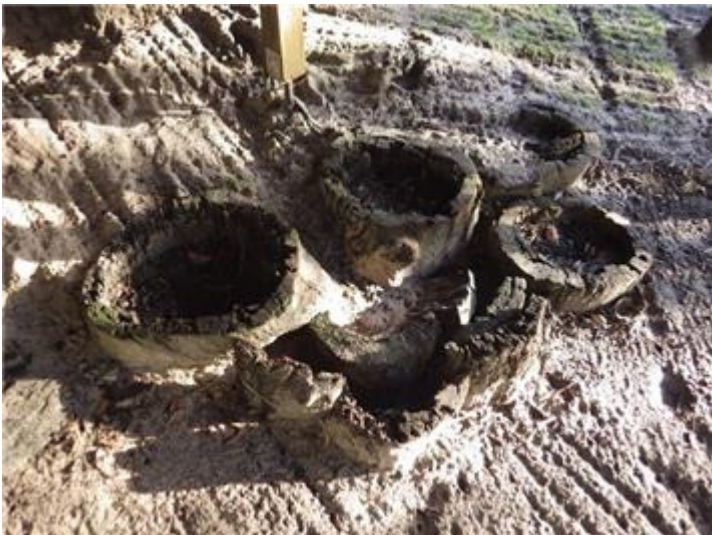
Tree stumps around dwelling should be test drilled for termites or removed

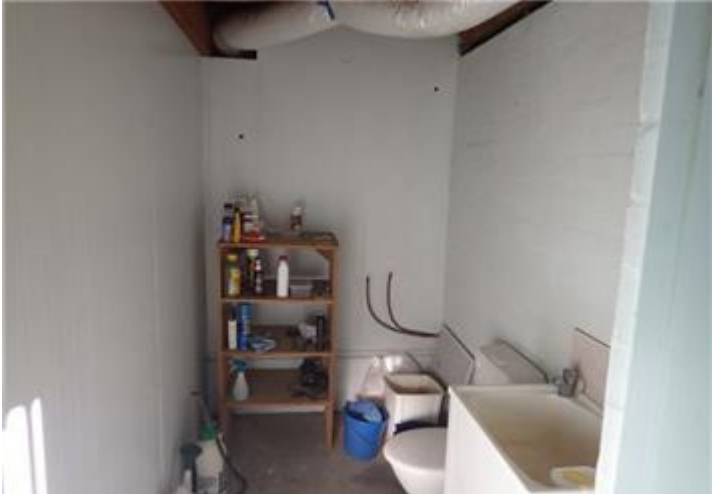
Garage

Mortar appeared weak due to long periods of moisture

An agi drain could be installed behind brick wall to stop any moisture coming through walls
