Buy-Wise Inspection Services P/L

SPECIAL PURPOSE INSPECTION REPORT

MOVEMENT AND CONDITION OF DWELLING

Inspected Property Address:	Carrum Downs	
Client Details:	Name: Sample Report	
	Address:	
	Phone:	Mobile:
	Email:	
	Client Attended Inspection: No	Contract Details: N/A
Inspection Date & Time:	Monday, 30 May 2011 1:30:00 PM	
Building Consultant:	Peter Hearn DB-U12617	Phone: 9775 7188
Agent:	Michelle	Phone:

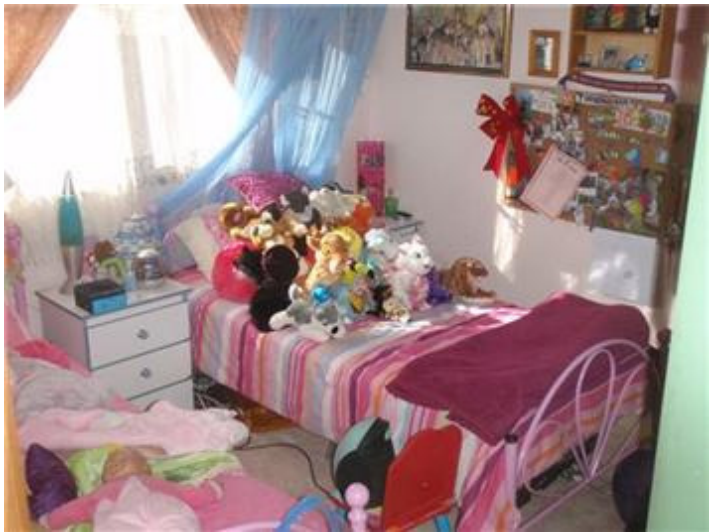
Ceilings	Plaster	Nail popping noted to plaster sheets in areas, extra screws may be required to support plaster sheets
-----------------	---------	---

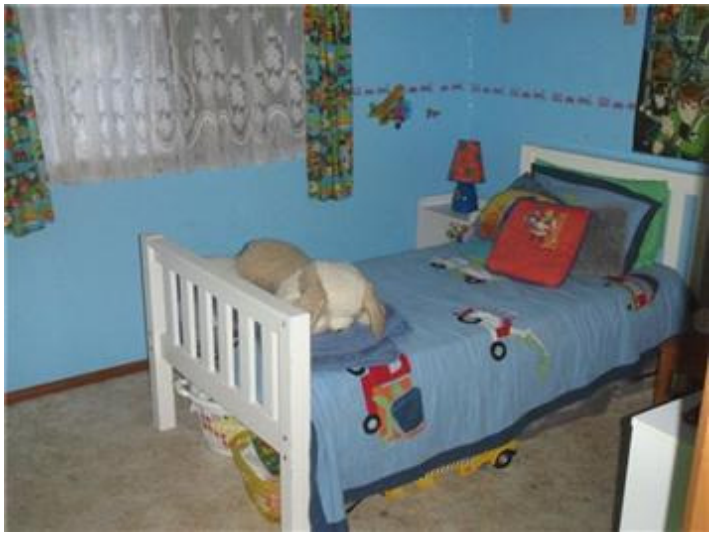
Ceilings	Plaster	Movement noted between plaster sheets at join, minor repairs required and is unknown if they will return Ceilings in roof space have not been back blocked which prevents movement between sheets See comments in roof space
----------	---------	--

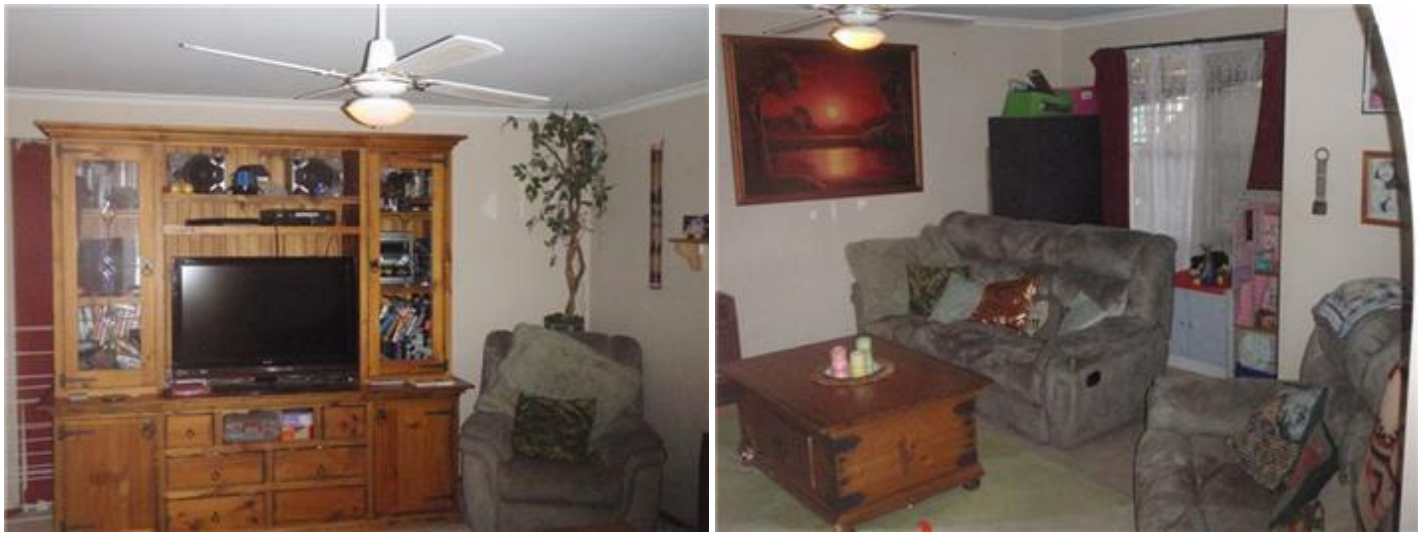
Walls	Plaster	Minor movement noted in areas
-------	---------	-------------------------------

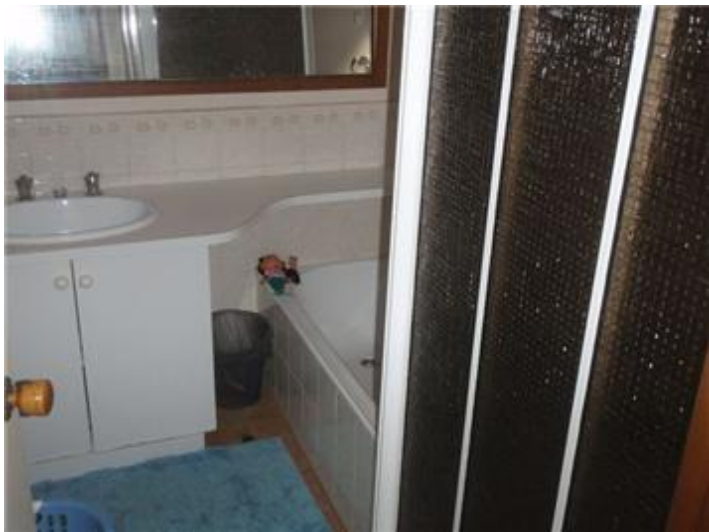
Ceilings Plaster Minor movement noted between plaster sheets at join,

minor repairs required and is unknown if they will return

Some water damage noted to bottom of doors under sink

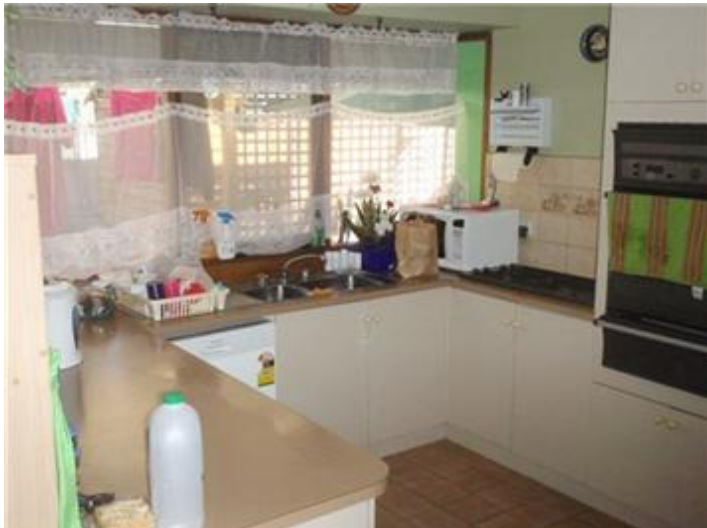
Ceilings	Plaster	Nail popping noted to plaster sheets in areas, extra screws may be required to support plaster sheets
Walls	Plaster	Hole noted to plaster behind door that has been filled, repairs required

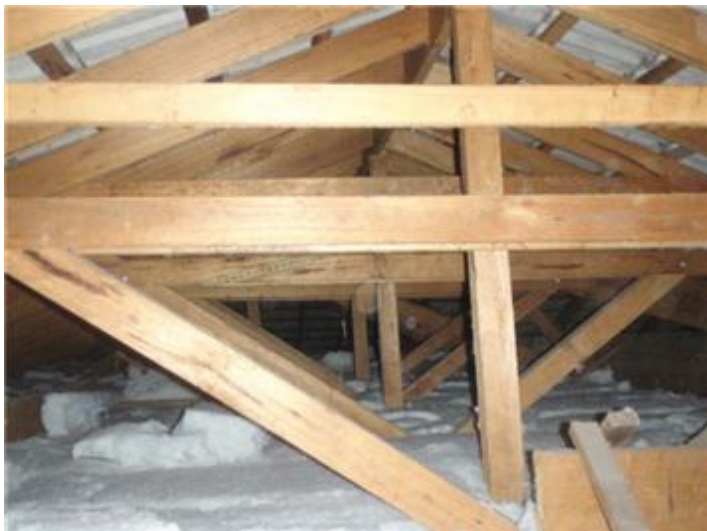
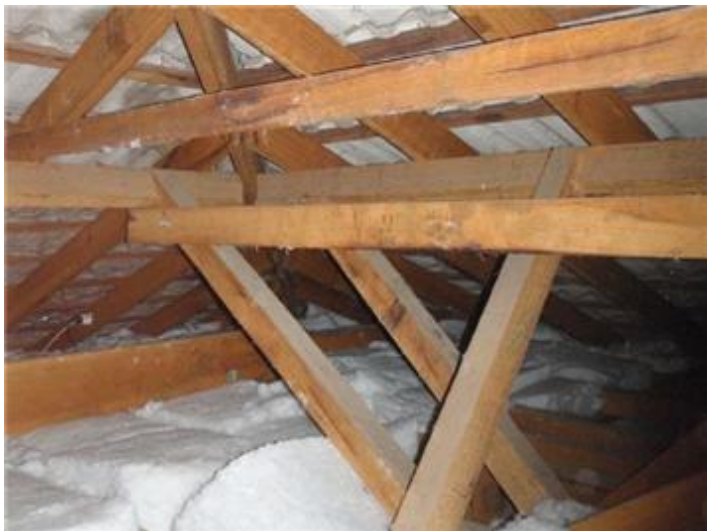
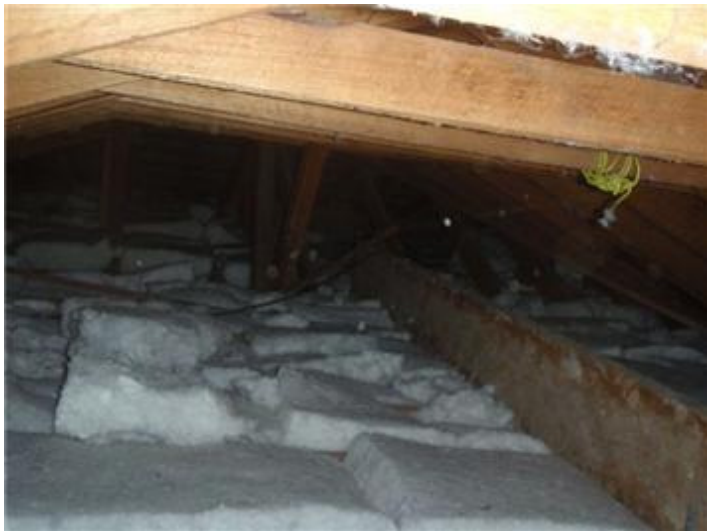
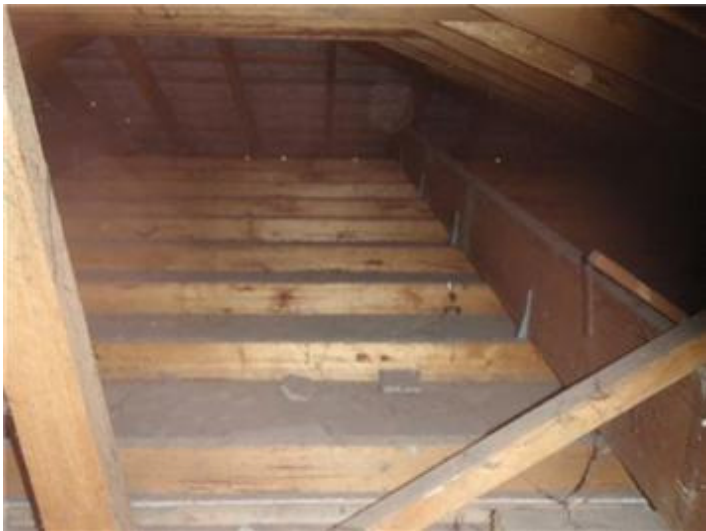
Comments Plaster ceilings are not back blocked on top of joins of plaster sheets, this is good practice and can eliminate movement or further movement between plaster sheets and can be installed Cost \$400

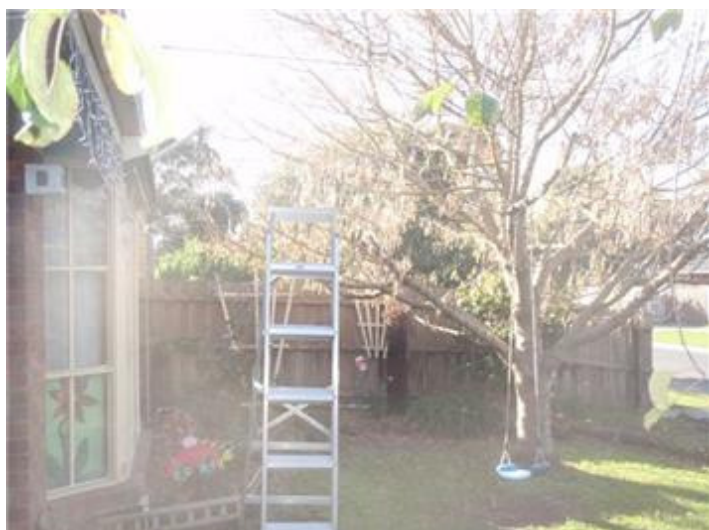
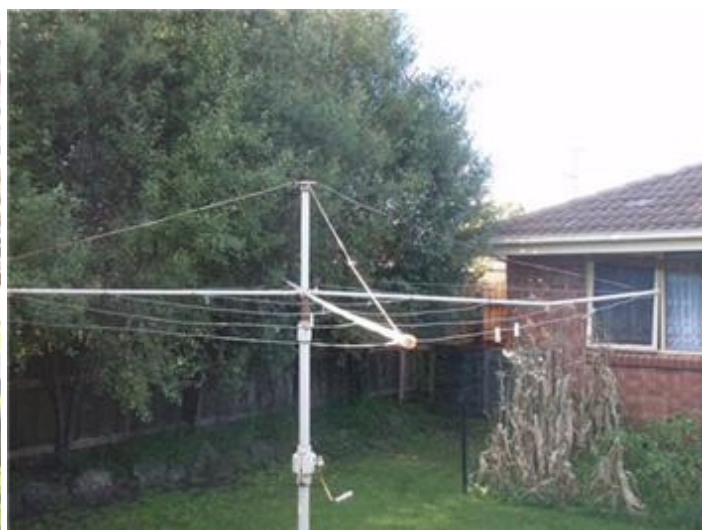
Walls	Brick	<p>All appears to be in good condition with little to no movement noted</p> <p>No expansion joints noted in brickwork to dwelling, this is a current requirement for new dwellings and will control the movement to these joints</p> <p>Where drainage or gutter/downpipe problems exist around a dwelling, these can have an affect on the dwellings foundations due to changing soil conditions</p> <p>Where trees are to close to the dwelling this could affect the performance of the footing as the moisture levels change in the ground. A Geotechnical Inspection can determine the foundation material and advise on the best course of action with regards to trees. large trees have been known to affect house foundations up to 1.5 times their height.</p>
--------------	-------	--
